## 2018 The Dalles Dam Spillway Stilling Basin ROV Inspection Report

**Inspection date:** 12/11/2018;

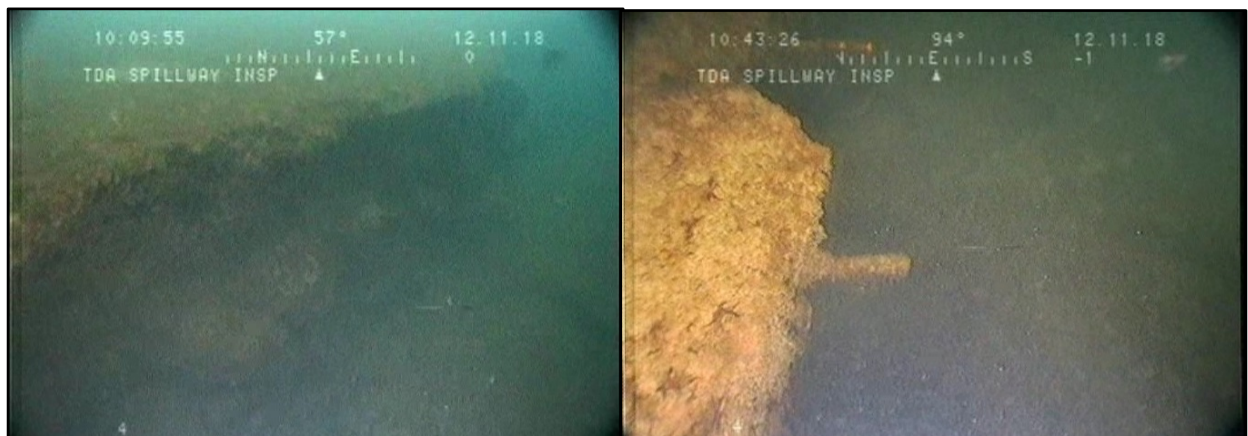
Figure 6 Images showing typical downstream apron end sill erosion along the entire apron downstream of Spillbays 1-8.

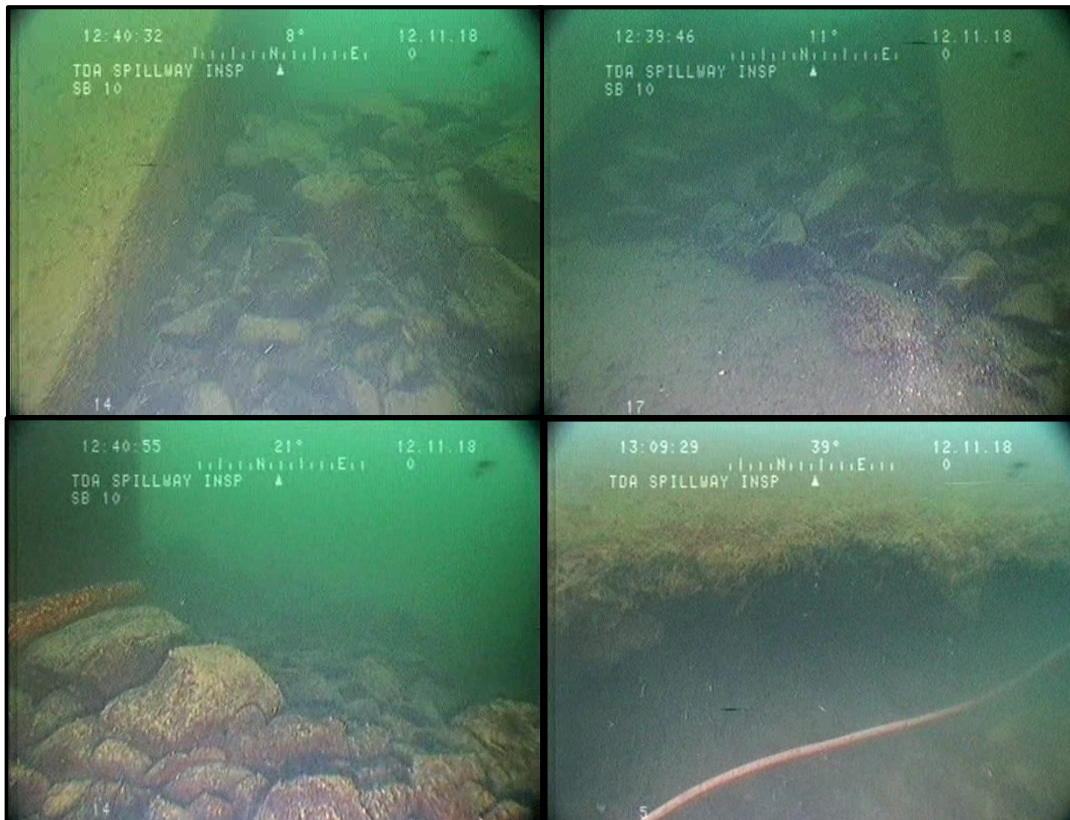
Figure 10 Images showing rocks found between baffle blocks in Spillbay 10 as well as the typical condition of the downstream apron end sill to riverbed interface showing minor undercutting.

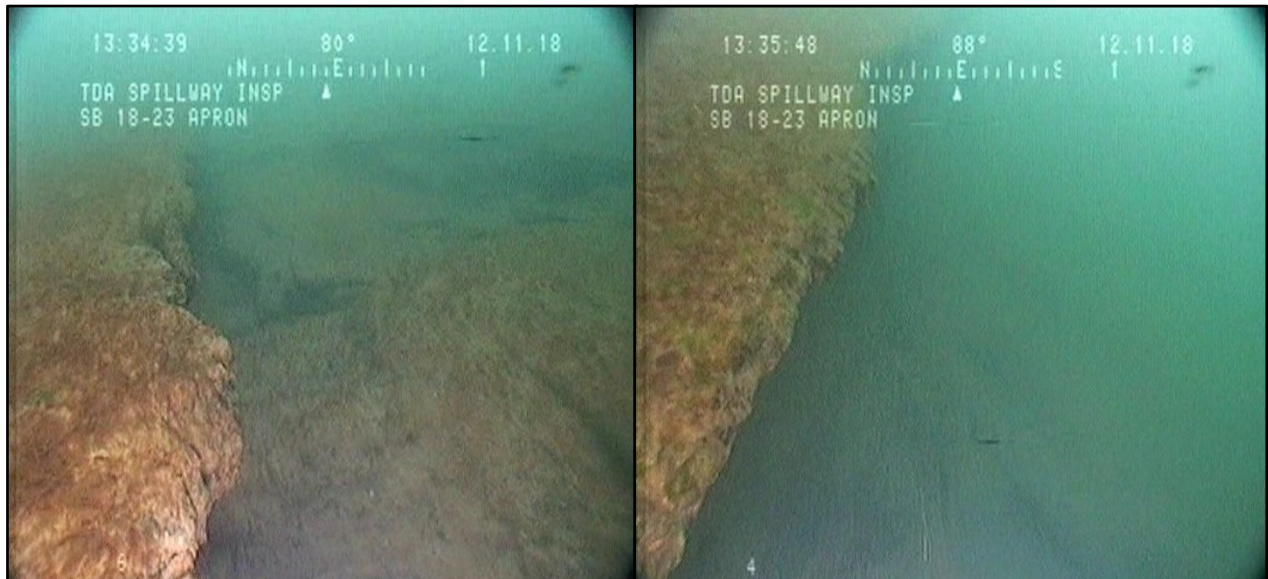
Figure 12 Image on the left is the apron to riverbed interface in the area of Spillbay 18. The image on the right is in the area of Spillbay 23. The distance from the apron edge to the river bottom increases in this area as does the noted undercut. This area is very difficult to inspect by ROV due to the powerhouse generation and ice & trash sluiceway flow.
