Subject: Bonneville Adult Collection and Monitoring Facility (Bonn AFF):
Proposed Improvements for Small Project work in the Fiscal Year (FY) 13 In-Water Work Period

From: Stephen Schlenker, EC-HD
Jon Rerecich, PM-E
Steve Sipe, EC-DM

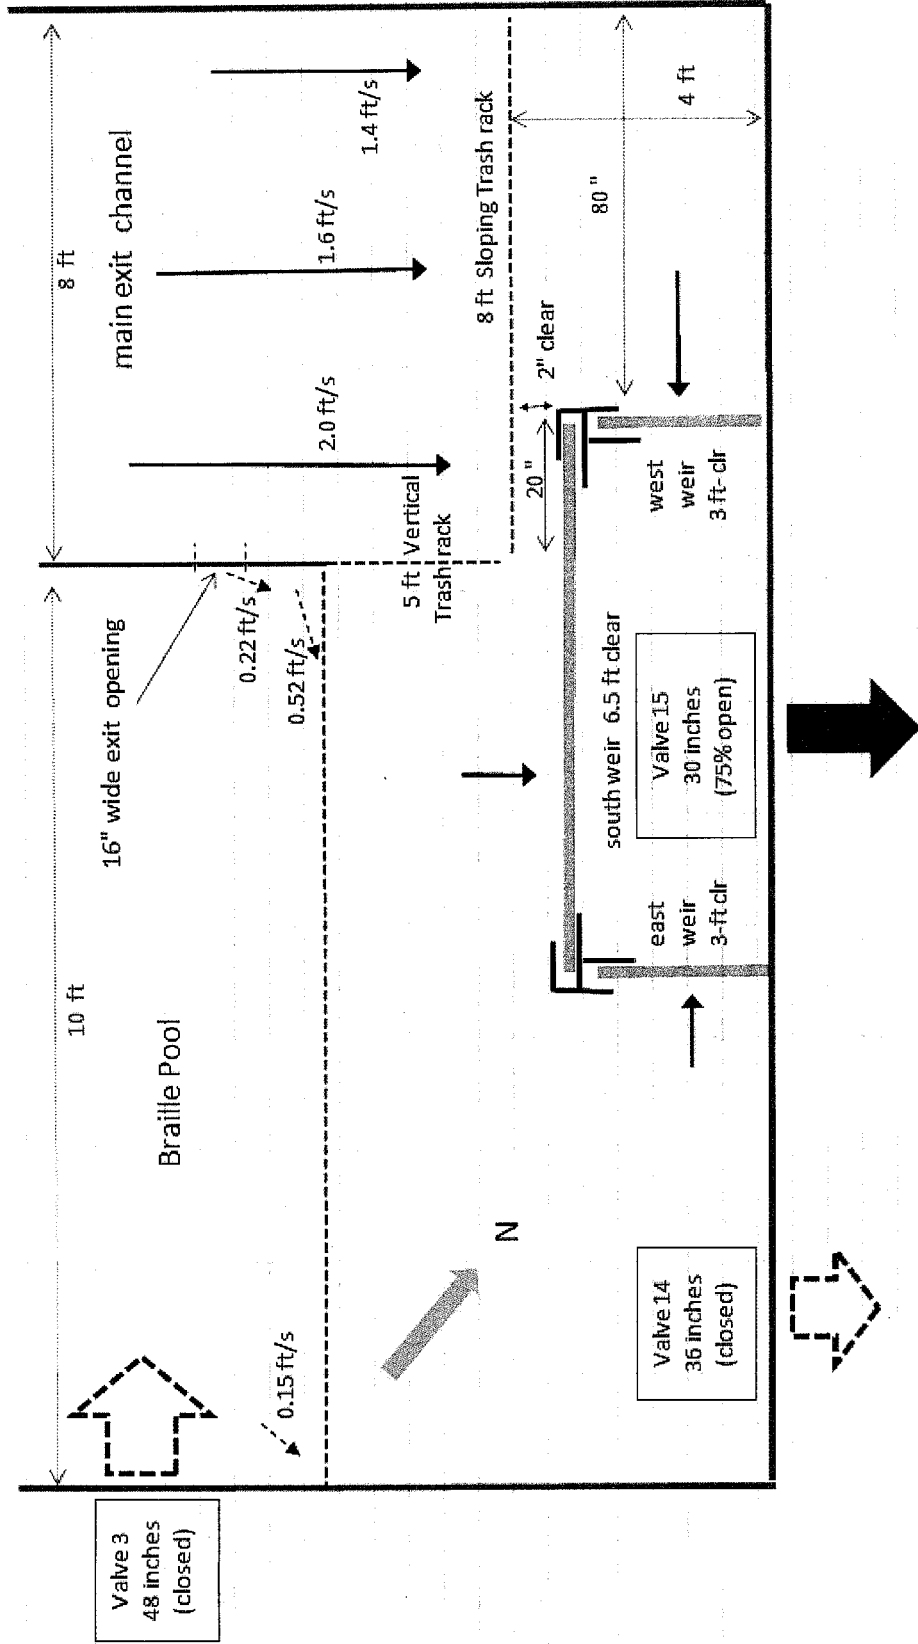
Figure 2 – Schematic of Existing Braille Pool and Exit Channel area under Existing Operation (with depth-averaged velocities).

The 20-foot long deeper section passes the 10-foot wide brail pool and terminates with a sloping 8-foot wide trashrack. There is an 16-inch wide x 1.9 feet deep exit opening from the brail pool into the main exit channel, located about 7 feet upstream of the main trashracks. This is where recovered fish (previously sampled) return to the main exit channel and main ladder system. A detailed schematic plan view of this area under existing operation is shown in **Figure 2**.

For the same exit channel measurements, the depth averaged velocity as a function of lateral location is shown in **Figure 4**. The velocity was averaged over the full depth (4.9 feet) at different lateral location. The Price Meter data (red curve) is more reliable. The velocities are higher on the right (east) side of the channel, adjacent to the Brail Pool. The reason is that there are multiple flow paths towards the stoplog weirs from the right side of the channel in the complicated non-symmetrical weir and valve pit geometry (See **Figure 2**).

Velocities were measured at different locations along the north (or NE) edge of the brail pool (which was most assessable and showed the most visible flow). The measurement locations and depth averaged velocities are shown in **Figure 2** (presented earlier). The highest velocities (0.5 ft/s) are in the far north (or NW) corner of the brail pool, adjacent to the main exit channel and exit opening. Velocities at the exit opening were notably lower at 0.2 ft/s with the direction of the flow parallel to the opening and west sides of the brail pool.

The higher surface velocities at location 1 and 1A indicate the influence of the adjacent exit channel and the downstream weirs. The velocities are faster in the lower depths at location 2 because the sides below water are blocked in the upper 2 feet and the bottom 2 feet have open grating.

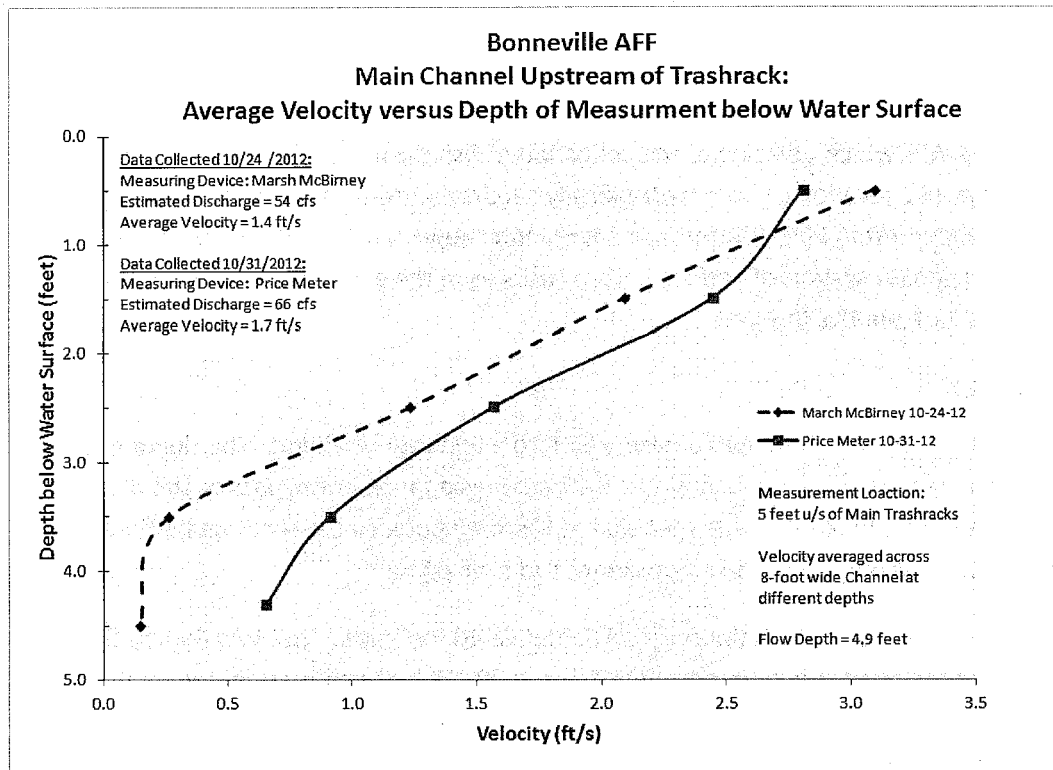
Figure 3 – Average Velocity versus Depth below Water Surface in Exit Channel (5 feet U/S of Trashracks)

The average velocity (as a function of depth below water surface) is shown in **Figure 3**. The velocities were averaged across the channel (8 foot width) at different depths (flow depth = 4.9 feet). The Price Meter data (red curve) is more reliable. The velocities are over 2.8 ft/s near the surface and less than 1 ft/s below 3.5 feet. The velocities are much faster near the surface because the outflow and water surface level is mainly controlled by stoplog weirs, and the weirs primarily draw water from the surface (there is also leakage through the stoplogs). The overall average velocity was 1.7 ft/s with an estimated total flow rate of 66 cfs.

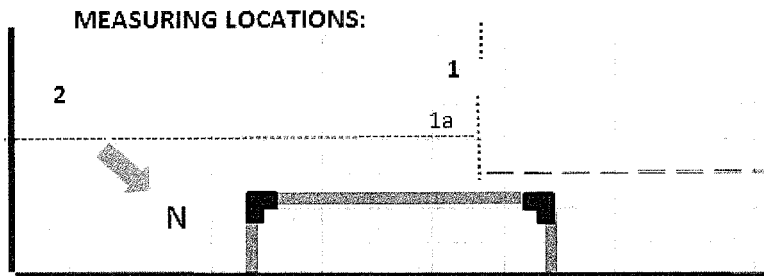
Table 1 – Braille Pool Measurement Locations and Velocities as a function of Depth

The velocities as a function of depth in the pool are shown at each location in Table the measurement locations are shown numbered in the upper schematic. The data for the current operation (valve 15 at 75% open) is shown in the lower left. The lower right has data from a modified operation (valve 15 @ 70% and Valve 14 @ 30 %). The velocities changed negligibly in the Brail Pool between these operations (but the velocities in the exit channel increased significantly under the modified operation.)

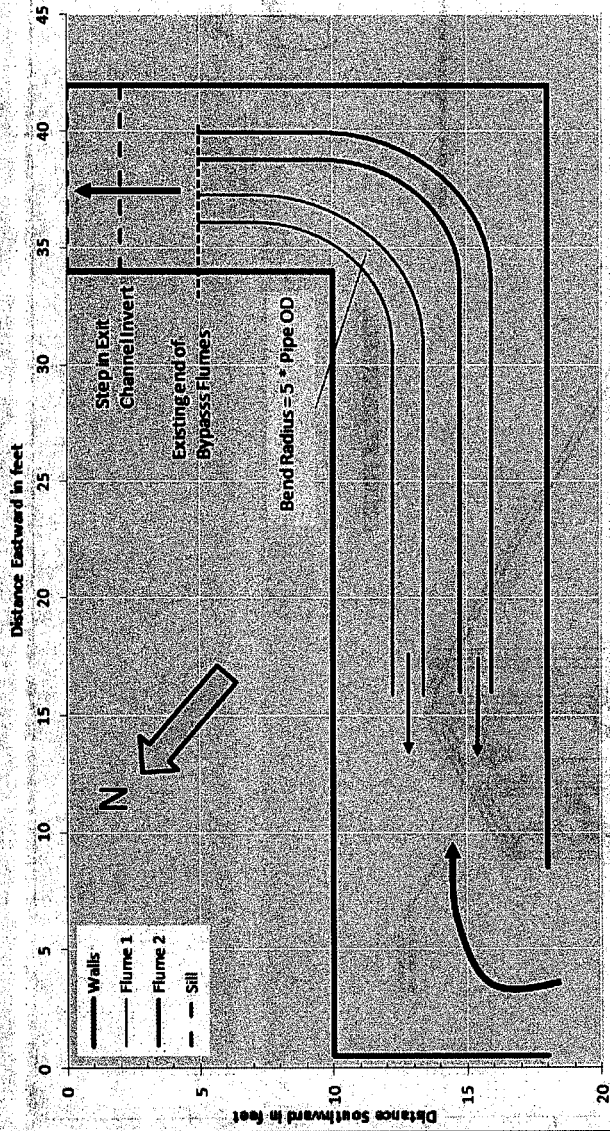
Figure 6 – Proposed Extension to Bypass Flumes at 5% Slope (Plan View).

The 14-inch OD Bypass Flumes exit at a level that has been measured to be about 2.6 feet above the water surface elevation in exit channel. This is in a fast, shallow (1.9 feet depth) location. There is vertical and lateral space to extend the flumes (at 5% slope) to at least 32 feet downstream and bend the pipes (per criteria: Radius = 5 x OD) to a location upstream that would reduce the drop from the flumes to about 6 inches. A plan view of the proposed extension is shown in Figure 6.

The new location would still be in a fast shallow location, however the added distance upstream plus reduced drop should help the bypassed fish.

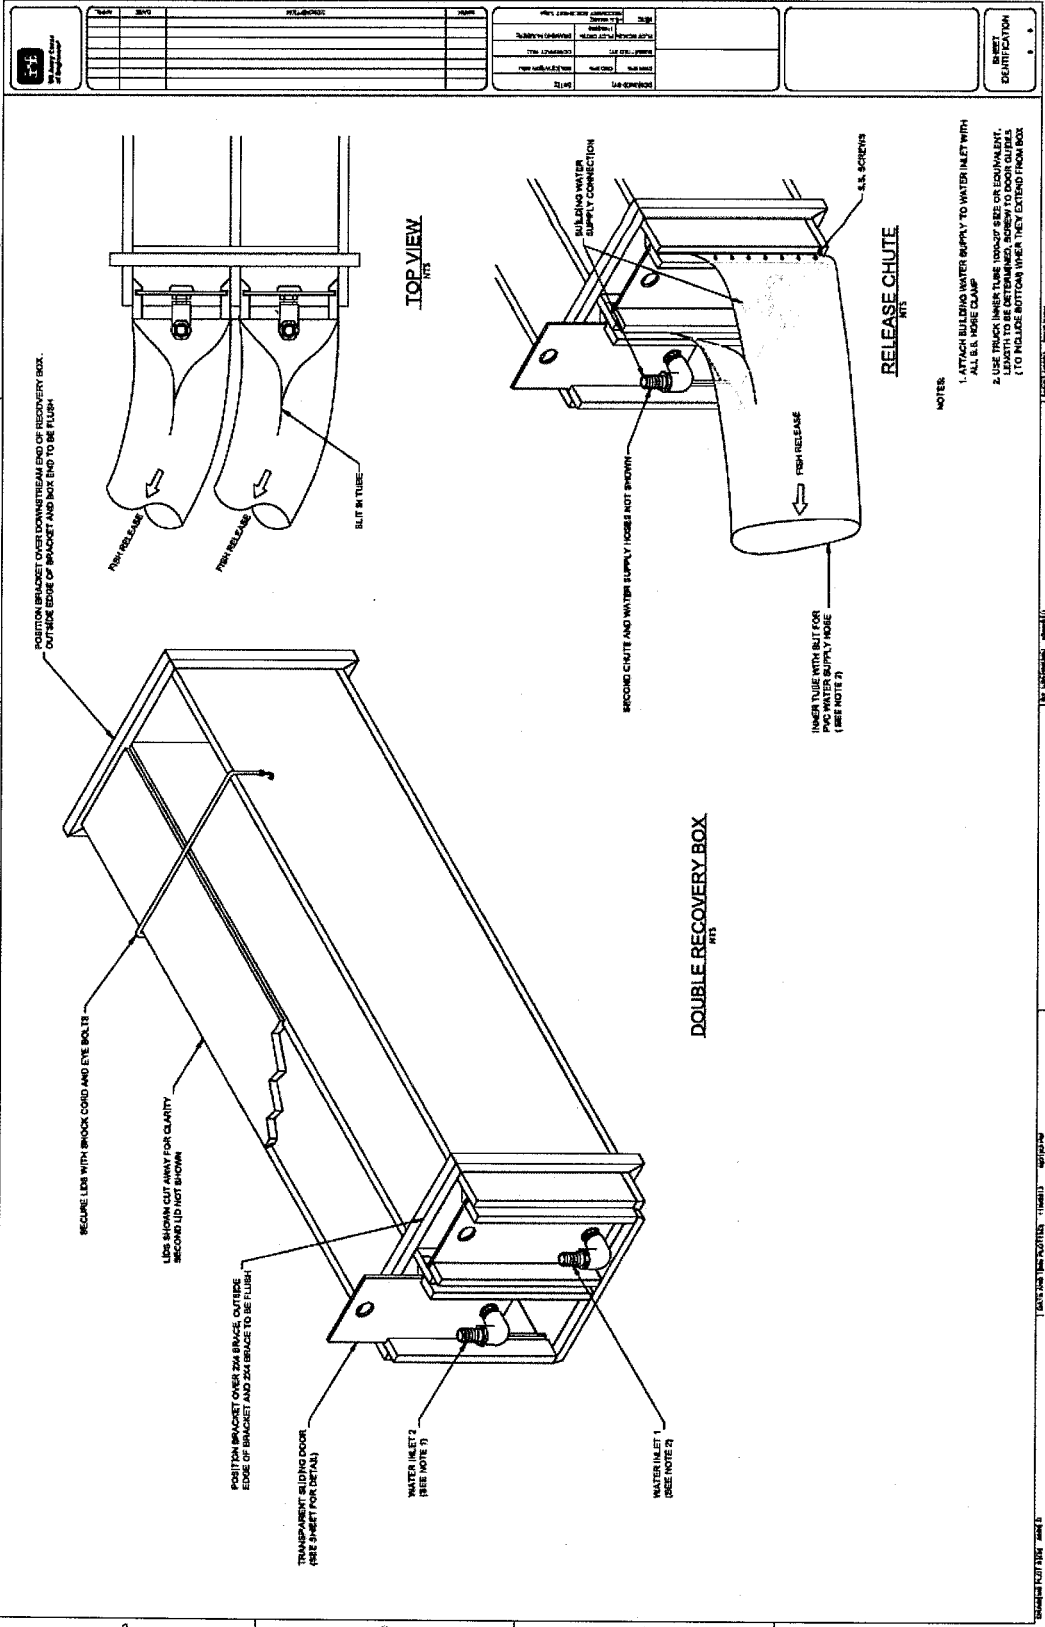
Figure 7 – Draft Recovery Tanks Drawing (Isometric).

The proposed recovery box volume is only 5.9 cubic feet and will fall well short of criteria.

Draft drawings of the tanks are shown in Figure 7 and Figure 8. However, there are changes intended since these drawings were developed:

- 1) The tanks are more intended to be aluminum instead of wood if possible.
- 2) A single fish holding chamber will be 4 feet long, 20 inches deep and 8.5 inches wide. There will be 4 chambers total, 2 boxes with 2 chambers each.
- 3) The bottom of each fish holding chamber will consist of a standard porosity plate, sloped at 5% toward the fish exit. There will be an additional chamber beneath the perf plate. The piped in flow will be discharged into the bottom chamber. The perf plate is intended to better distribute the flow into the fish holding chamber.
- 4) The wall separating the two chambers in each box will be removable to accommodate larger fish.
