Subject- New Lamprey ¾” Grating Criteria Implementation Recommendation

### **Proposed Lamprey Passage Improvement List for The Dalles and John Day The Dalles East**

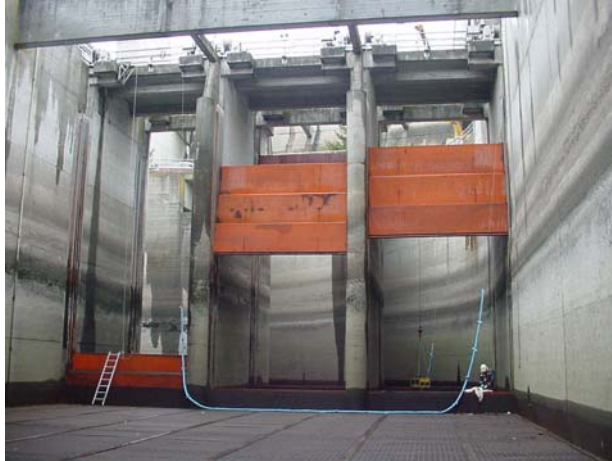
- 1) Grating – All 1" gap. New grating also 1" gap. Need to determine if ¾" can be used effectively against wall where lamprey travels. New 1" gap grating on site to be installed in junction pool and east entrance. Reducing gap requires hydraulic analysis (velocity and volume), structural analysis and risk analysis in the event of zebra/quagga mussels.  
*Prioritization for ¾" installation;*
  - A) Lower east #L6 thru L15 and north #N5 thru N15 ladder grating exposed during dewatering
  - B) Junction pool #J1 thru J8 and L1 thru L5
  - C) East #E1-1 thru E1-6, West #E2-1 thru E2-4, South #E3-1 thru E3-8 and North #1-A thru 1-H and #N-1 thru N-5 entrance equal priority value.
- 2) Junction pool bulkhead stub walls – Used to prevent debris accumulation under bulkhead slot. Lamprey commonly found in this area during dewatering. Bulkheads not used here

for at least 15 years. Picture below. Options; ramp or removal.

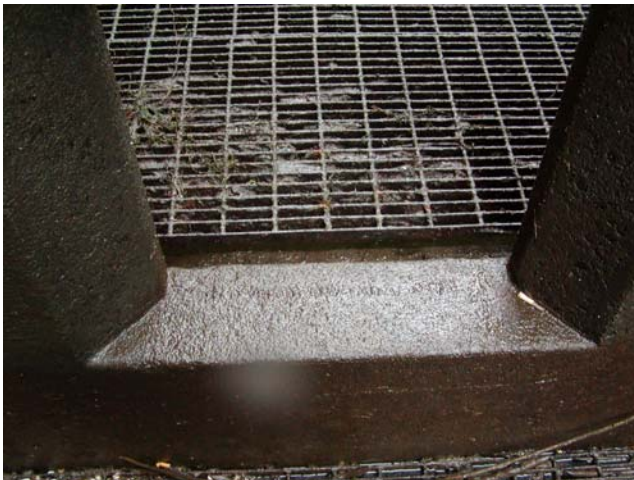
- 3) Step up on first ladder weir – Needs a ramp. Will be a challenge due to grating. Could be chamfered. Picture below.

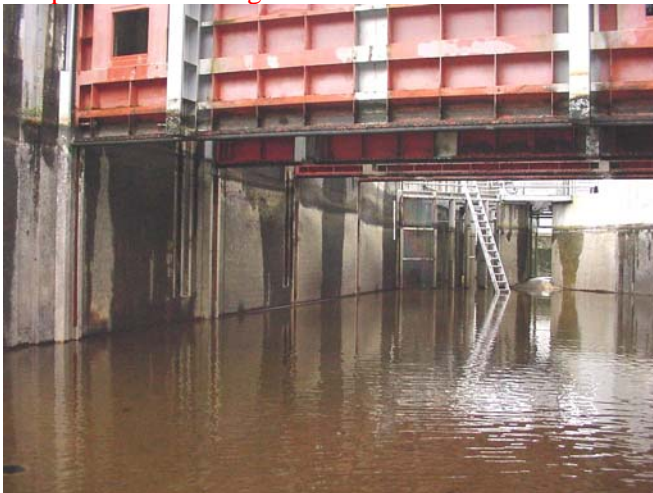
- 4) **Step up on 180 bend upstream weir** – Needs ramp. Can be done by project during winter outage. No Picture.
- 5) Weirs 154-147 – orifices raised various distance from floor. Options; new design or modify with ramp. **Worn seals to be replaced to prevent lamprey entry into guide and potential crushing.** Picture below.

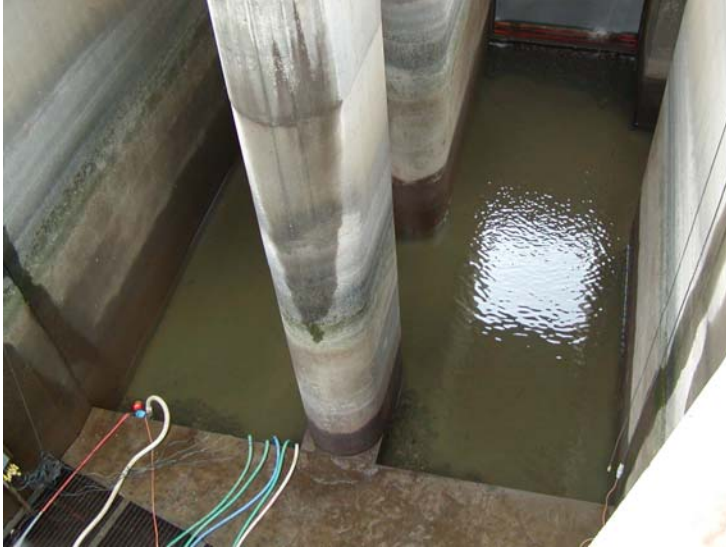
- 6) Entrance and exit weir guides – Provide hiding place for lamprey. Potential crushing when weir makes adjustments. Lamprey observed pinched by lift beam extension. Option; install brush to deter lamprey entry. No picture.
- 7) South entrance depression – 3’ floor depression immediately upstream of weirs. Option; ramp upstream edge of pool. Picture below.

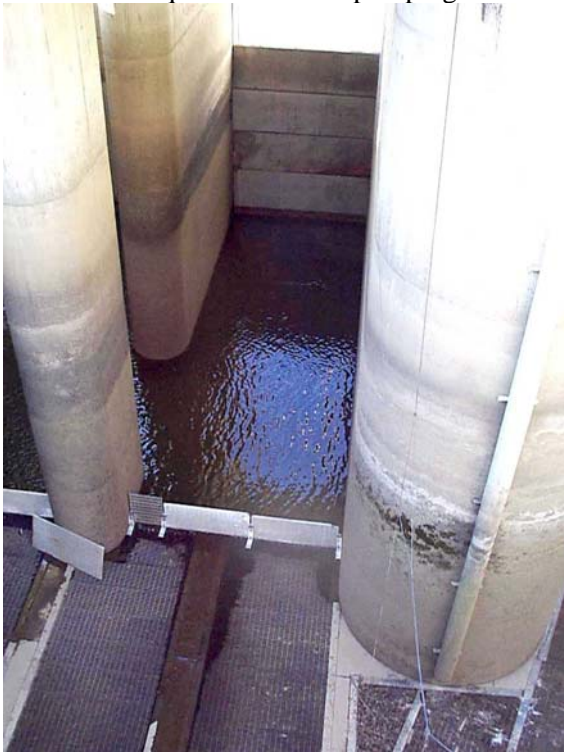
- 1) Grating – Same as above.
- 2) Lower weir pools with rock pools – Floor raise up to 3’ to weir orifice. Option; ramp. Would require additional pumping for remove water from pool. Picture below.

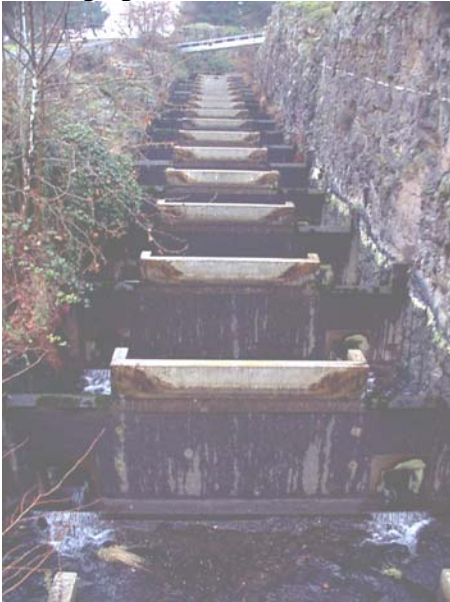
- 4) Rock channel in ladder – Not smooth, but may not be detrimental to lamprey passage. Routinely find lamprey in these areas during dewatering. May also be beneficial lamprey staging area. Picture below.

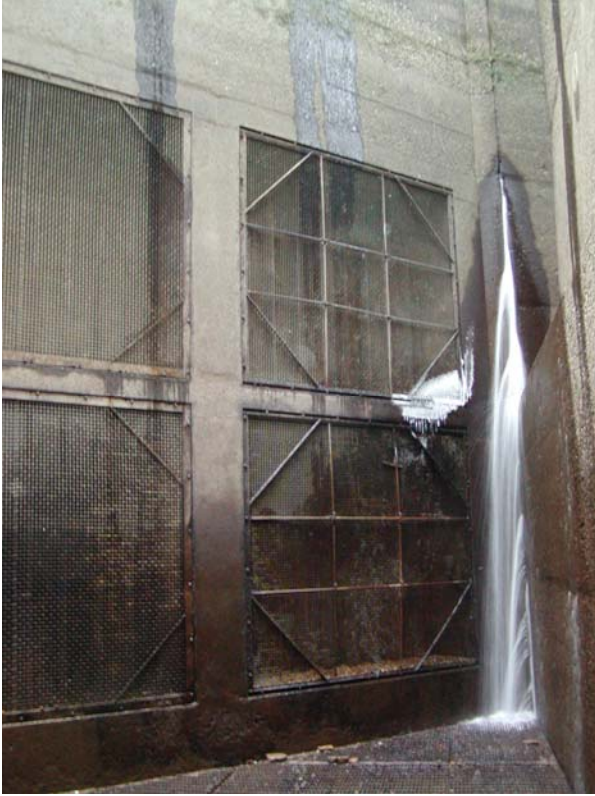
- B) *South ladder dewater exposed grating #9-#16*
- C) *North ladder dewater exposed grating #7-#15*
- D) *South entrance and south collection channel grating*
- E) *Remainder of collection channel*
- F) *Remainder of north fishway.*
- 2) South entrance depression – Immediately upstream of SE1 weir. Approx 12' depression. Option; round upper edge. Ramp not feasible due to grating and distance.
- 3) **Wall Diffuser** – Chain link grating. No longer used. Should be plated over. Picture below.

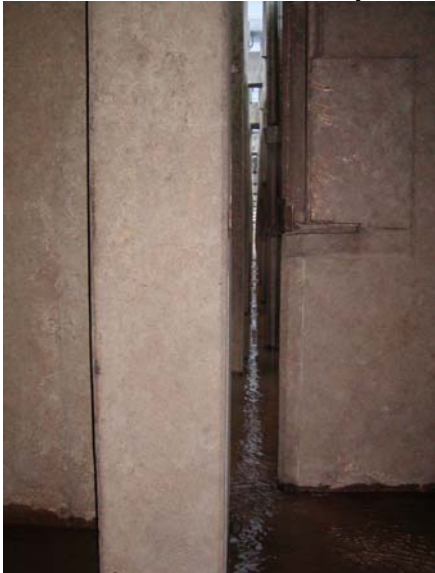
- 4) Upper diffuser grating – 1” gap. Known lamprey trapping area. Change to  $\frac{3}{4}$  same as north.
- 5) New exit flow control weirs hydraulic sills – Option; design change.

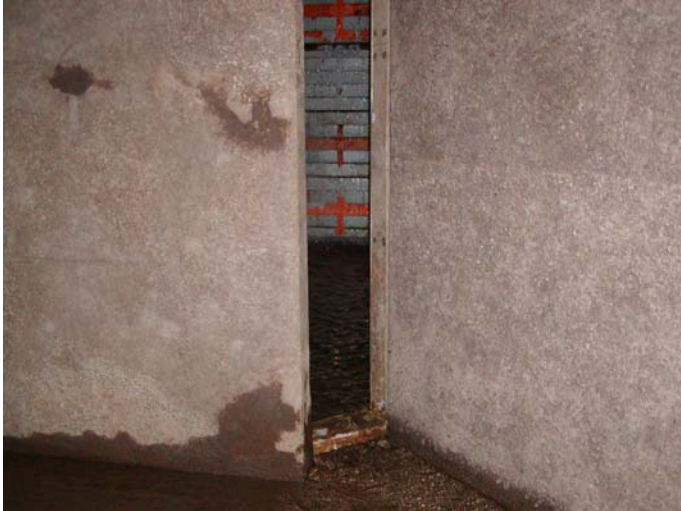
- 6) **Exit stub wall** – 6” raise in floor under road deck located at half duplex antennae. Option; ramp. Picture below.

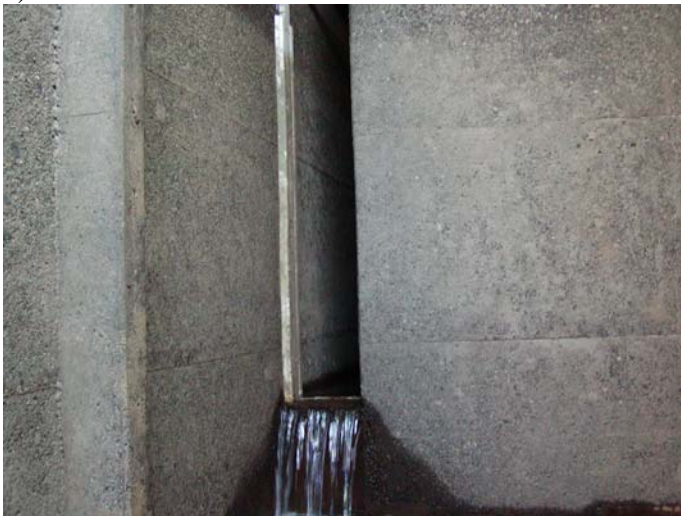
- 1) Grating - same as above.
- 2) Upper diffuser grating – Changed to  $\frac{3}{4}$ '. Seemed to be effective preventing entrapment. Floor raise approx 1' still exists at first upstream weir. **Grating for the south upper diffuser is comparable to the north and will be replaced with  $\frac{3}{4}$ ".**
- 3) Exit hydraulic sills – Option; design change. Picture shows sills open. Normally operate with sills closed.
- 4) **Exit stub wall** – same as above. Picture below.

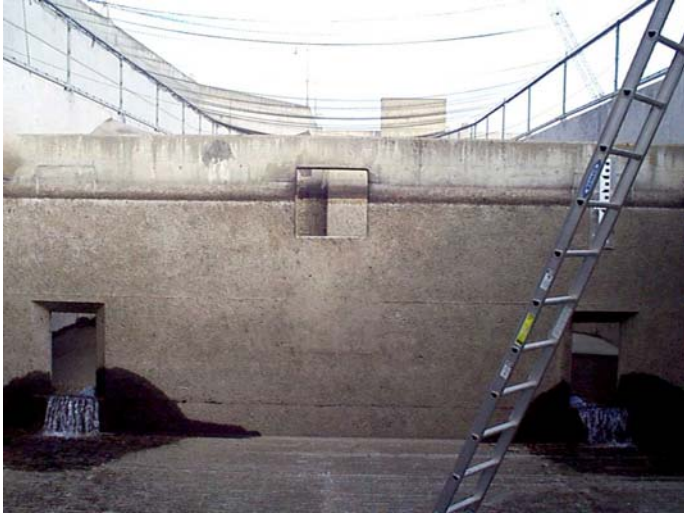
5) **Orifice raised upstream of count station** – Option; chamfer orifice floor. Pictured below.
