Lower Monumental North Shore Fish Ladder (Dewatered)
27 January 2011
Inspection Report
Prepared by: Brett Morris, CENWW-EC-H. Photos by Derek Fryer

Purpose – A brief field inspection of the partially dewatered north shore adult fish ladder was performed to ascertain additional physical obstacles to lamprey migration.

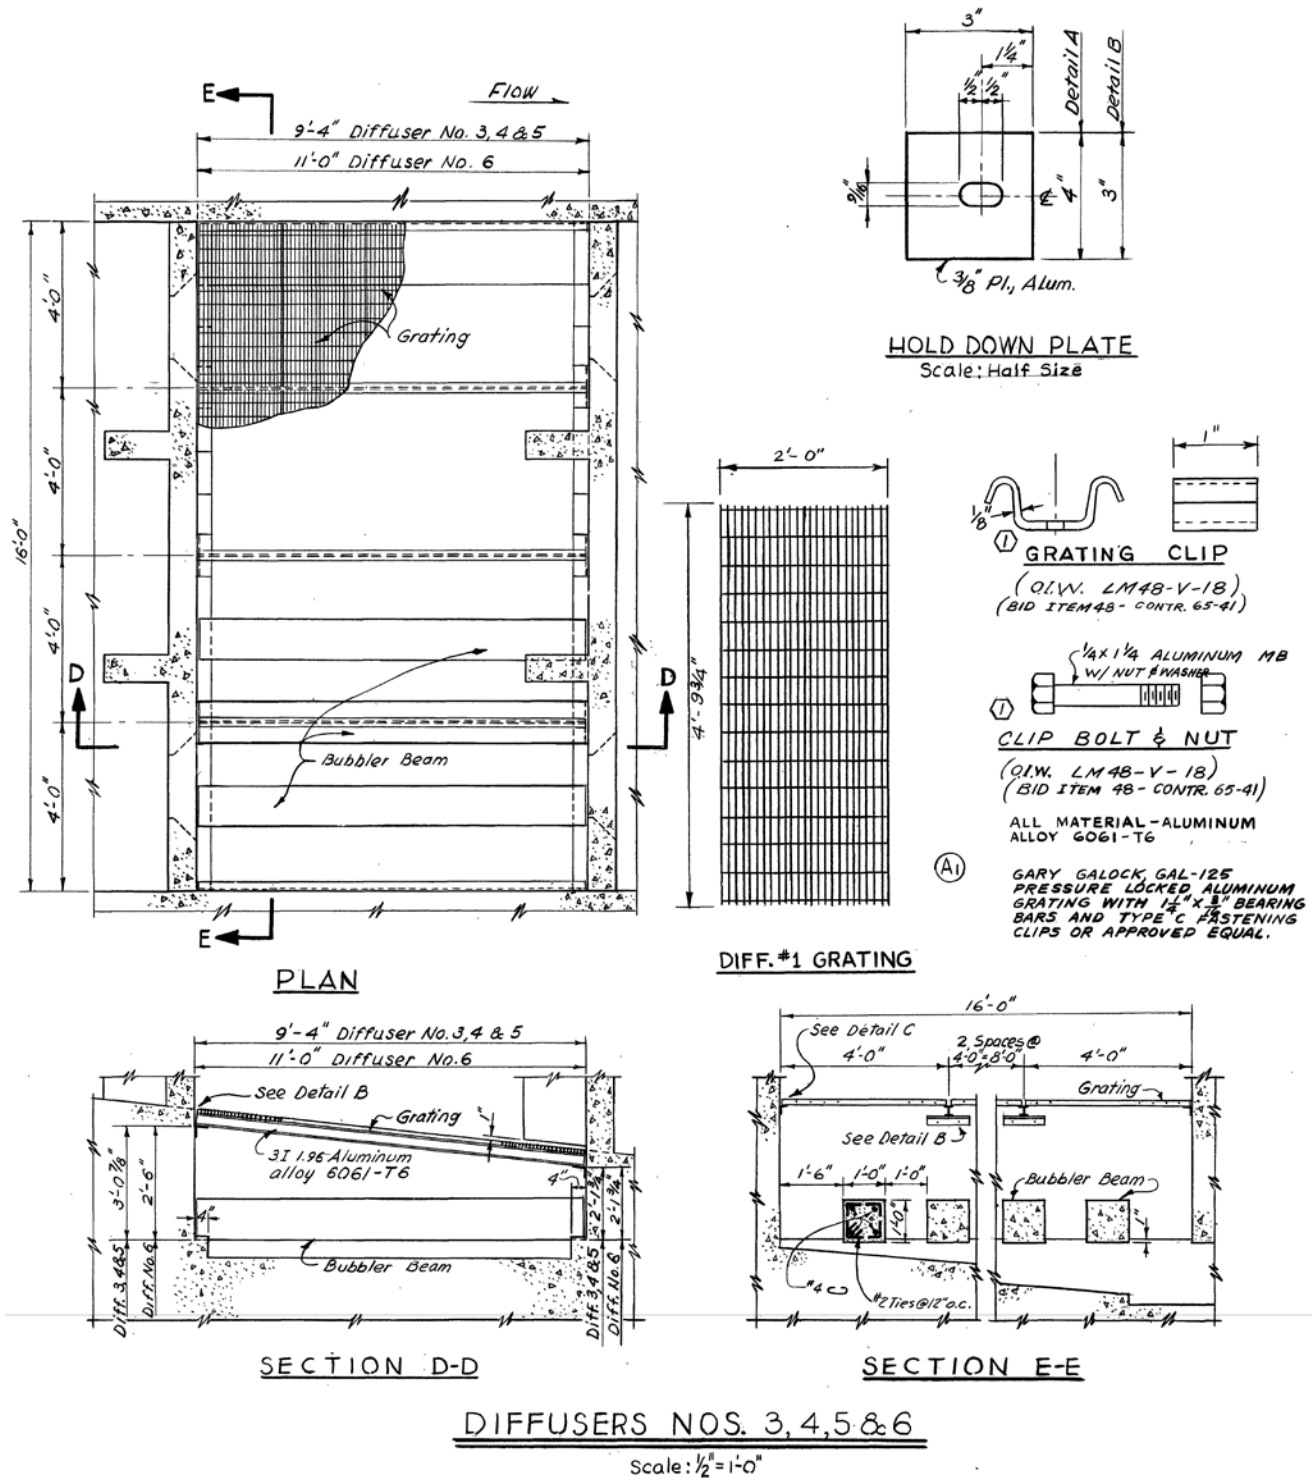
Figure 2 – Lower Monumental North Shore Fish Ladder Diffuser Grating Details (2A and 2B similar)

The team walked over the locations of the lower diffusers 2A, 2B, 3, 4, and 5 (1 is located on the south shore ladder). The grating was submerged and couldn't be inspected, however the project has indicated that the grating is overdue for replacement.

As indicated earlier, the grating on the lower diffusers 2A, 2B, 3, 4, and 5 is overdue for replacement, and diffuser 6 grating will likely be replaced should the lower diffuser grating get replaced. Adult lamprey friendly grating clear spacing has been shown to be $\frac{3}{4}$ inch or smaller. Currently, the grating has a 1 inch clear spacing. The smaller grating clear spacing will prevent lamprey from entering the diffuser chamber and being trapped or delayed. If the diffuser grating spacing is reduced to $\frac{3}{4}$ inch, any supply system intake screens must be replaced in-kind to prevent entrapment and subsequent clogging of debris behind the diffuser grating. The costs associated with replacement of both the diffuser grating and the supply system intake trash screens could be prohibitively high, in particular given the uncertainty of the degree of the lamprey separation problem.

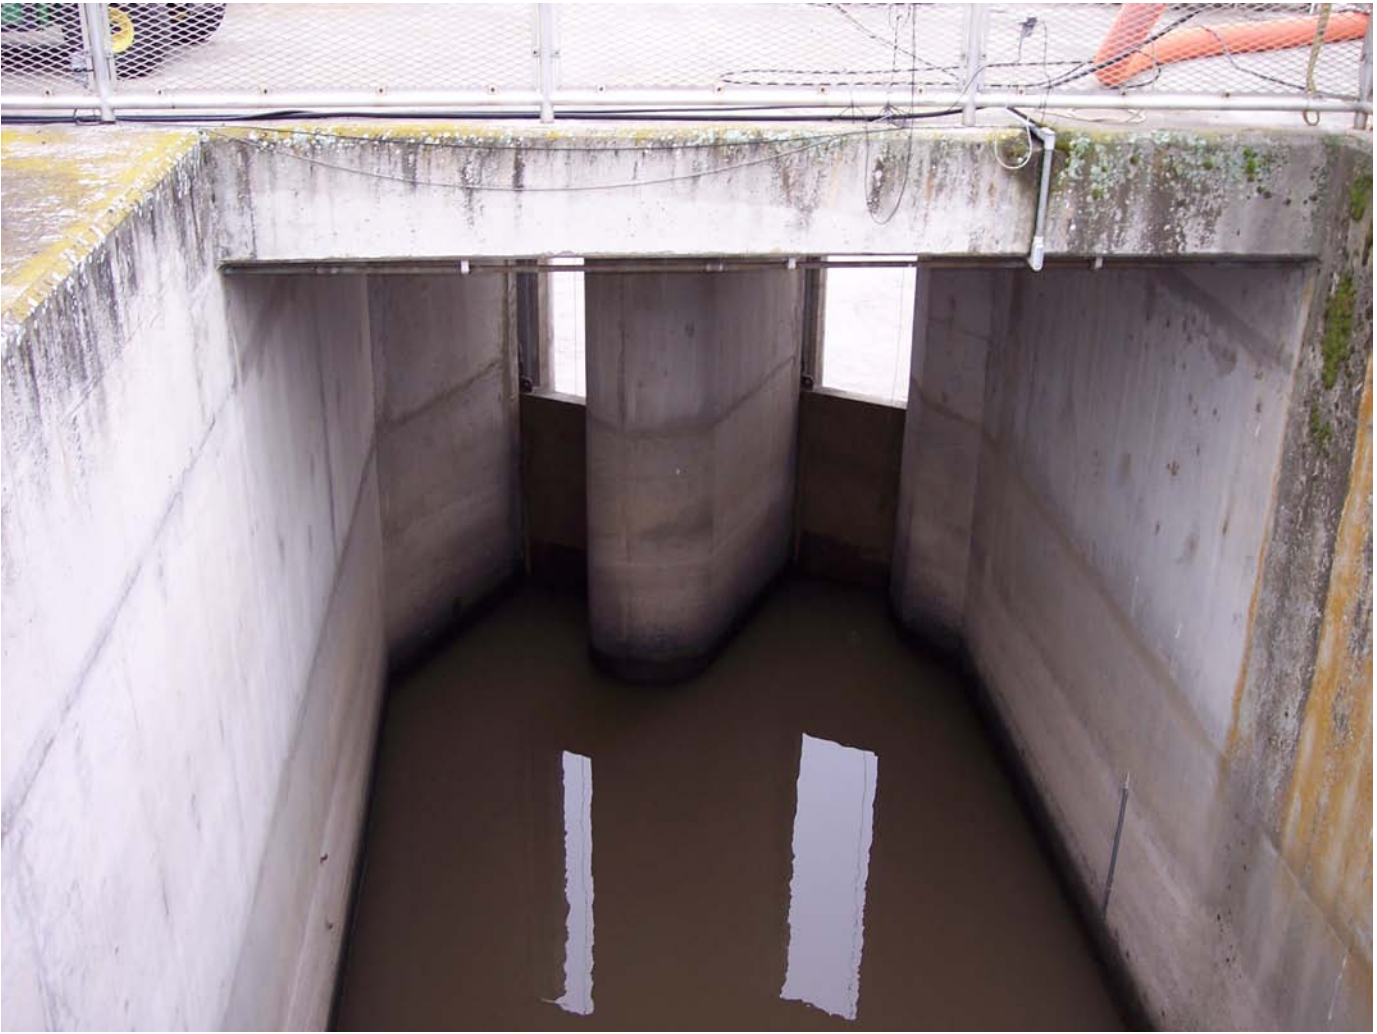
Figure 3 – North Shore Entrances NSE1 and NSE2 Looking Downstream.

The team next observed the north shore and south powerhouse fish ladder entrances, designated as NSE1 and NSE2, and SPE1 and SPE2, respectively. All entrances were temporarily bulk headed shut for dewatering of the fish ladder. NSE1 and NSE2 utilize 4 feet wide by 18 feet high, upstream skin plated, single leaf overflow weir gates and face powerhouse outflow with a 30° downstream skew. SPE1 and SPE2 utilize 6 feet wide by 15.5 feet high, upstream skin plated, single leaf overflow weir gates and face directly downstream. It should be noted that SPE3, another south powerhouse entrance that faces the spillway tailrace in the lateral direction, has been permanently closed.

As noted earlier entrance gates at the north shore (NSE1 and NSE2) and south powerhouse (SPE1 and SPE2) are single leaf overflow gates, unlike the double leaf (telescopic) overflow entrance gates at McNary and Ice Harbor Dams. The telescopic gate configurations at McNary and Ice Harbor allow the bottom of the lower gate leaf to be raised above the sill while the upper leaf functions normally, adjusting for varying tailwater elevations. The resulting gap between the sill and bottom of the lower gate leaf allows the installation of a lamprey passage device such as the current ported lamprey hood box and baffle section being tested at McNary via physical modeling at ERDC. The current single leaf gate configuration cannot operate normally while simultaneously maintaining a constant gap at the sill for the installation of a McNary-style lamprey passage device. Should a McNary style lamprey passage device be considered for the entrances at Lower Monumental Dam, the design and installation of a telescopic gate modification may be necessary.

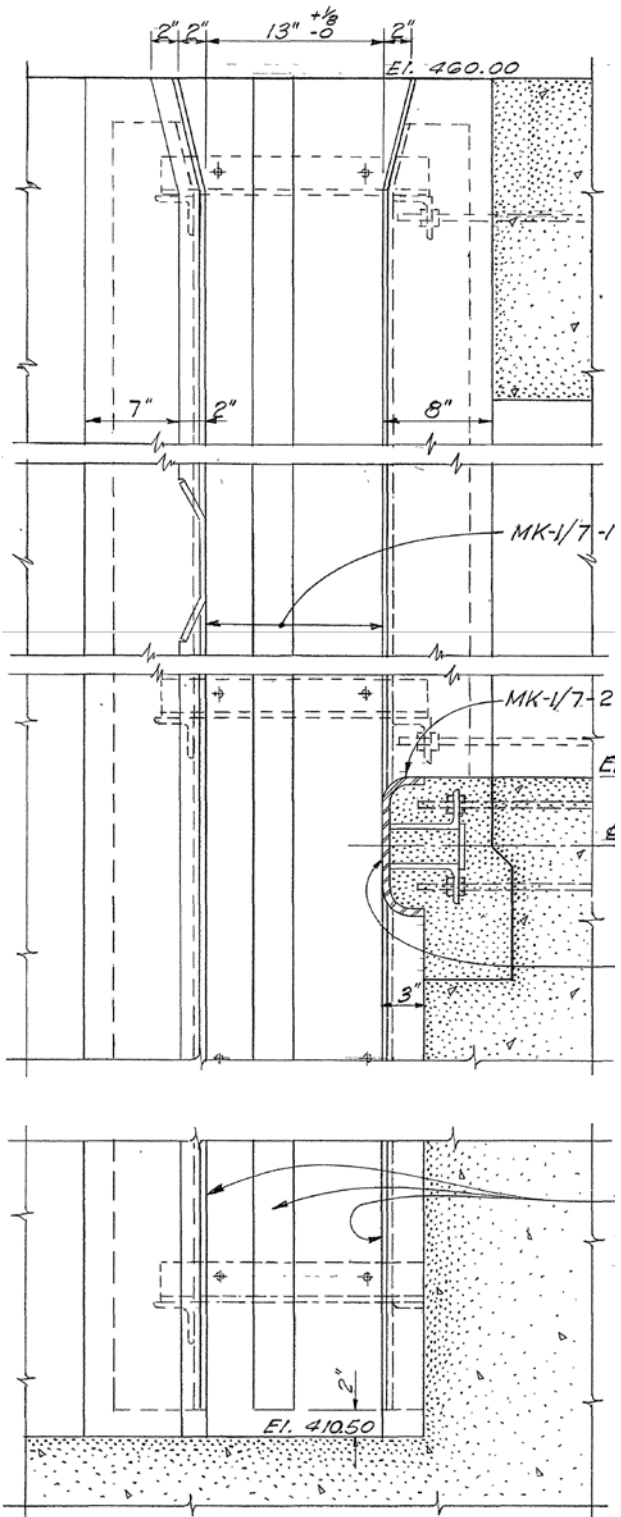
Figure 5 – North Shore Entrances NSE1 and NSE2 Gate slot and sill. Sill Elevation is 429.0.

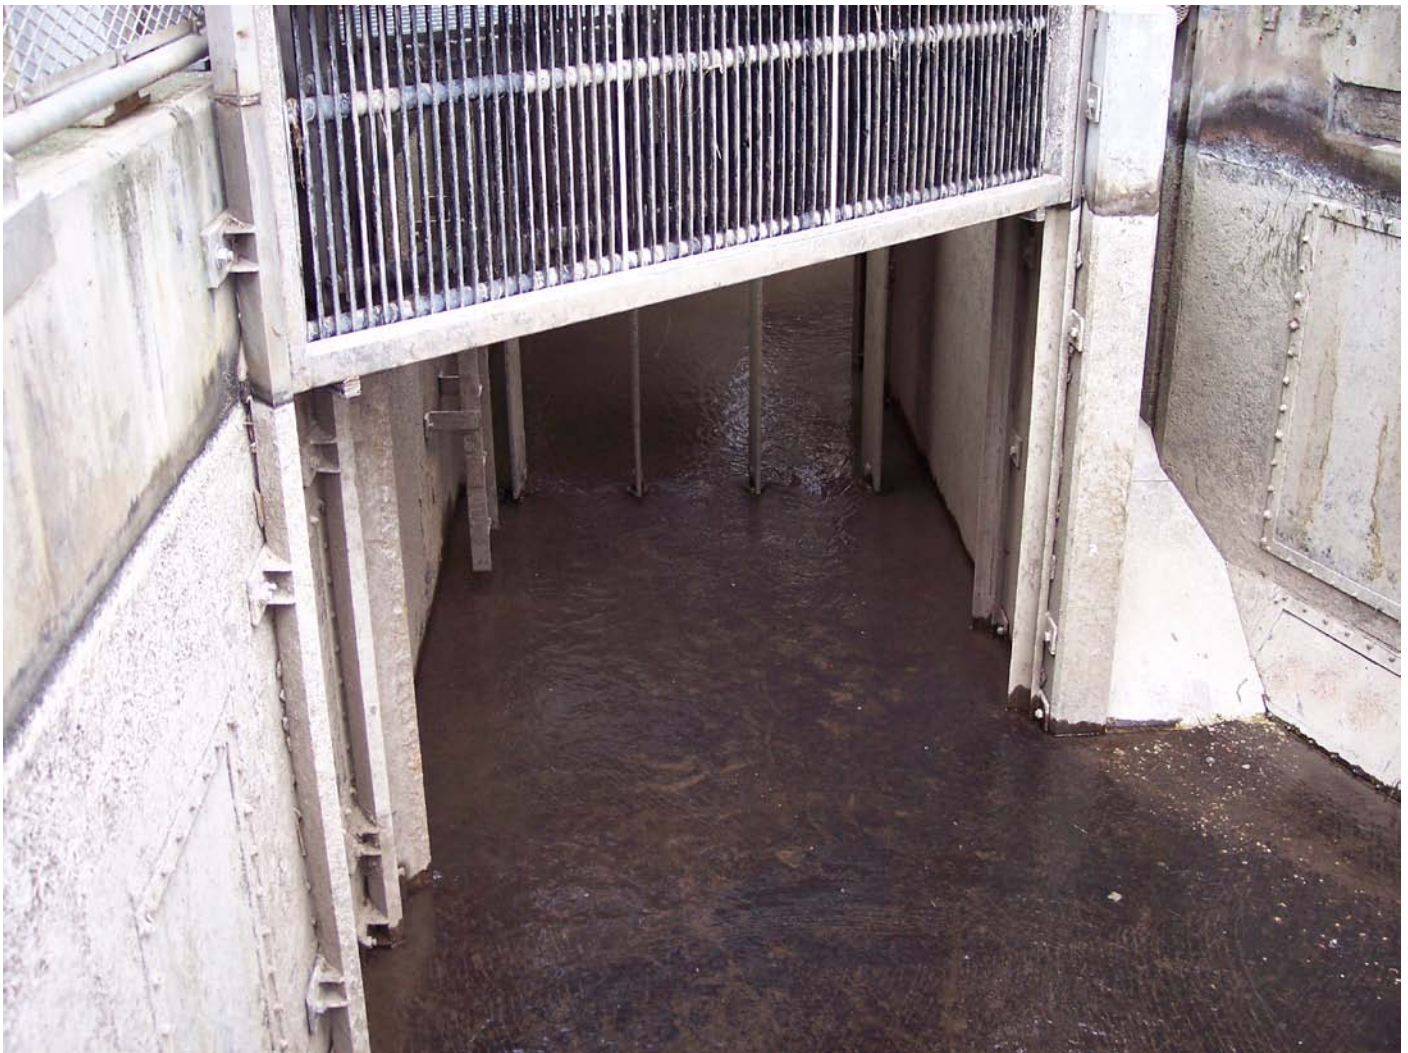
At the counting station, the team noted the clean smooth surfaces throughout the counting station: all grating and vertical projections of the counting window slot have been removed and replaced with smooth plating, including the window slot ramp. Steel blocking 1.5 inches high was observed to be welded to the bottoms of the picketed lead framing. The observed spacing of the adjustable flow vanes within the picketed lead section should provide adequate clearance for lamprey passage. Bill indicated that north shore vanes are configured differently than the south shore adjustable vanes that were removed some time ago, and that the north shore vanes have never been adjusted and have remained in the open position since they were installed. The picketed lead clear spacing was measured to be $\frac{3}{4}$ ".

As mentioned earlier, the team noted very clean smooth surfaces throughout the counting station and picketed lead section, as well as permanent blocking to raise the picket leads frames that will allow adult lamprey a more velocity-friendly alternative passage route behind the picketed leads along the channel bottom.

Removal of the unused adjustable flow vanes behind the picketed leads should not impact the hydraulic functioning of the counting slot given that they have never been adjusted and have remained in the open position. Their removal would probably reduce maintenance requirements behind the picketed leads,

however the observed spacing of the adjustable flow vanes within the picketed lead section should provide adequate clearance for lamprey passage.

Figure 7 – North Shore Fish Ladder Counting Station Looking Upstream. Note the spacing on the channel bottom of the flow control vanes located behind the raised picketed lead panel and permanent blocking (1 ½ inch) welded to the bottom of the picketed lead frame at each end.

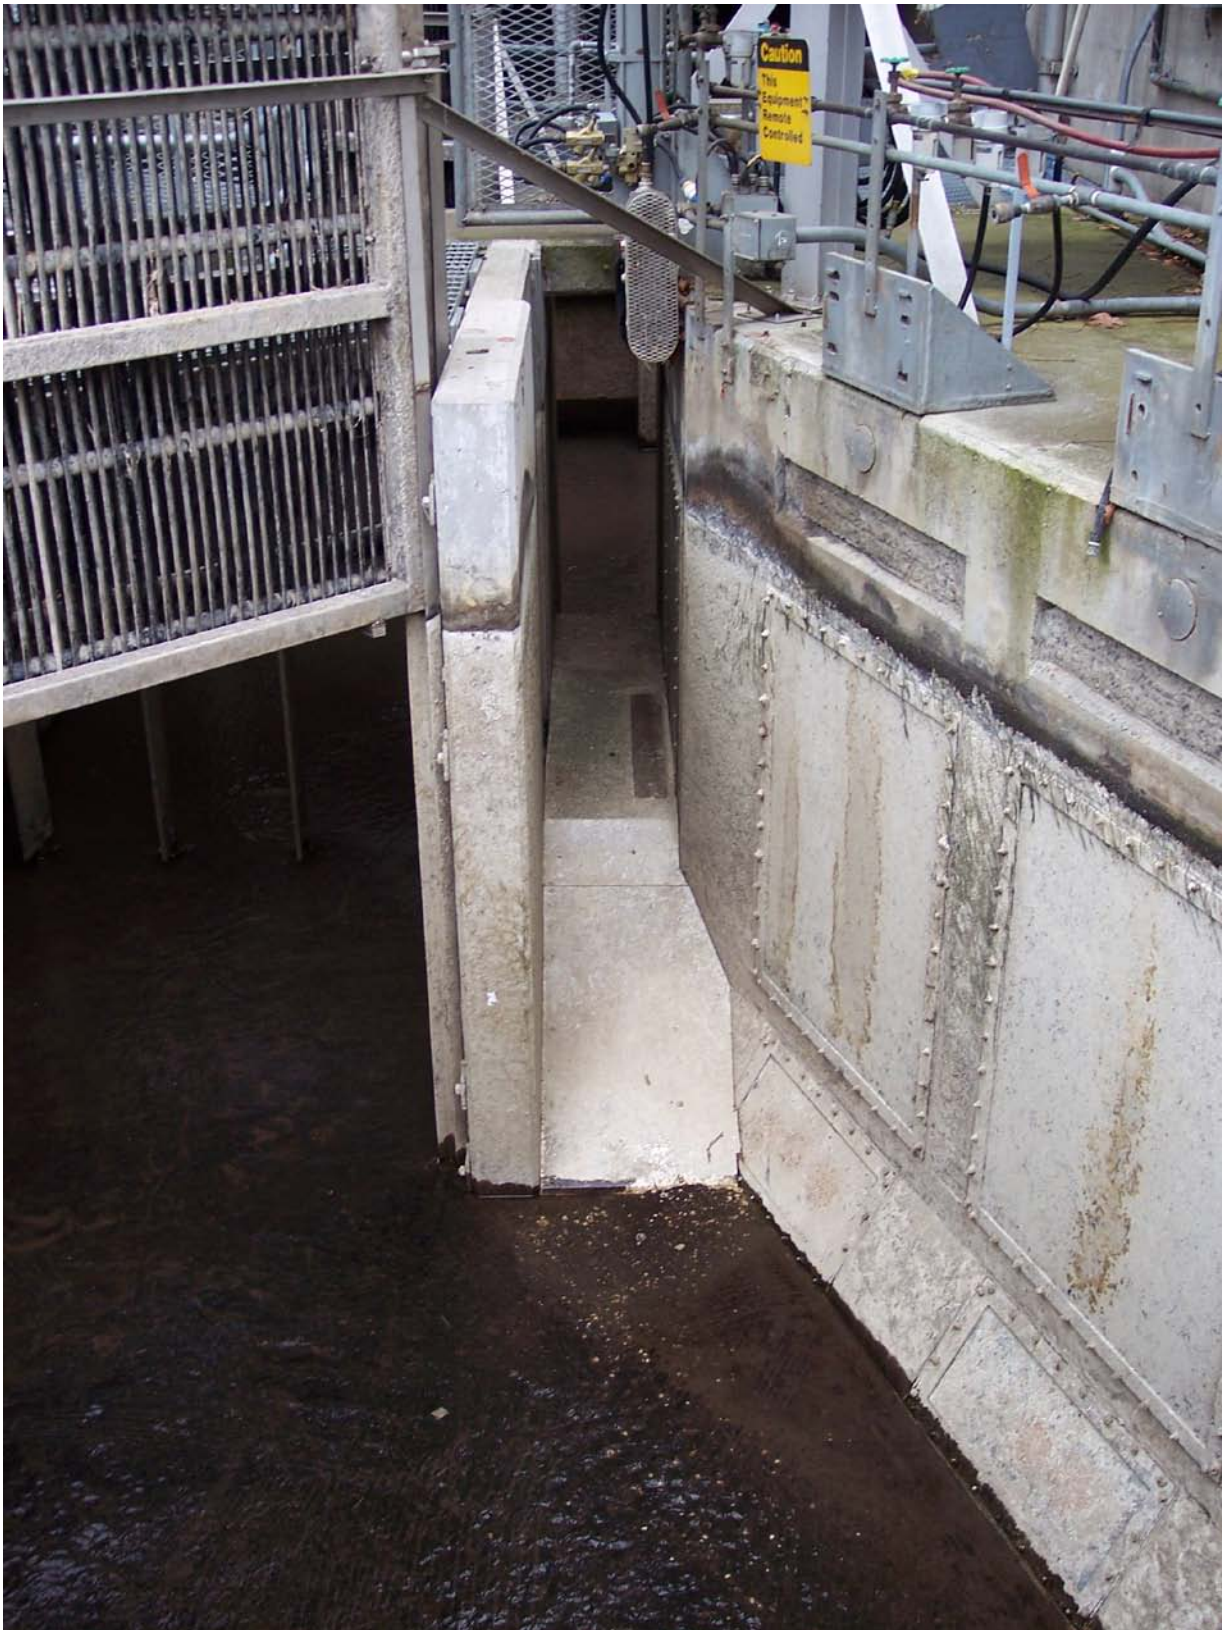
Figure 8 – North Shore Fish Ladder Counting Station Looking Upstream. Note the smooth plate ramps in lieu of grating on the approach to the counting slot.

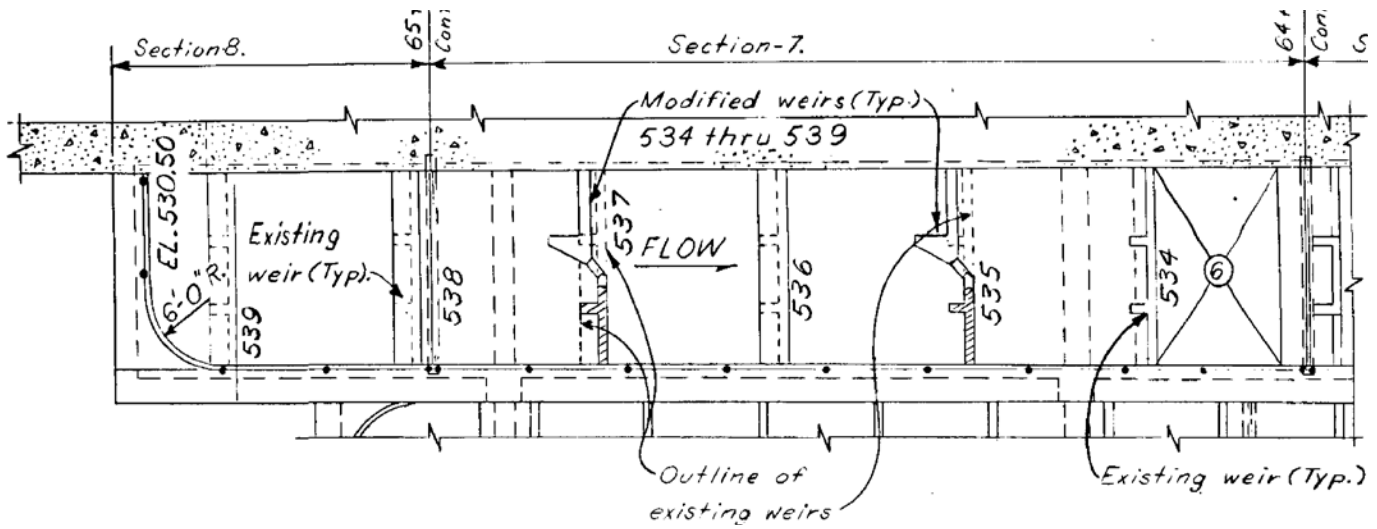
Weirs 534 to 539 are configured with a combination of 1 foot wide chamfered vertical slots on the east side of the weir wall, and 18" x 24" chamfered rectangular orifices on the west side. The sill heights of the vertical slots are incrementally increased in the upstream direction by 6", from weir 534 at a sill height of 0'-9", to weir 538 at sill height of 2'-9". The vertical slot sill height of weir 539 repeats weir 538's height at 2'-9". Similarly, with the exception of weir 535, the orifice invert heights are incrementally increased in the upstream direction, from weir 534 at an orifice invert height of 0'-0", to weir 539 at an orifice invert height of 2'-6". The orifice invert height at weir 535 is 0'-7" above the channel bottom.

Figure 9 – North Shore Fish Ladder Control Section Plan. Weirs 534 to 539 are to receive lamprey orifices.

The elevated fish orifices and vertical slots are vertical projective obstacles for lamprey that impede their passage thru, and along the bottom of the fish ladder. It is recommended that orifices be installed through the weir walls along the channel bottom in the ladder control section to facilitate lamprey passage. Since the fish ladder control section and weir wall configuration is similar to Ice Harbor's, the orifices should be configured and located similarly to the requirements of the current lamprey orifice installation plan for Ice Harbor. More specifically, a stainless steel lined, 2-1/2 inch by 18 inch rectangular orifice filleted to a minimum 4 inch radius should be installed on the vertical slot side of the weir wall, 12 inches to 24 inches from the sidewall along the bottom of the channel. The final size and configuration of the lamprey orifice should be confirmed with the PDT biologist prior to the generation of design documents and construction.

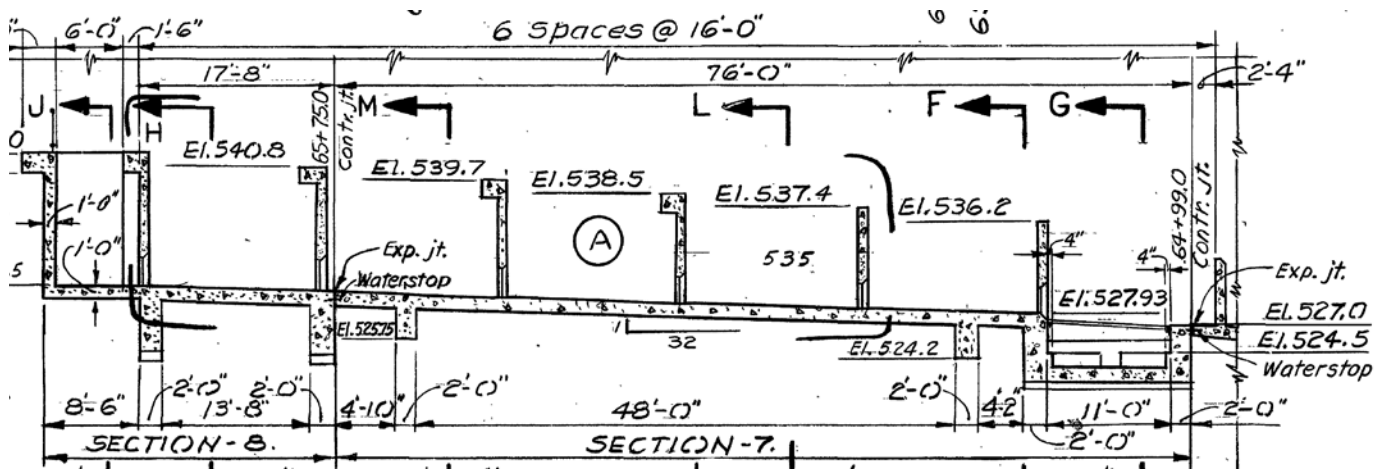
Figure 10 – North Shore Fish Ladder Control Section Profile. Weirs 534 to 539 are to receive lamprey orifices.

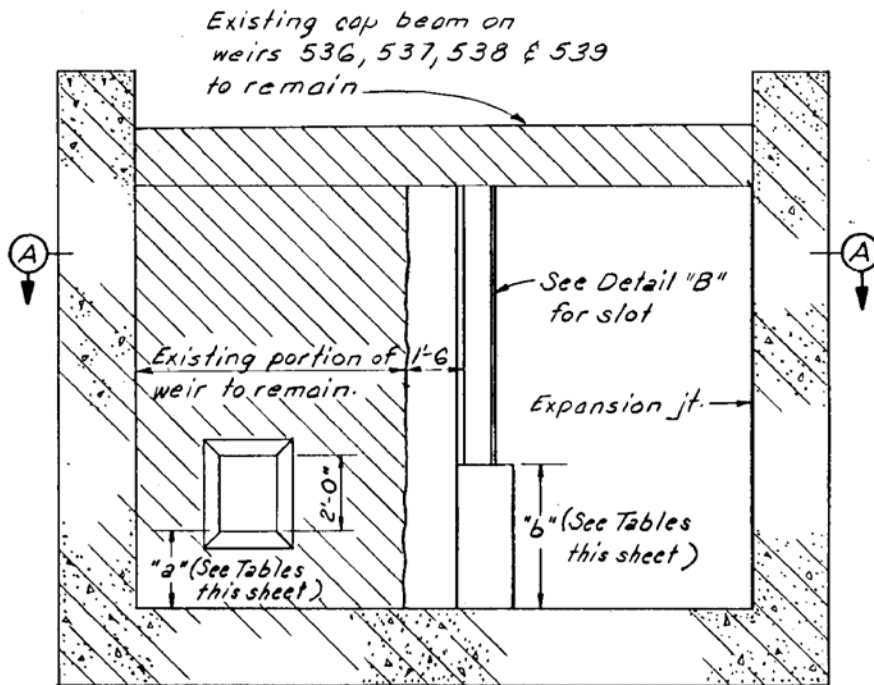
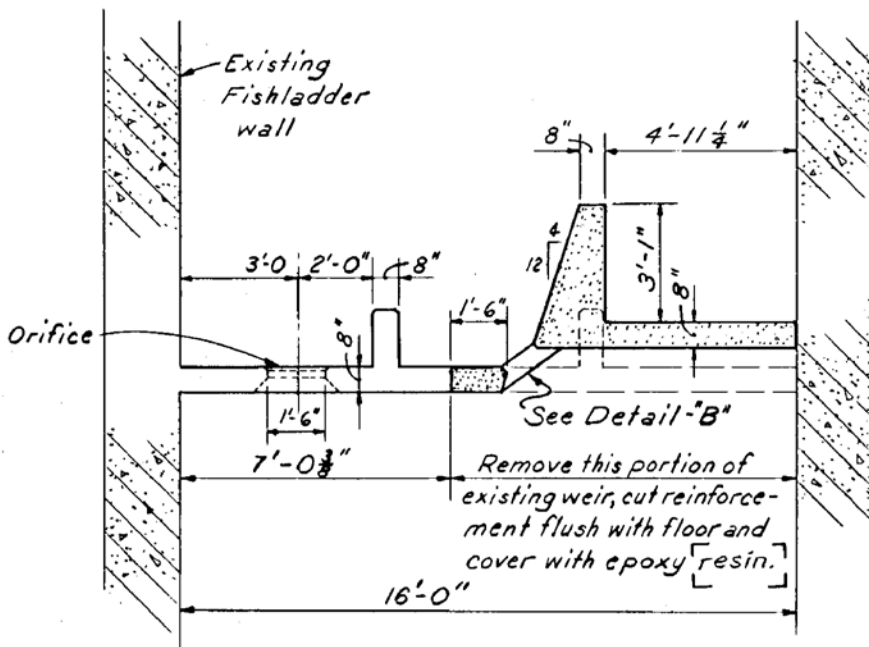
Figure 11 – North Shore Fish Ladder Control Section Weir Details. Weirs 534 to 539 are to receive lamprey orifices. The orifice is to be located to right of the vertical slot, 12 inches to 24 inches from the sidewall, at the bottom of the channel.

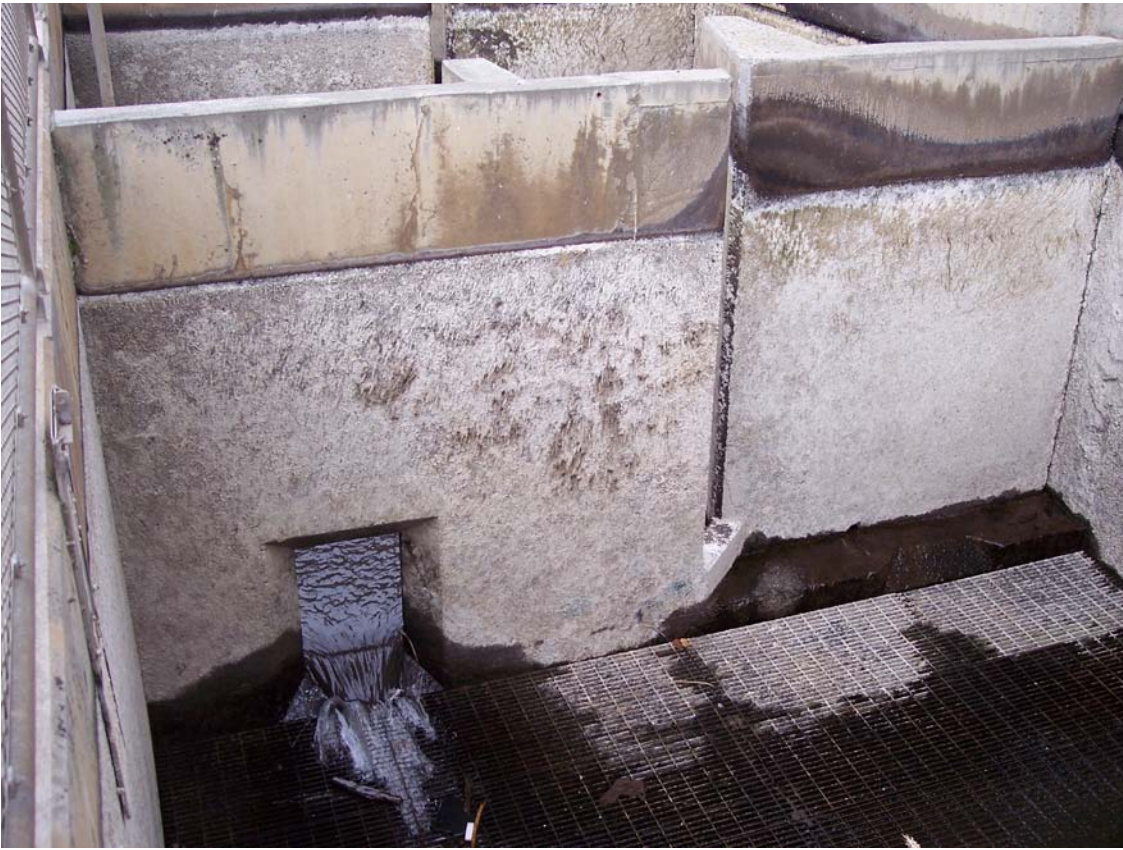
Diffuser 6, a grated channel floor diffuser located between weirs 534 and 533, provides supplemental transport flow to the upper fish ladder to account for variation in the forebay pool elevation. The grating for diffuser 6 appeared to be intact but may be replaced when the lower diffuser grating is replaced.

Figure 13 – North Shore Fish Ladder Control Section Weir 534 and Diffuser 6 Photo, Looking Upstream.
