# MCNARY SPILLWAY STATUS

FPOM  
22 August 2024

# MCNARY SPILLWAY

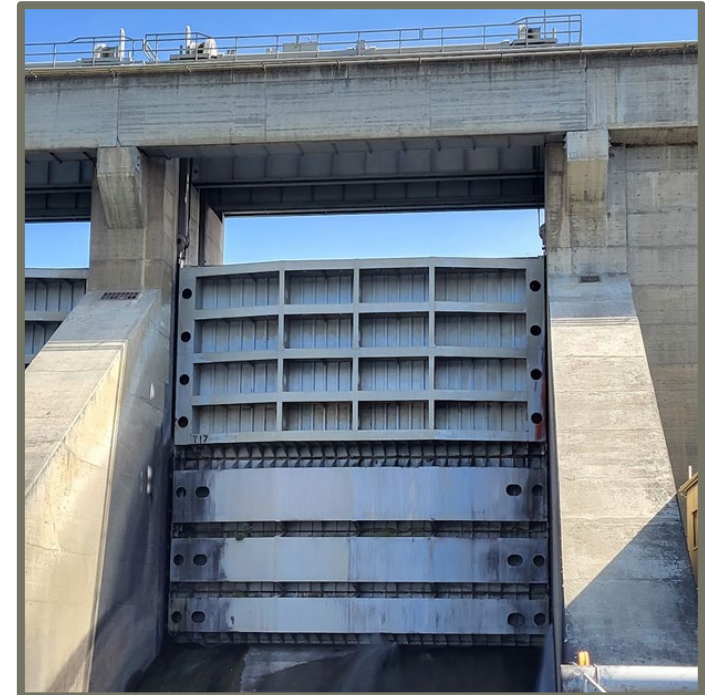
- 2022, Testing of lifting eyes showed deterioration and overload of design capacity  
Gate girders; several were close to failure for normal operations, and many did not meet criteria for emergency operation
- 2023, Spillbay #16 closed to repair cracks in dogs and dog mounting points  
Bays #1, #3, #21 taken OOS to repairs dogs. Other bays to follow over the next year
- Result of structural analysis is that all 22 (+2 spares) spill gates should be replaced
