MCNARY SPILLWAY STATUS

FPOM
24 October 2024

MCNARY SPILLWAY

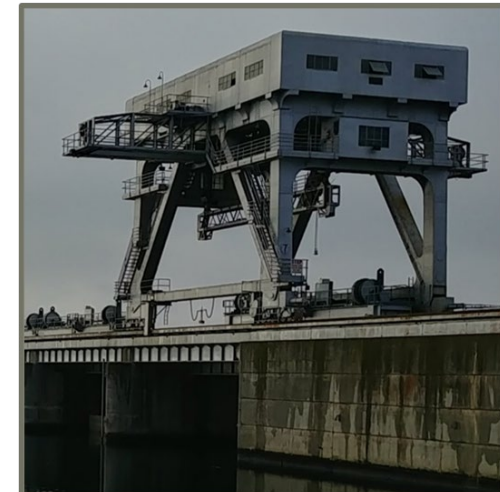
- Overloaded by estimated 20% according to BDI tests in 2003/05- not counting for lifting beam or frictional losses. – Violation of American Society of Mechanical Engineers (ASME) and Engineer Manual (EM) 385.

- Gantry crane frames do not comply with current American Institute of Steel Construction (AISC) codes - Under breakdown torque simulations, the downstream legs fail.

- The electrical system is outdated. Asbestos. DC hoist controls at risk of failure. Obsolete component replacement is becoming more challenging.
- Frequently down for weeks or months at a time – most recently a gantry drive gearbox failure required bearings that are no longer readily available.

- Recently had a main hoist gearbox replacement to address severe vibration issues, with mixed results.
- January 2023, Cranes 6 & 7 were limited to two engineered lifts (250 tons) per year.

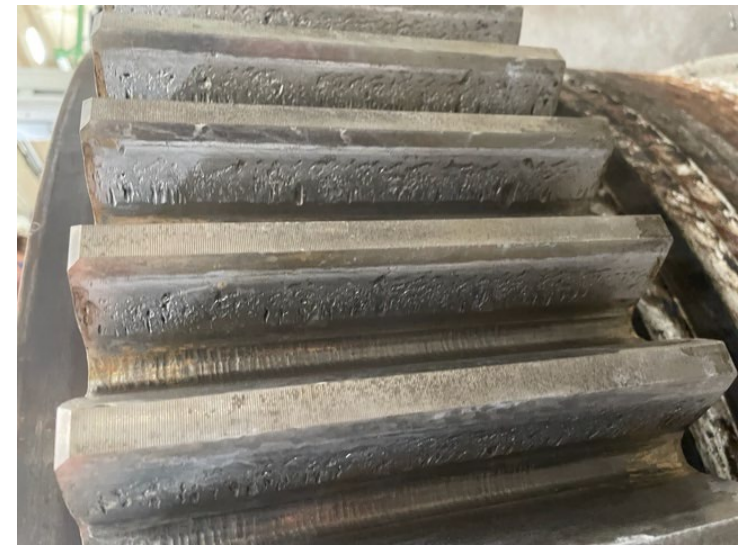
- 2002, Failure of hoist gearbox coupler
- 2003-2005, Testing indicated all hoists were overloaded, 13 were > 125% overloaded
Up to 480,000 lbs of load. Did not include sheave friction.

- 2022, Hoist #6 failed, gears showed severe pitting due to material fatigue from high contact stresses, replaced with hoist from bay #16. Bay #16 RTS after about three month outage.
Hoist #15 OOS for one week for repairs
Hoist #20 taken OOS for repairs
Hoist #21 gearbox coupler failed and brakes failed during closure causing gate to fall on sill

- October 2023, Hoist operations were limited to either no (13) or two (7) overload lifts per year

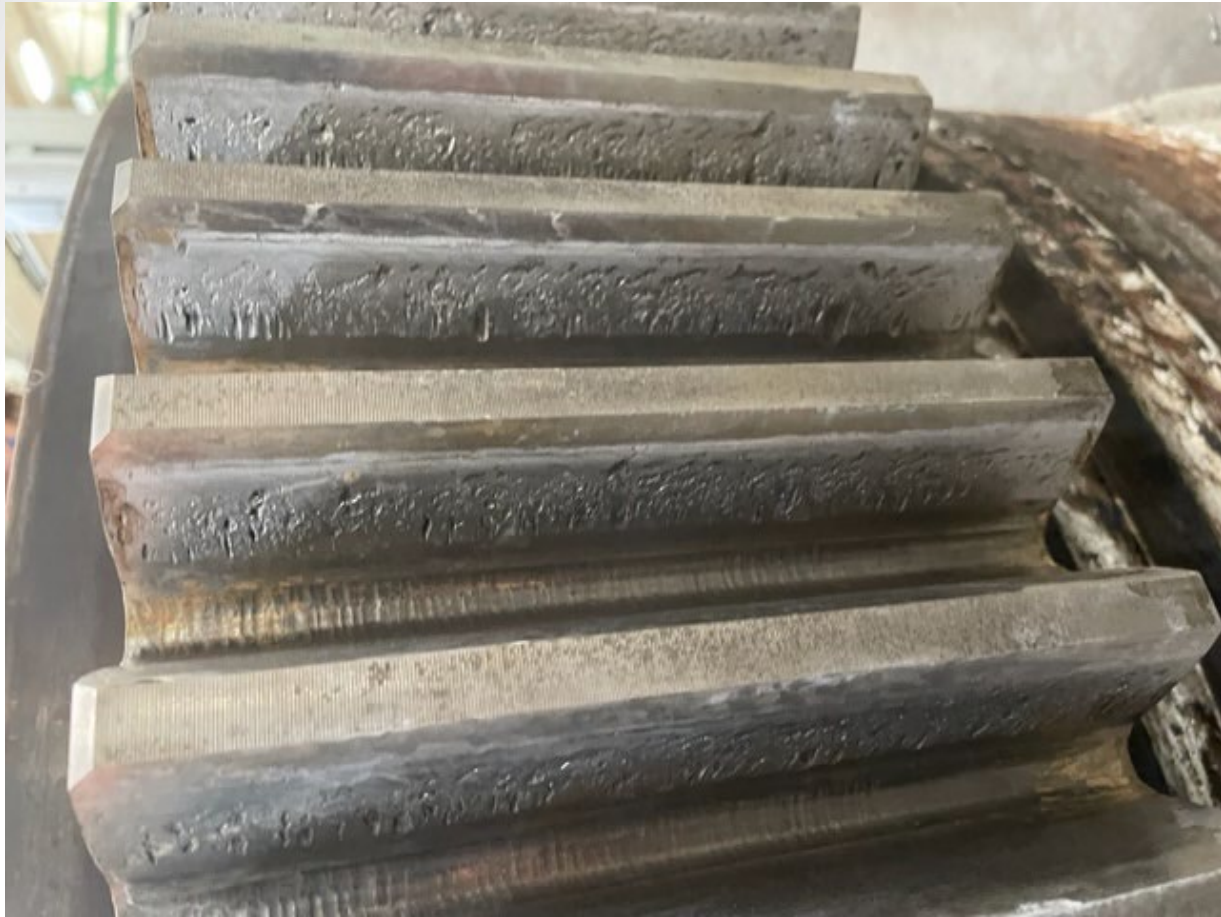
Pitted north drum gear

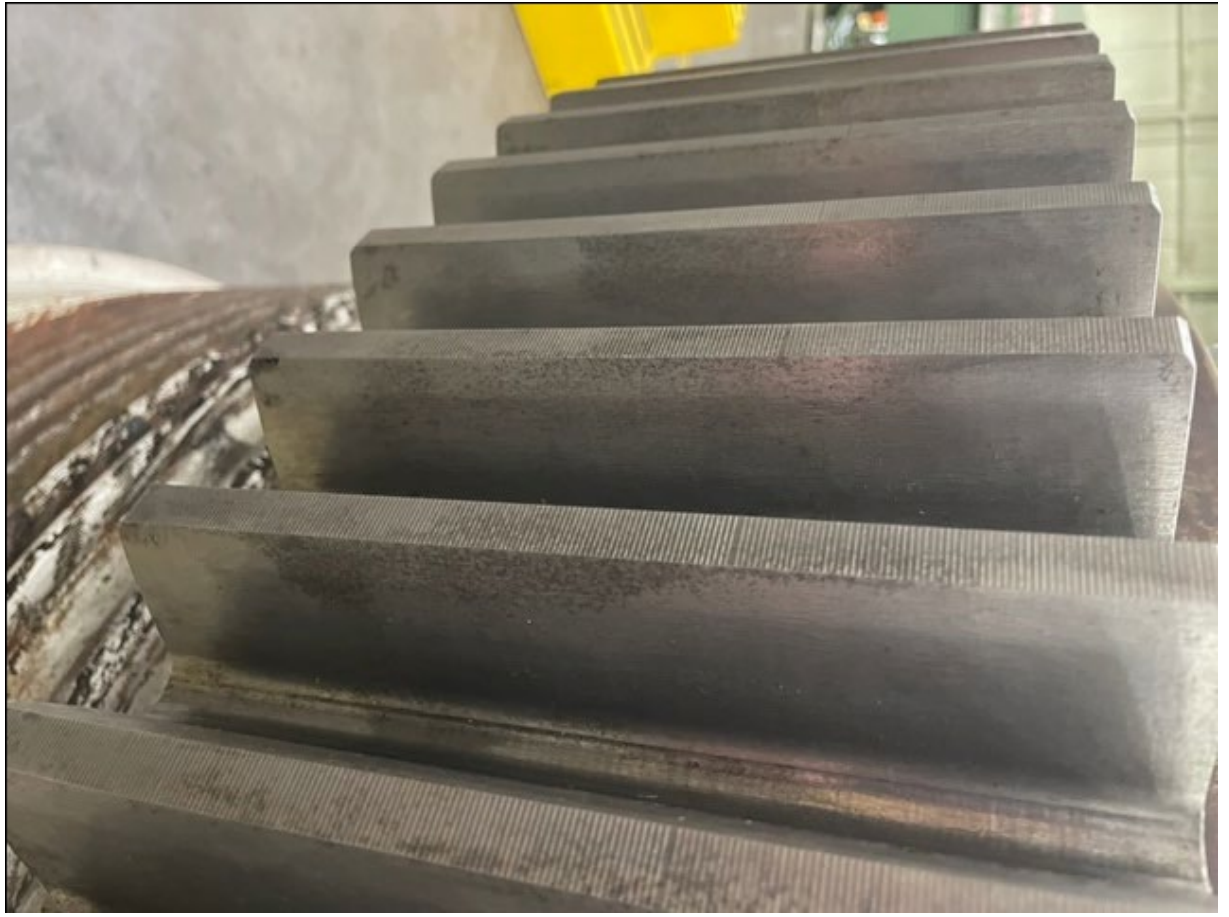
Unworn gear

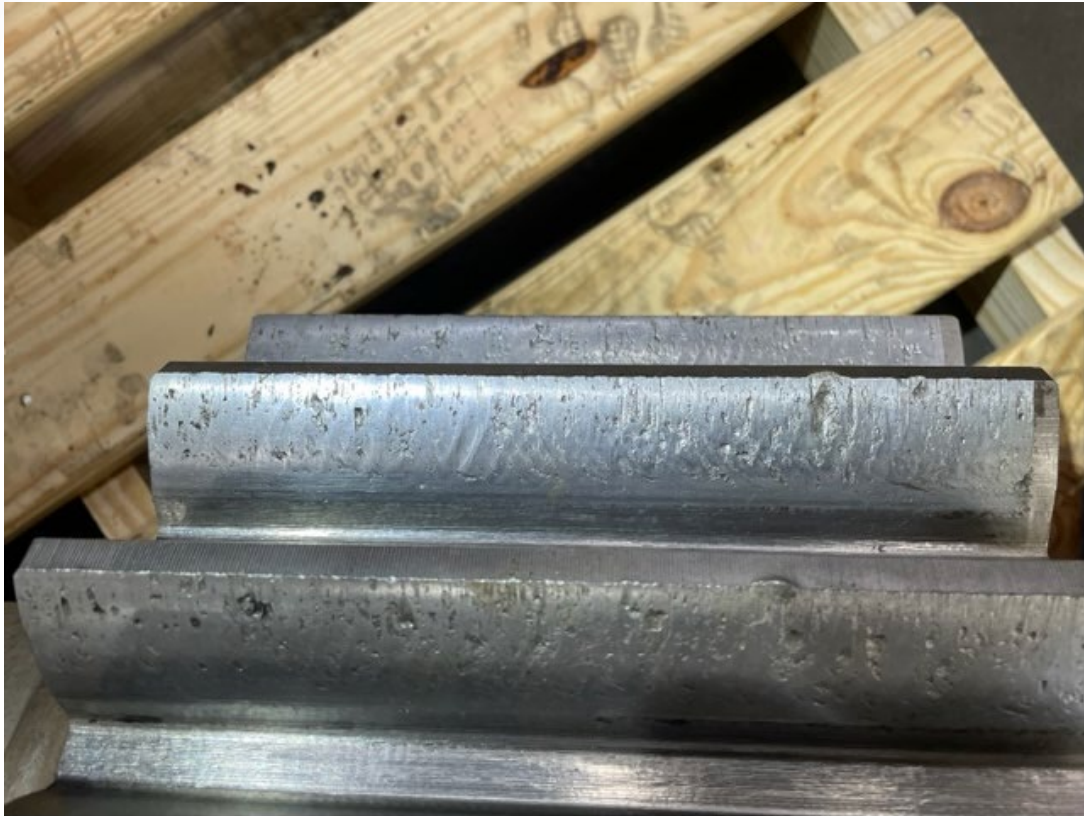
Pitting on south pinion gear

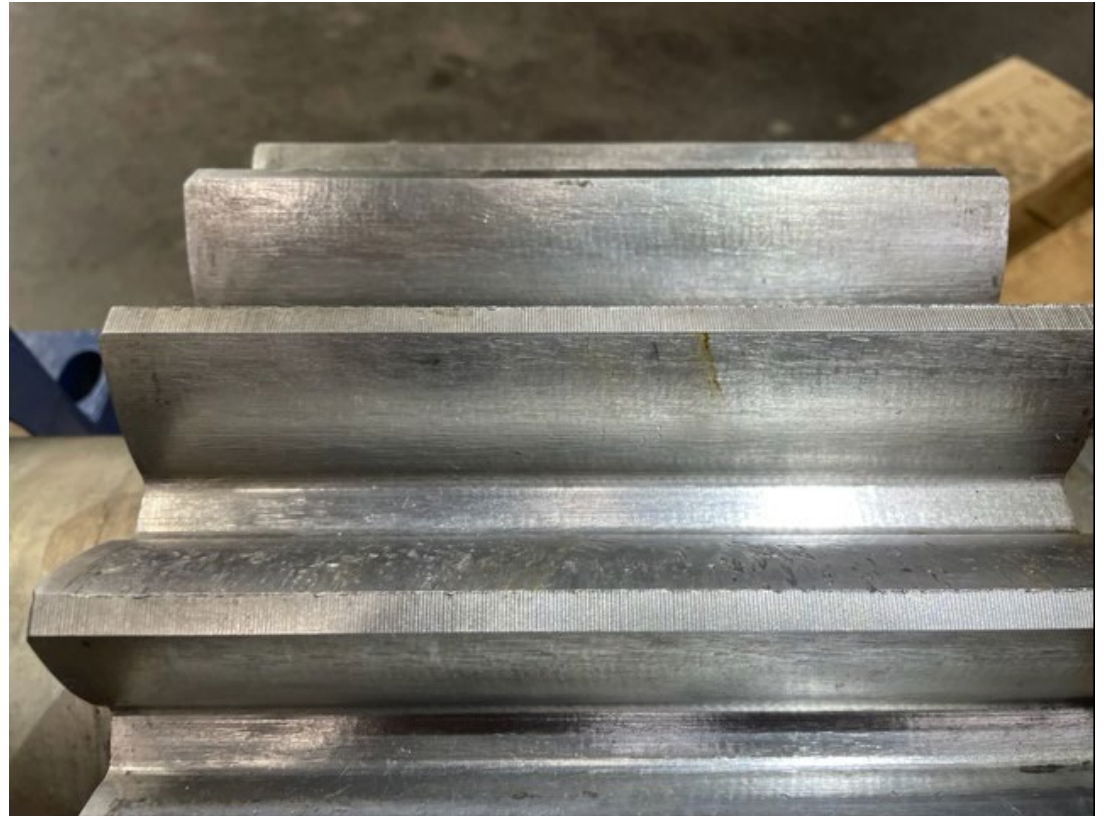
Unworn pinion gear

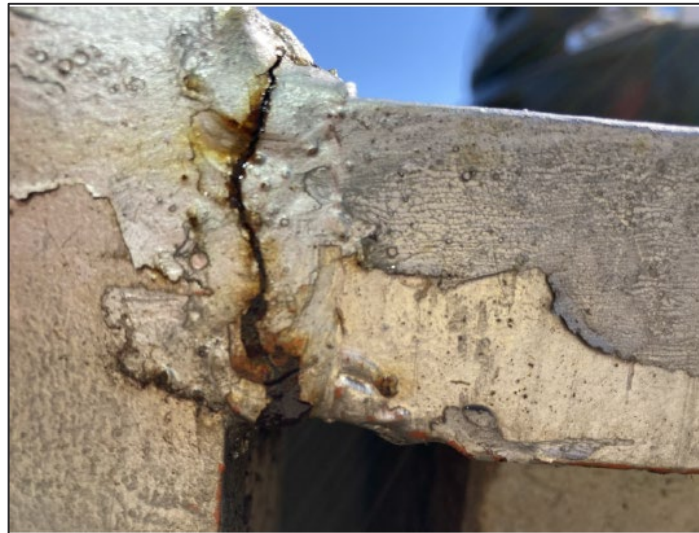
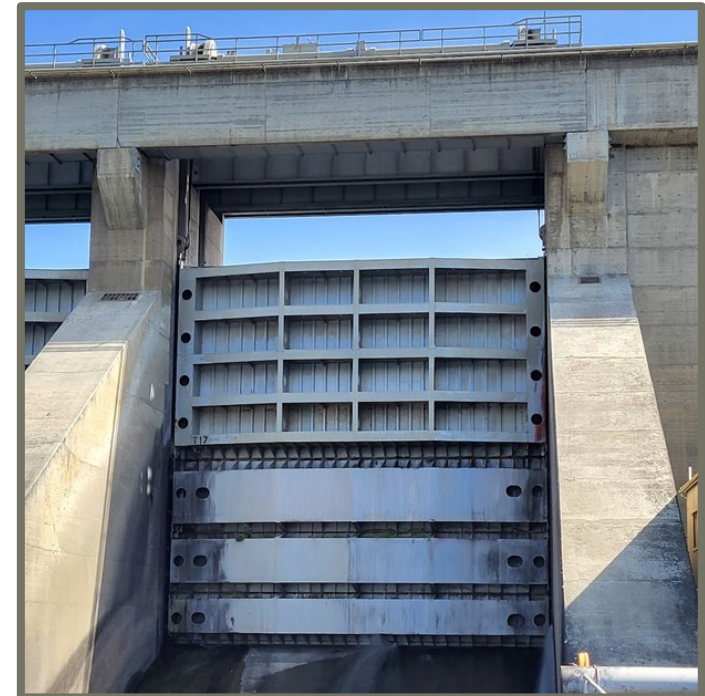
- 2022, Testing of lifting eyes showed deterioration and overload of design capacity
Gate girders; several were close to failure for normal operations, and many did not meet criteria for emergency operation
- 2023, Spillbay #16 closed to repair cracks in dogs and dog mounting points
Bays #1, #3, #21 taken OOS to repairs dogs. Other bays to follow over the next year
- Result of structural analysis is that all 22 (+2 spares) spill gates should be replaced
