### **MCNARY SPILLWAY**

### MCNARY CRANES 6 & 7

### **MCNARY HOISTS**

### MCNARY SPILLWAY UPGRADE STATUS SCOPE OF SPILLWAY UPGRADES

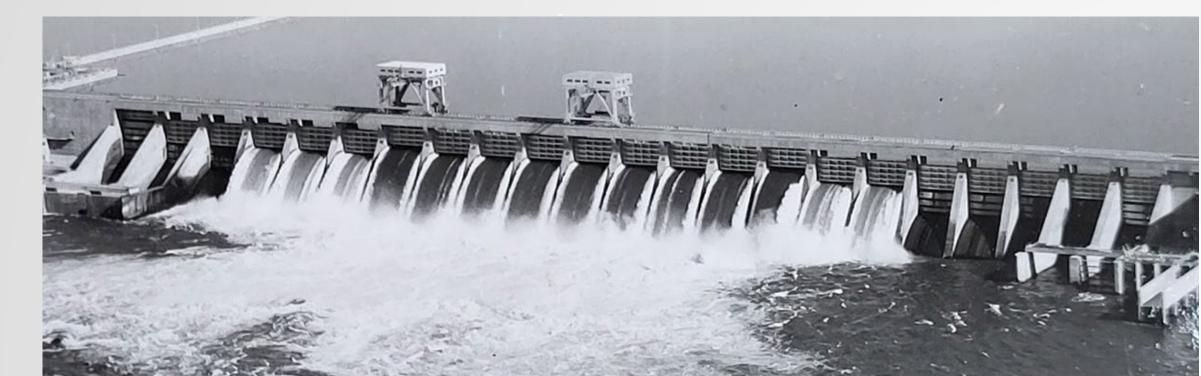
- Overloaded by estimated 20% according to BDI tests in 2003/05- not counting for lifting beam or frictional losses. – Violation of American Society of Mechanical Engineers (ASME) and Engineer Manual (EM) 385.

- Gantry crane frames do not comply with current American Institute of Steel Construction (AISC) codes
  Under breakdown torque simulations, the downstream legs fail.

- The electrical system is outdated. Asbestos. DC hoist controls at risk of failure. Obsolete component replacement is becoming more challenging.
- Frequently down for weeks or months at a time most recently a gantry drive gearbox failure required bearings that are no longer readily available.

- Recently had a main hoist gearbox replacement to address severe vibration issues, with mixed results.
- January 2023, Cranes 6 & 7 were limited to two engineered lifts (250 tons) per year.

- Replace spillway gantry cranes with uprated (350 ton) cranes (**PRIORITY**)
- Replace spillway gate lifting beams with uprated lifting beams

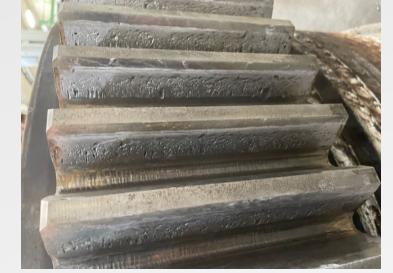
- 1976, 16 Ederer hoists added, 175 tons (350,000 lbs) capacity Flow deflectors added
  - Spillway predominately operated as full gates
- 2002/2003, Four Transco hoists added.
  350,000 lbs capacity
- 2002, Failure of hoist gearbox coupler

- 2003-2005, Testing indicated all hoists were overloaded, 13 were > 125% overloaded Up to 480,000 lbs of load. Did not include sheave friction.
- 2004-2009, Rehab of some gates wheel bearings, guide slots, guide shoes, replaced seals Minor improvement only
- 2007, Hoist replacement project initiated
- 2020, Work restriction while hoists were under load implemented to reduce risk to health and human safety
- 2021, Load cell data collected on four hoists for prototype hoist project showed overload condition
- 2022, Hoist #6 failed, gears showed severe pitting due to material fatigue from high contact stresses, replaced with hoist from bay #16. Bay #16 RTS after about three month outage. Hoist #15 OOS for one week for repairs Hoist #20 taken OOS for repairs

Hoist #21 gearbox coupler failed and brakes failed during closure causing gate to fall on sill

Replace all 20 gate hoists (**PRIORITY**). Add 2 new gate hoists so each spill bay has a hoist. 350 ton capacity

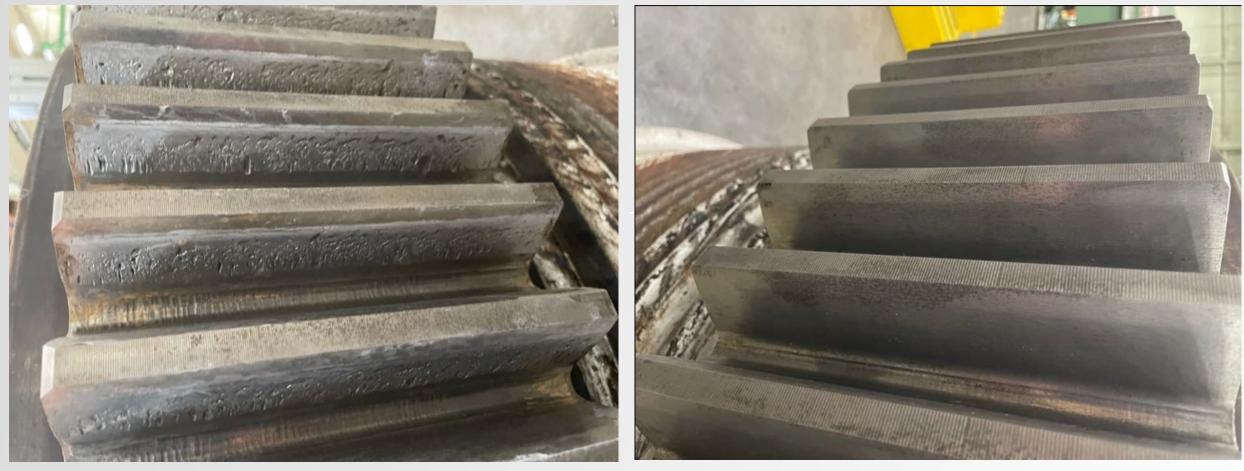
Pitted north drum gear

Unworn gear

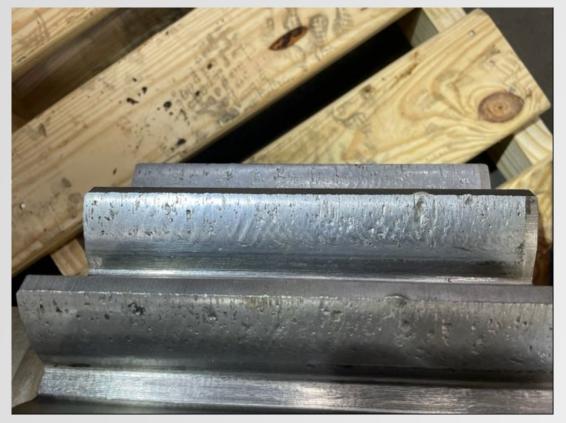
Pitting on south pinion gear

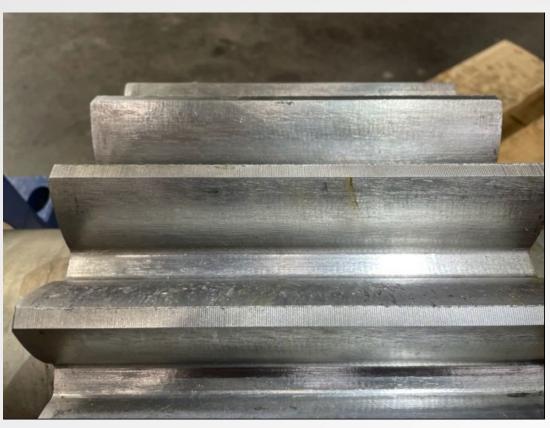
Unworn pinion gear

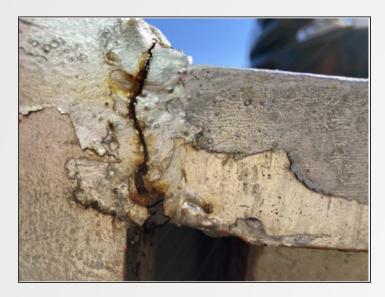
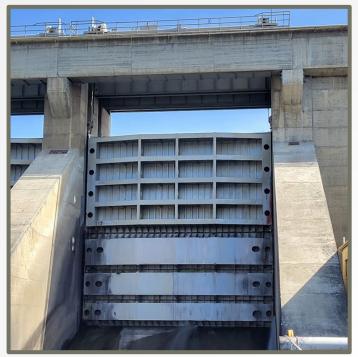
- 2022, Testing of lifting eyes showed deterioration and overload of design capacity Gate girders; several were close to failure for normal operations, and many did not meet criteria for emergency operation
- 2023, Spillbay #16 closed to repair cracks in dogs and dog mounting points Bays #1, #3, #21 taken OOS to repairs dogs. Other bays to follow over the next year
- Result of structural analysis is that all 22 (+2 spares) spill gates should be replaced

• Based on 2023 structural analysis, we must replace all spillway gates with uprated capacity for sheave friction and hydraulic down-pull forces.
