# BONNEVILLE DAM

## FISHWAY STATUS ANNUAL REPORT

### 2012

31 January 2013

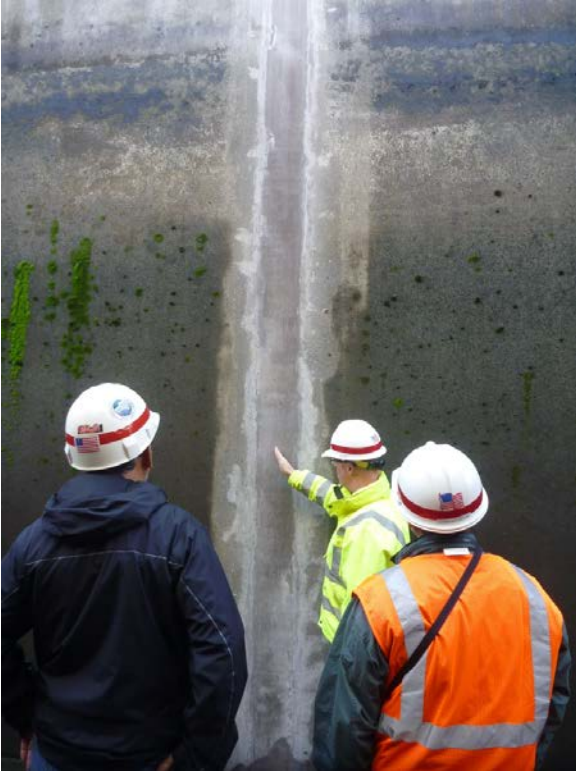
B2CC Joint Repair.

**2012.** B2CC bulkhead converted to permanent hoist with automatic control.  
**2012.** B2CC joint repair to fix spalling and decrease channel roughness.

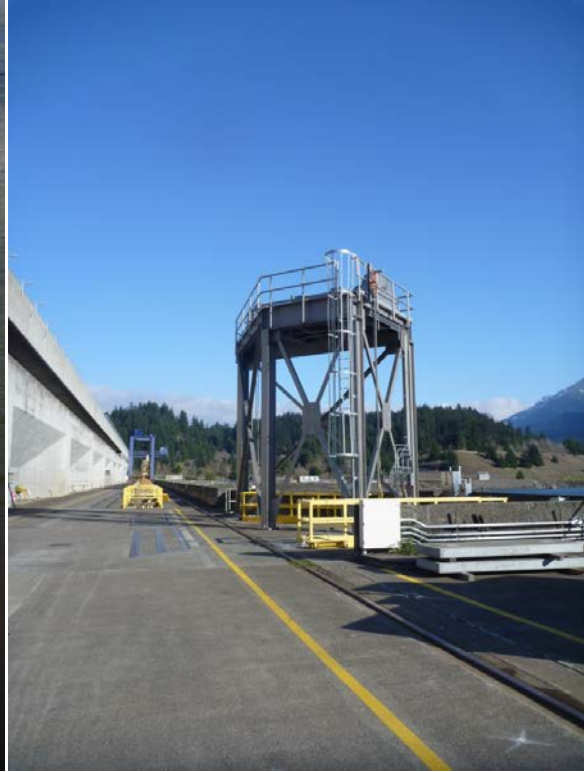
B2CC Automatic Hoist.

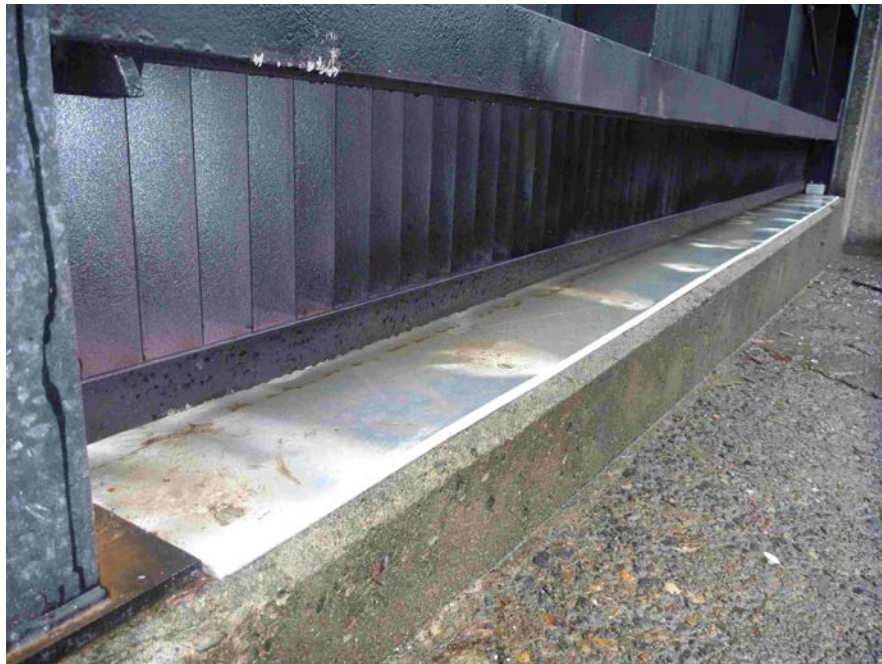
Bradford Island Picket Lead Mods

**2012.** Picket lead modifications to insure one inch spacing between leads and sill plate and prevent lead bending. Spacers installed.

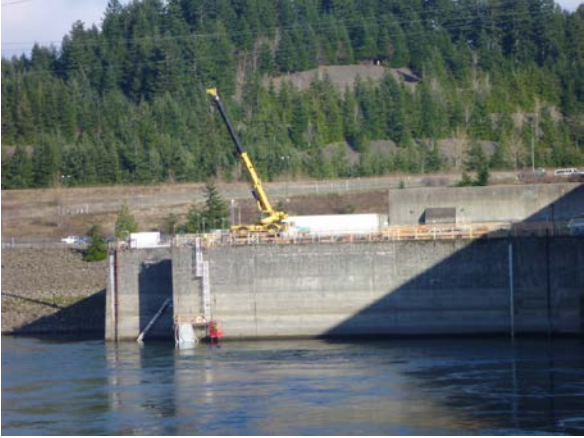
WA Shore LPS Construction.

The Washington Shore ladder (WA shore) and the DSM were taken out of service in November 2012 to allow construction workers early access to the North Monolith in order to construct and install a lamprey passage system (LPS) and make additional repairs in the North Monolith area. In addition, the South Monolith was dewatered in order to allow the removal of large quantities of sand and silt from the WA shore Auxiliary Water Supply (AWS) and accompanying diffuser chambers.

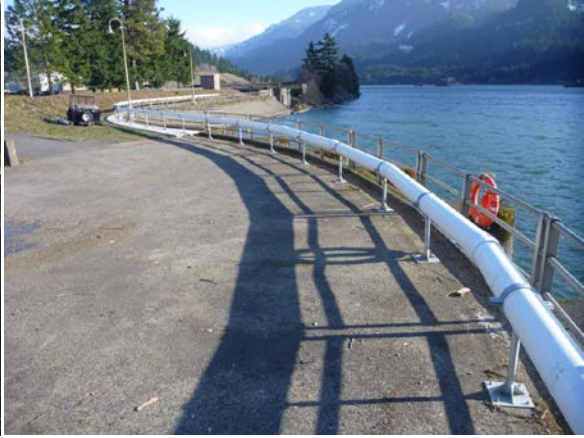
Cascades Island LPS Extension.

**2012/13.** Lamprey passage system extension into the forebay and conversion to volitional passage system.  
**2008/09.** Lamprey ramp and bollards installed in CI entrance pool. Variable width entrance weir installed in May.  
**2005/06.** Half duplex PIT tag detectors were installed along the picket leads to track lamprey.

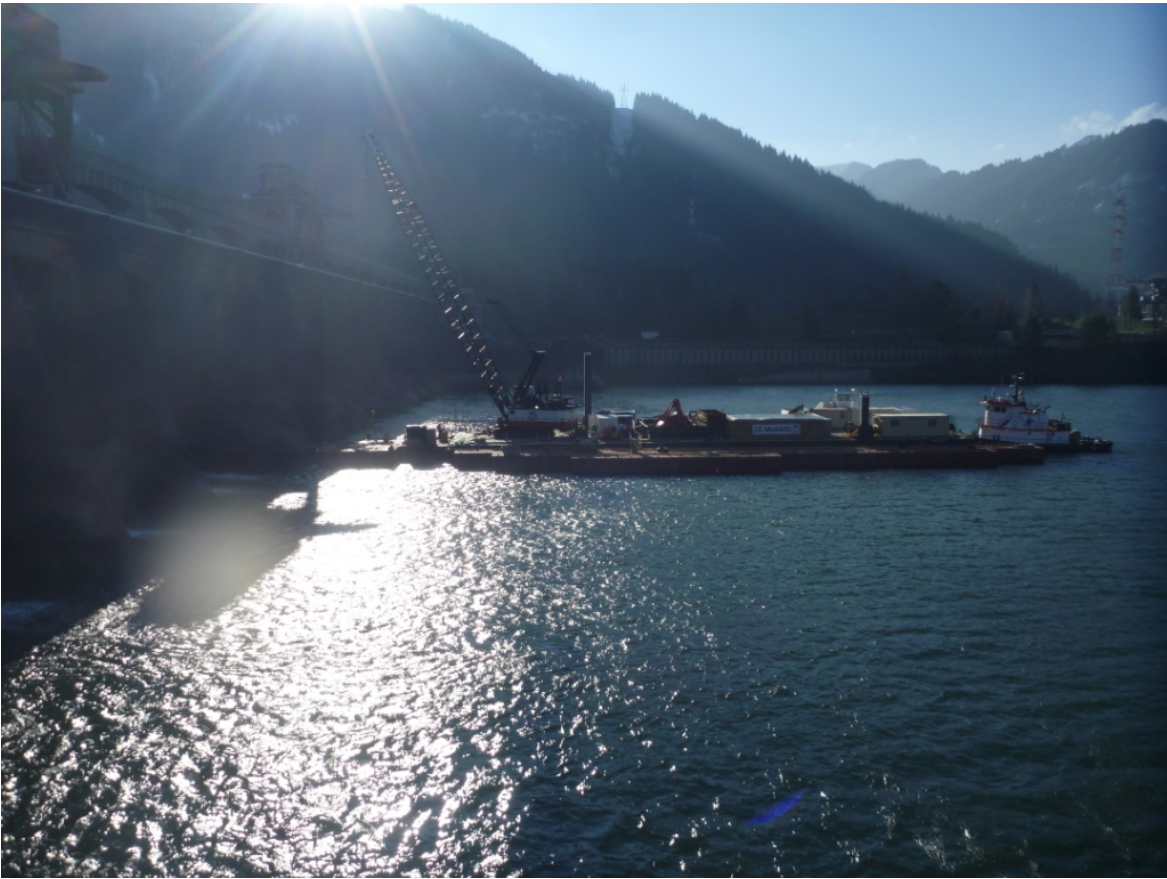
Spillway Erosion Repair.

**2012/13.** Spillway erosion hole and ogee repair.
