2013 ANNUAL FISHWAY STATUS REPORT

THE DALLES DAM

Date: Jan, 2014

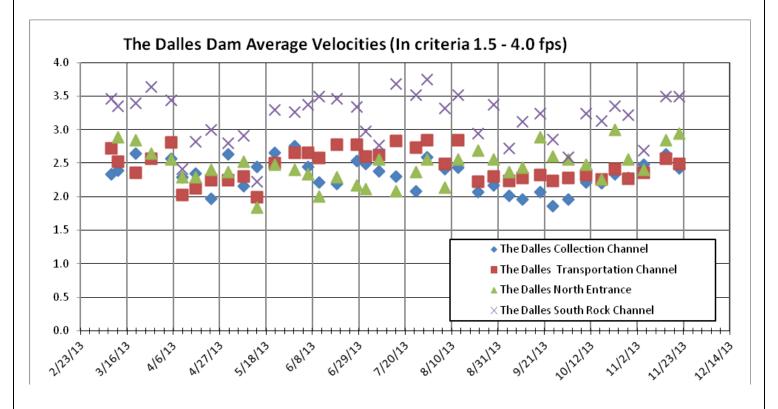
Weekly Water Velocity Measurements

Fishway channel water velocities were measured three times weekly during Adult Fish Passage Season (Mar1 – Dec 1). Wood floats were timed through all fishway channels that are supplemented by auxiliary water and results were provided in the project weekly fishway status report. Criteria velocities of 1.5 to 4 fps were maintained throughout the fish passage season. Velocities were not always taken at unit 22 due to turbulence preventing float tracking. Velocity is generally slower from junction pool to unit 21. Past University of Idaho analysis did not reveal passage problems in this area.

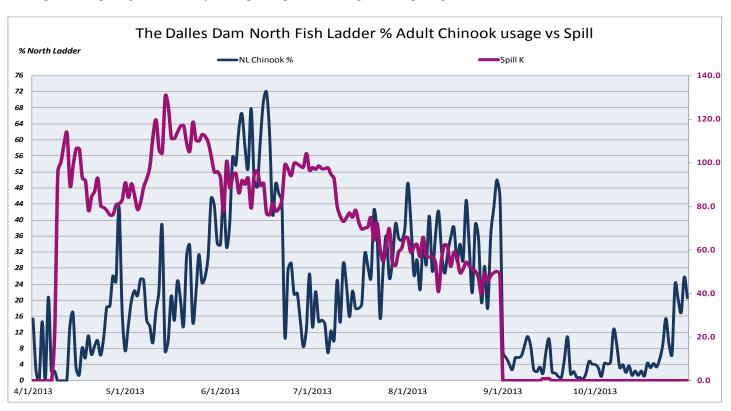
NORTH LADDER PASSAGE VS SPILL

Spill operation has been documented to affect north fishladder passage in the past several years. Spill >110KCFS tended to block salmonids from entering the north ladder. This was very apparent early May to early June 2012 when spill volume dropped below the 110KCFS and passage increased. In 2012, spill reached approached 200KCFS twice and passage remained low. It did not reach the 230KCFS mark as it did in 2011, so we did not see the return of passage after the ~220KCFS mark as we did in 2011. This was not evident for Chinook jacks or other salmonids. The theory remains that spill from ~110KCFS to ~220KCFS impedes north passage for adult Chinook. It was again clearly demonstrated that with no spill, salmonids are not attracted to the north entrance area either; hence the drop in north passage immediately after spill stops. Monitoring to north passage trends will continue.

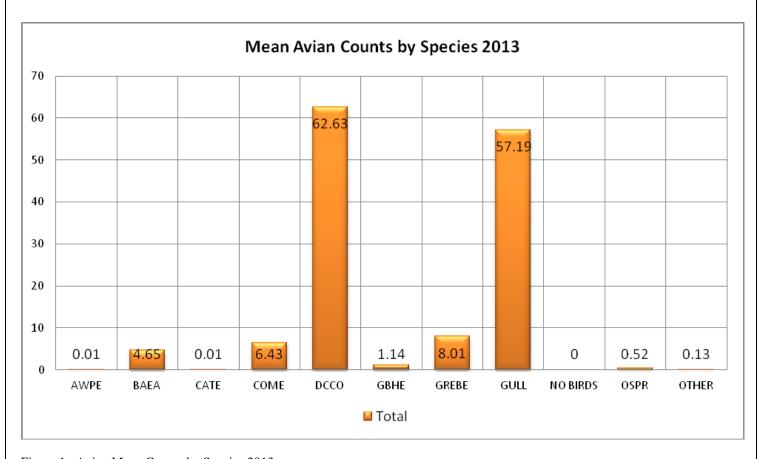
Figure 1. Avian Mean Counts by Species 2013

Most of the gull feeding activity occurred just up stream and down stream of The Dalles Bridge (SWT3 and SWT4). Due to the high cost of gull hazing by boat, shore hazing was selected for 2013. The high numbers of cormorant numbers is primarily roosting behavior. Cormorant near dam feeding behavior starts to occur in November and December when the shad juvenile outmigration peaks. The high numbers observed in the forebay are roosting in the power line towers and north side debris boom. There was a substantial gull number increase in May and Cormorant increase in September.
