# 2018 ANNUAL FISHWAY STATUS REPORT

## THE DALLES DAM

Date: January 2019

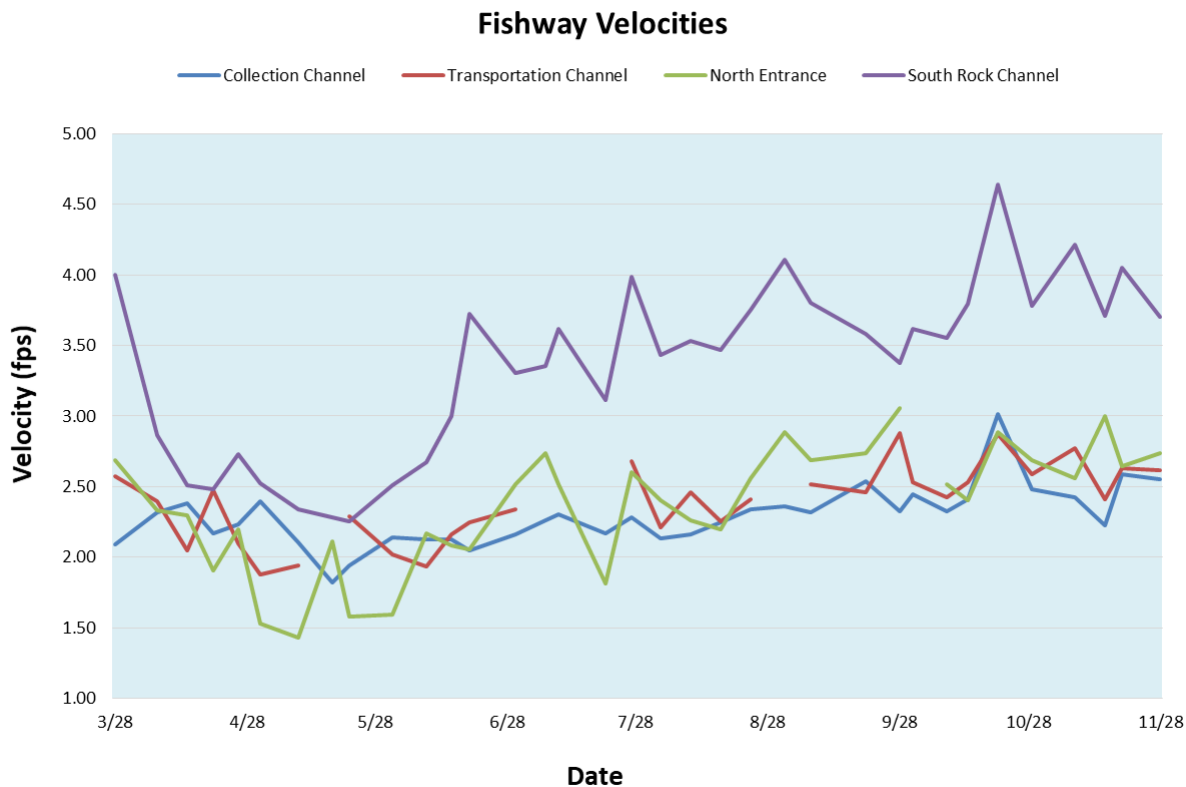
**WATER VELOCITY**

Fishway channel water velocities were measured weekly during Adult Fish Passage Season (Mar 1 – Dec 1). Floats were timed through all fishway channels that are supplemented by auxiliary water and results were provided in the project weekly fishway status report. Criteria velocities of 1.5 to 4 fps were generally maintained throughout the fish passage season, with a few instances of velocities >4 fps in the South Rock Channel. Velocities were not always taken at unit 22 due to turbulence preventing float tracking. Velocity is generally slower from junction pool to unit 21, however past University of Idaho analysis did not reveal fish passage delays in this area.

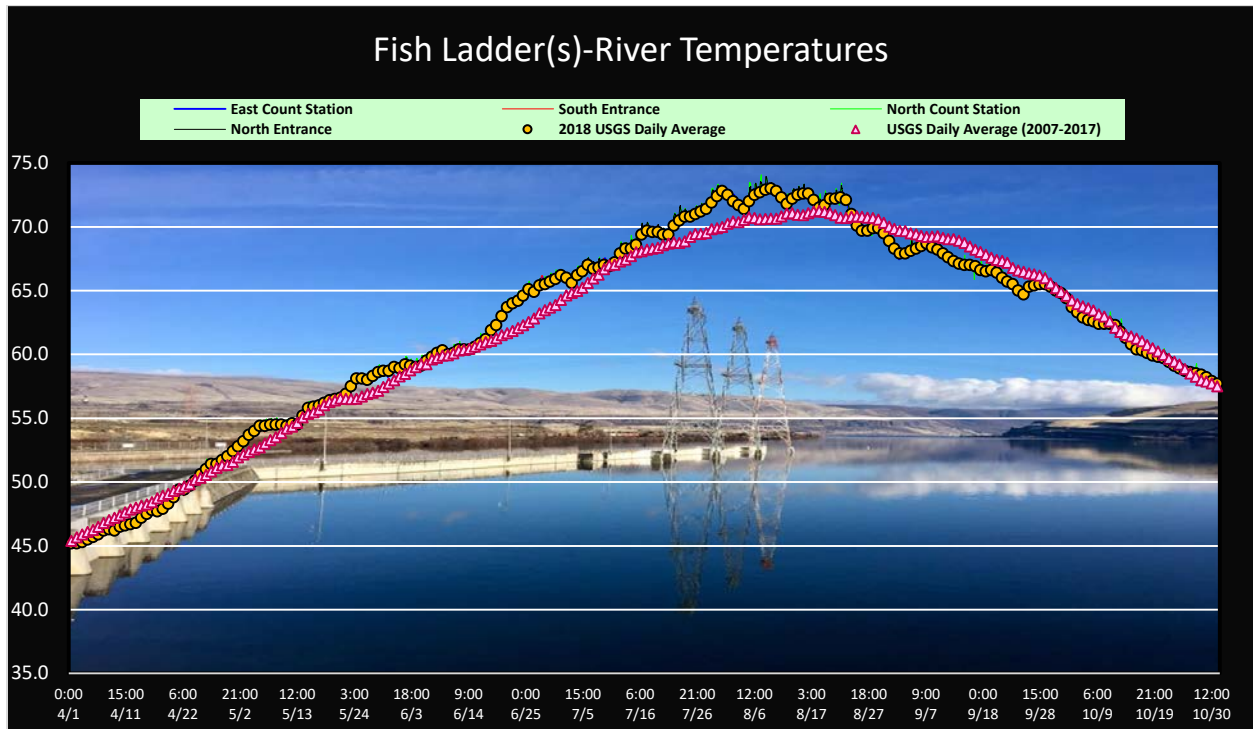
## WATER QUALITY

Water clarity was read by secchi dish at the count stations. Water clarity data is not included in this report due to its questionable accuracy, but can be obtained on request. Temperature monitoring with data loggers in each fishway is provided weekly in the fishway status reports. Additional monitoring will be done to determine differences from upper to lower ladder. The following graph is a compilation of weekly readings collected by data loggers in the east and north fishladders. Readings are taken immediately upstream of the count stations and the lower entrance area of each ladder.

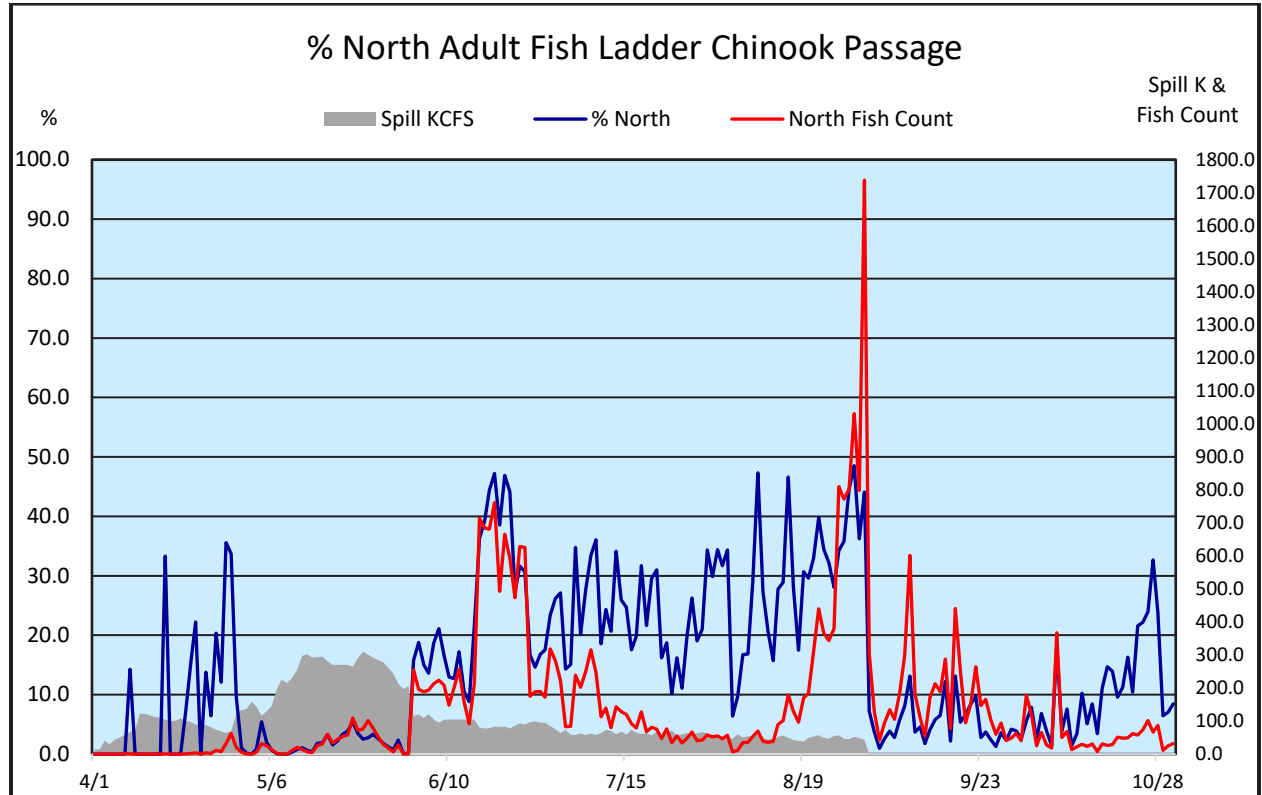
## NORTH LADDER PASSAGE VS SPILL

Spill operation has been documented to affect north fishladder passage in the past several years. In previous years spill >110KCFS tended to block salmonids from entering the north ladder. During late April and early May, this trend is apparent. It was again clearly demonstrated that with no spill, salmonids are not attracted to the north entrance area either; hence the drop in north passage immediately after spill stops.
