**MEMORANDUM FOR Biologist, Operations Division (CENWP-OD)**

**SUBJECT:** Bonneville Project, Fishway and Fish Activities for **Week 39** of 2021, which covers the period from **19 to 25 September 2021**.

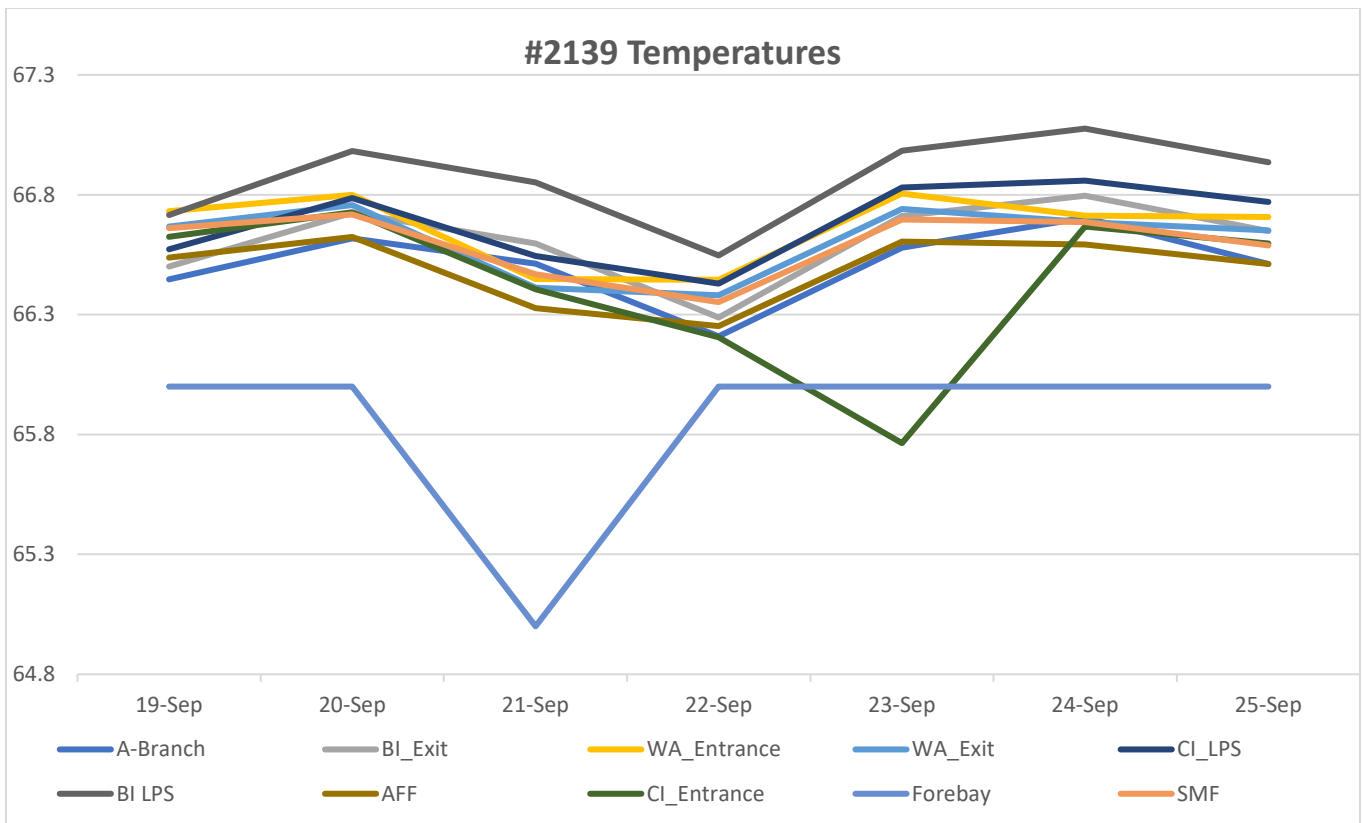
**Figure 1.** Average fishway temperatures for 19 to 25 September at Bonneville Lock & Dam.

\*\*\*B-Branch Entrance temp. probe is no longer serviceable. We are currently working on finding a replacement temp. probe\*\*\*

\*\*\*The WA Shore LPS temp. probe is no longer transmitting data. We are working to find a replacement probe\*\*\*

\*\*\*The Cascades Island temp. probe has not been collecting data correctly at low tailwaters.\*\*\*
