# The Dalles Dam Fishway Status Report

Inspection Period: 03/13/2016-03/19/2016

## THE DALLES DAM

US Army Corps  
of Engineers  
Portland District

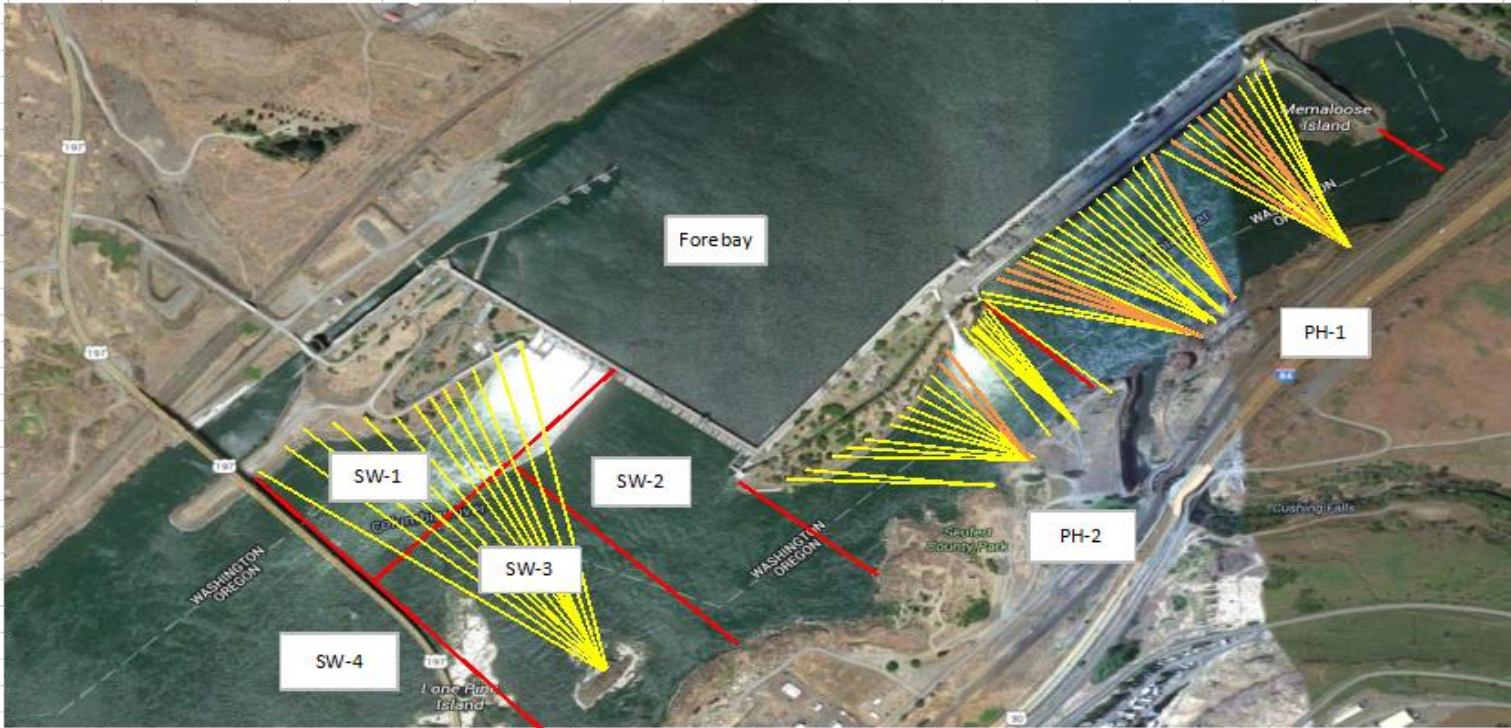
Spillway avian lines repair plan approved. Spillway closure needed for installation, which will likely be problems with high flows.

Yellow line = present avian lines

red line = Barriers between observation zones

Orange lines = Missing or down avian lines

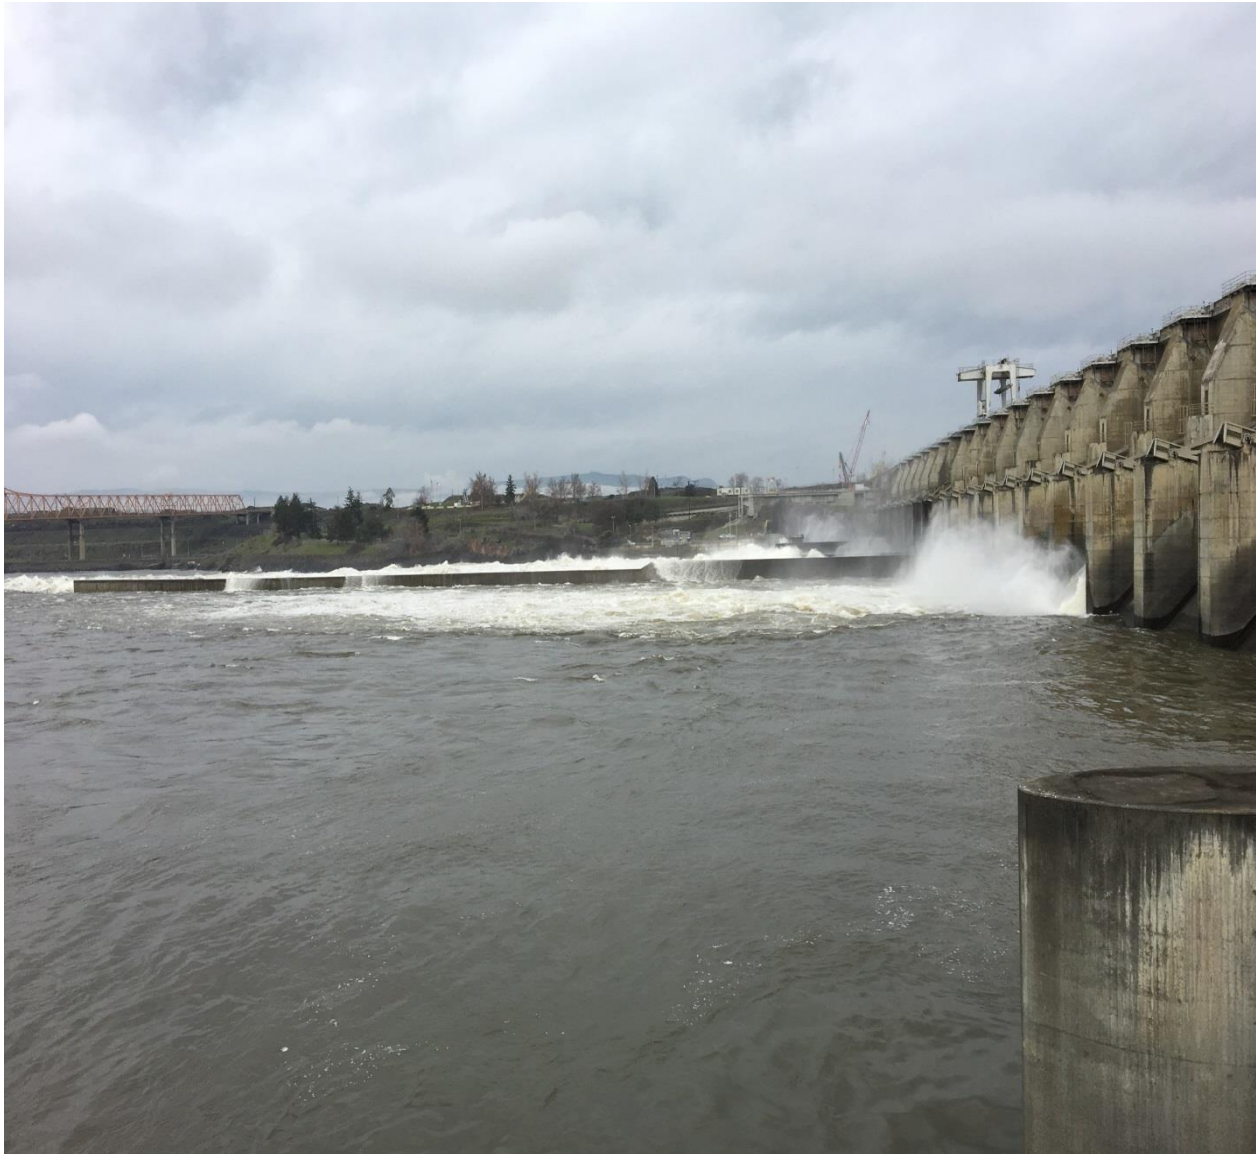
High spill overtopping wall.

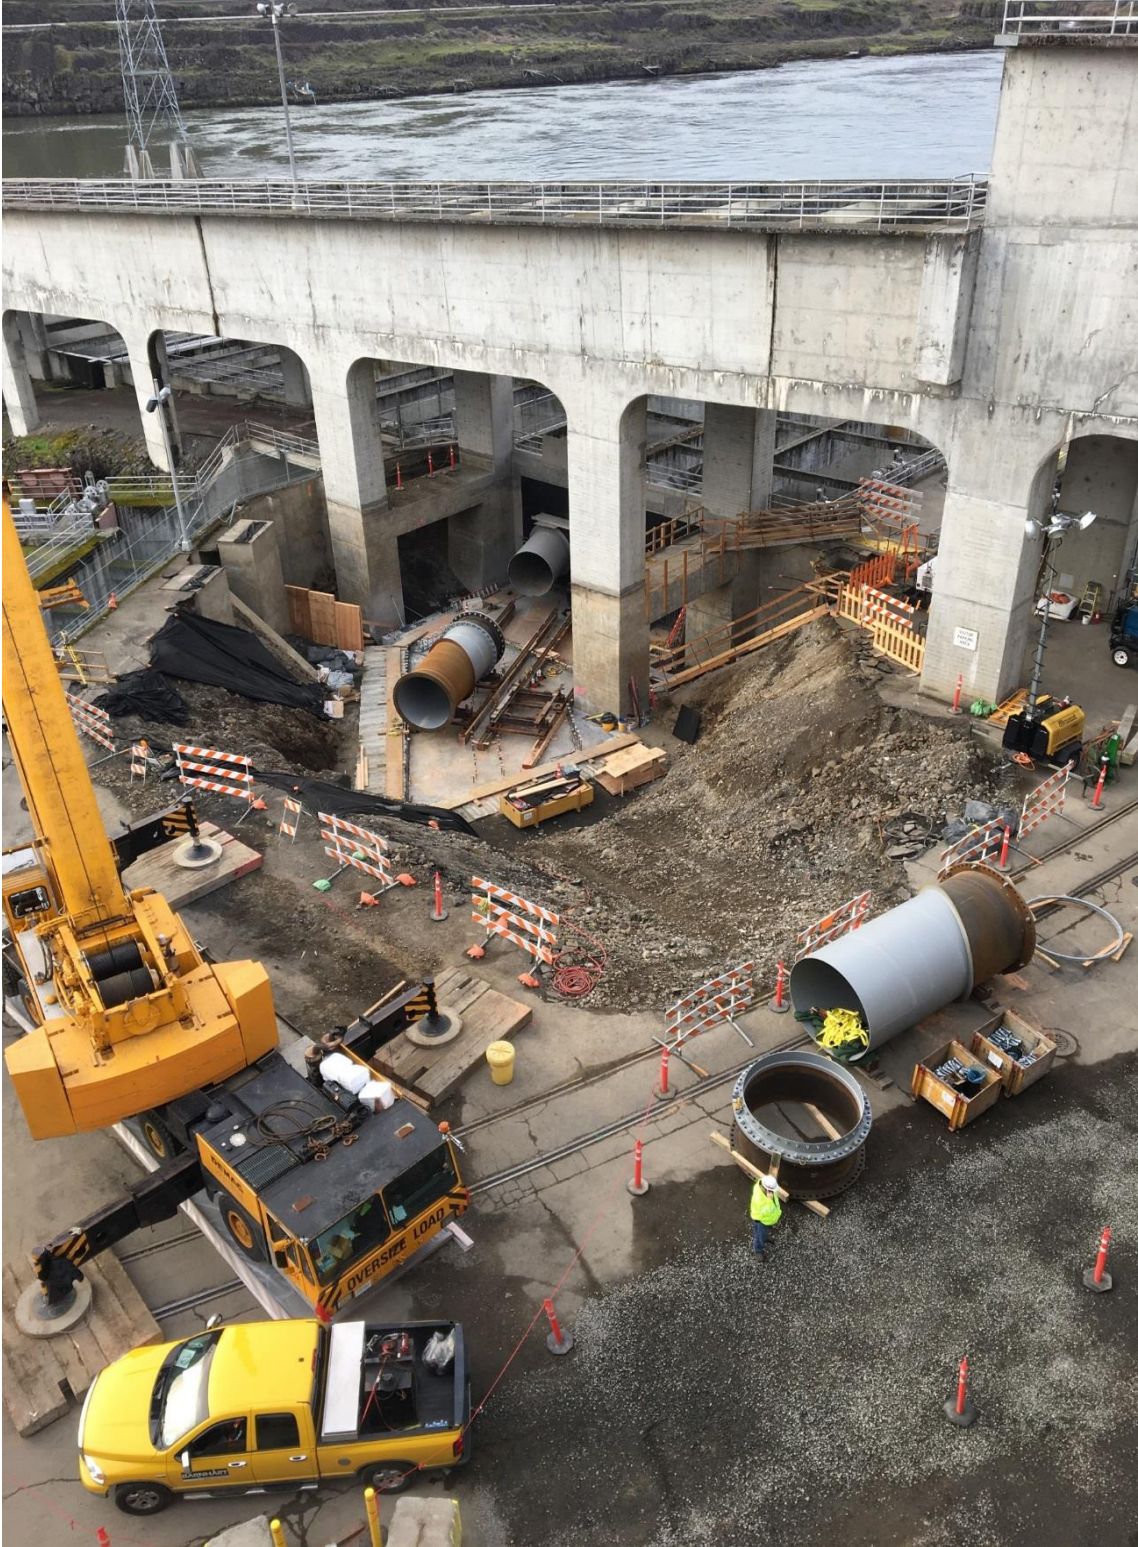
East fishladder AWS emergency backup - Forebay diving night work continues through March. Junction pool 7' pipe valve room concrete pouring underway.

Placing sections of 7' pipe. Possible placement of steel frame in forebay, FPOM approved.

Installing AWS 7' pipe sections.
