The Dalles Dam Fishway Status Report

11/4/2017

Inspection Period: 10/29/2017-11/04/2017

THE DALLES DAM

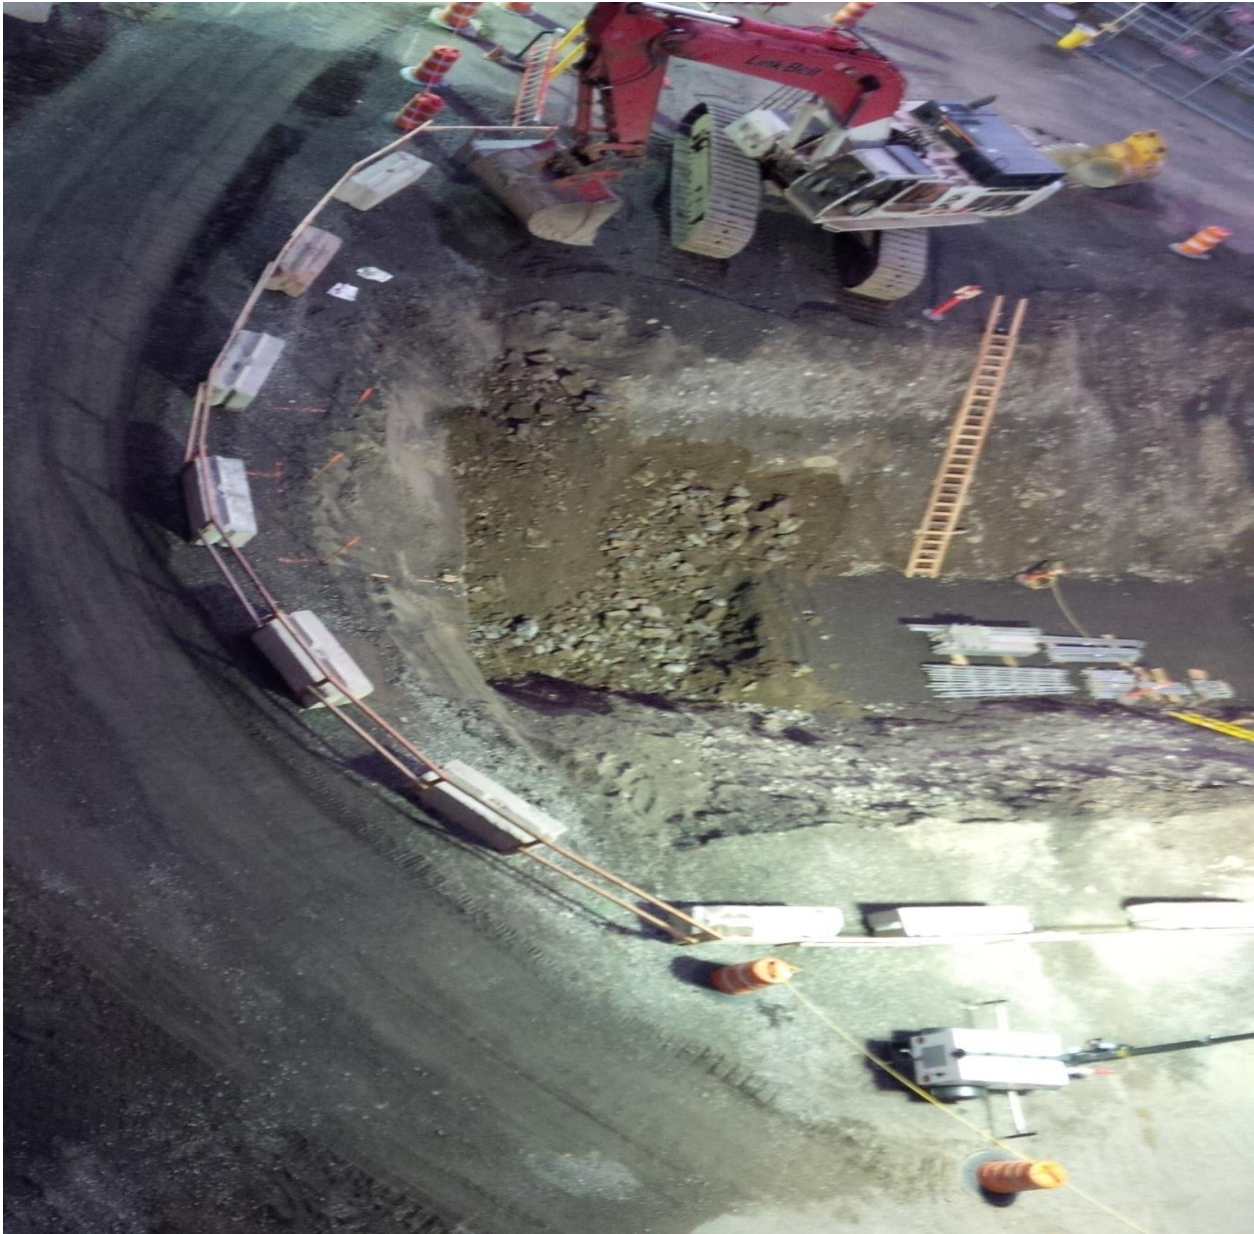
Small bedrock section that required rock hammer.
