The Dalles Dam Fishway Status Report

The Dalles Project-Fisheries

| | 12/3 | 31/2017 | | US Ar | | | | 30x 564 alles, OR 97058-9998 | | | |
|---|---|---|---|---|---|---|---|---|---|--|--|
| Insp | ection Period: | 12/24/2017-1 | 12/30/2017 | | Portland District | | Phone: 541-506-3800 | | | | |

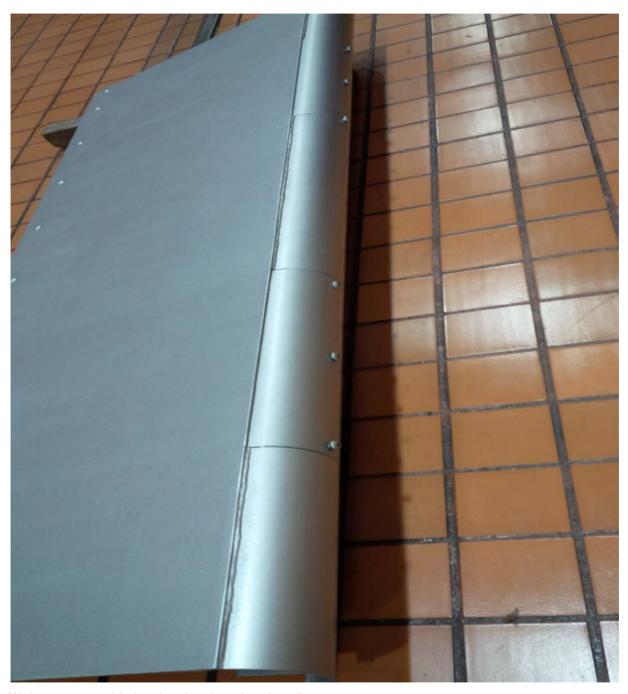
Weir caps assembled, painted and ready to install

Lamprey minor mods - Rounded entrance weir caps on sight. Working on attaching to west weirs. South and north to follow.

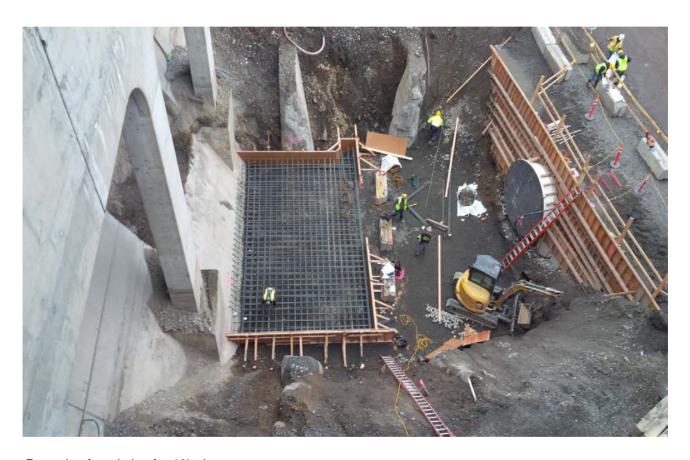
Preparing foundation for 10'valve room
