The Da	lles Dam F	THE DALLES DAM							
	Ϊ. <del>Υ</del>	H		es Project	-Fisheries				
		my Corps	P.O. Box	k 564 es, OR 97	058-0008				
lass	of En Portiar	gineers id District		541-506-38					
Inspection Period: 01/07/2017-01/13/2018									
The Delles Dem	Inspections	Criteria	Total Number	5	Tempera	ture:	39.9	°F	
The Dalles Dam	Out of Criteria	Limit	Comments			Secchi:	5.0	feet

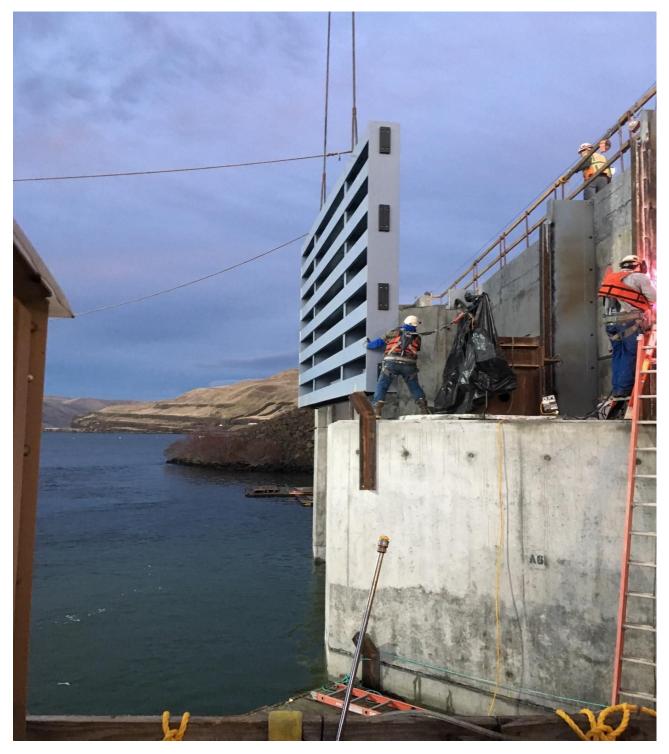
Bulkheads installed. Ready to finish boring hole at bottom of dam.

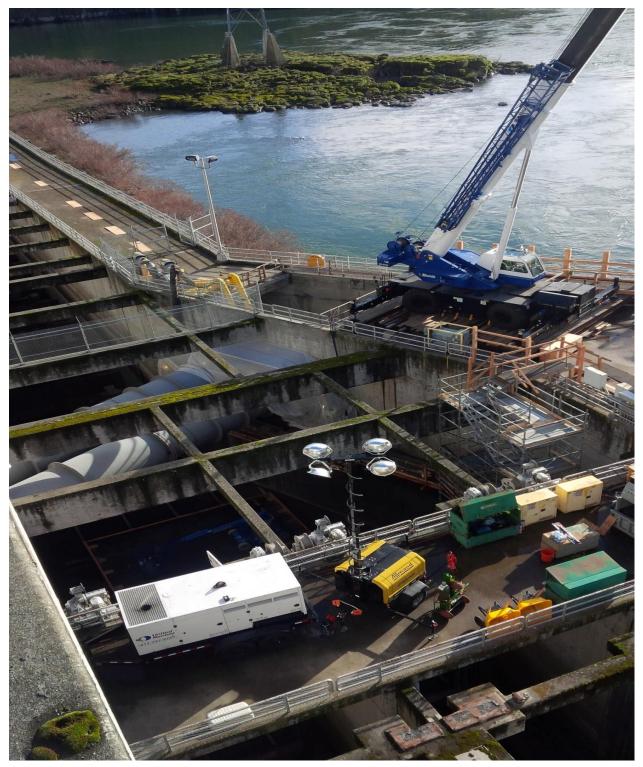
Installing pipe section into AWS chamber.

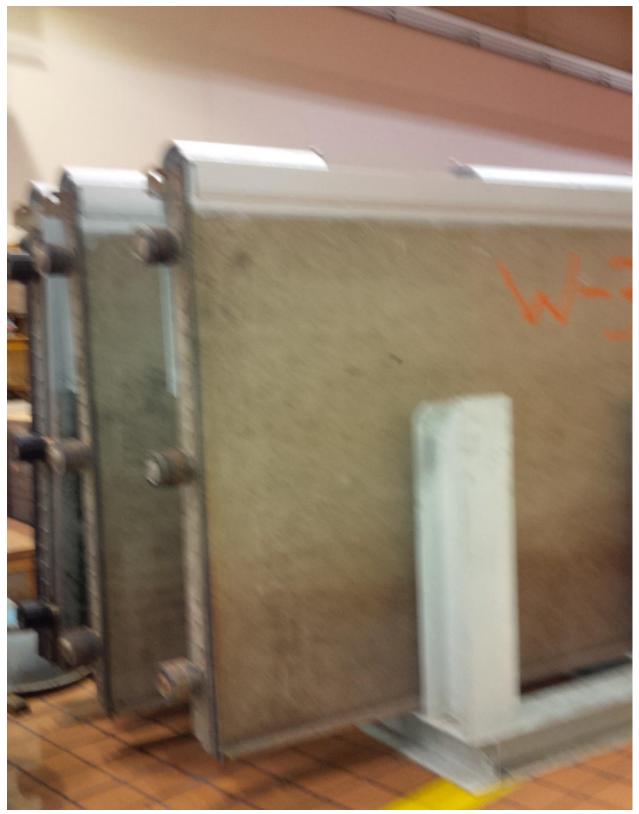
West entranc weir caps installed
