The Dalles Dam Fishway Status Report

1/28/2018

Inspection Period: 01/21/2018-01/28/2018

THE DALLES DAM

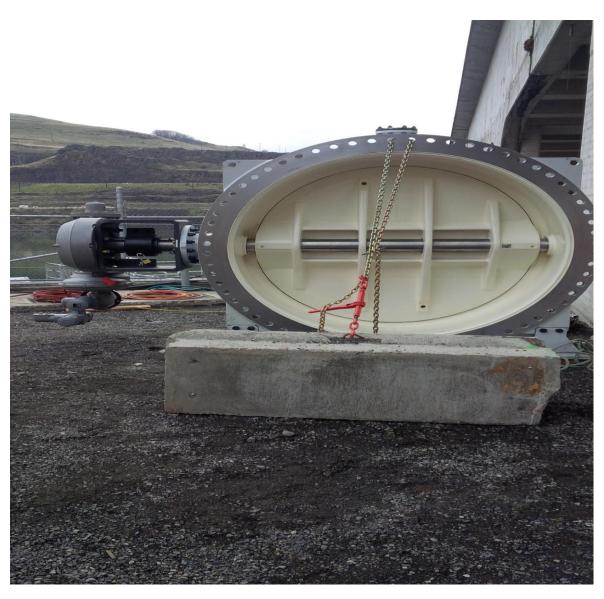
New italian 7' valve ready for install

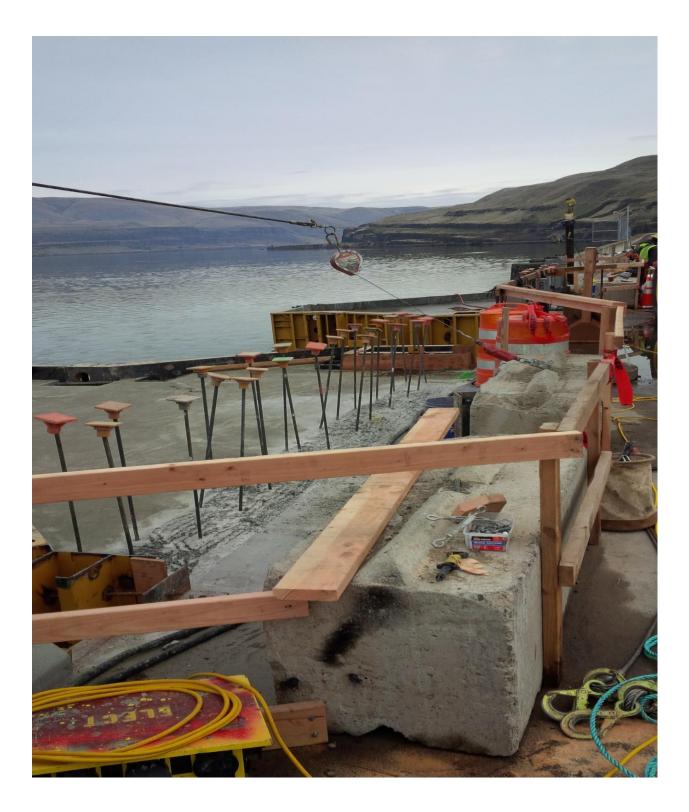
Capping the AWS intake slot

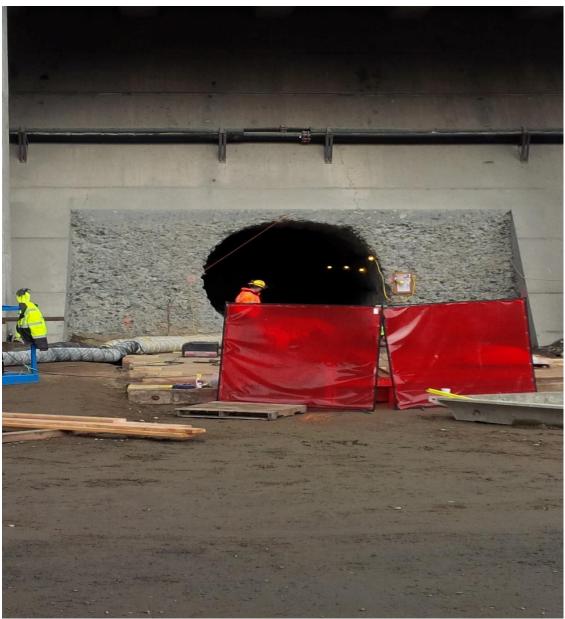
Prepping slide to insert 10' pipe in dam.
