The Dalles Dam Fishway Status Report

12/22/18

Inspection Period: Dec. 16 - Dec. 22, 2018

US Army Corps
of Engineers
Portland District

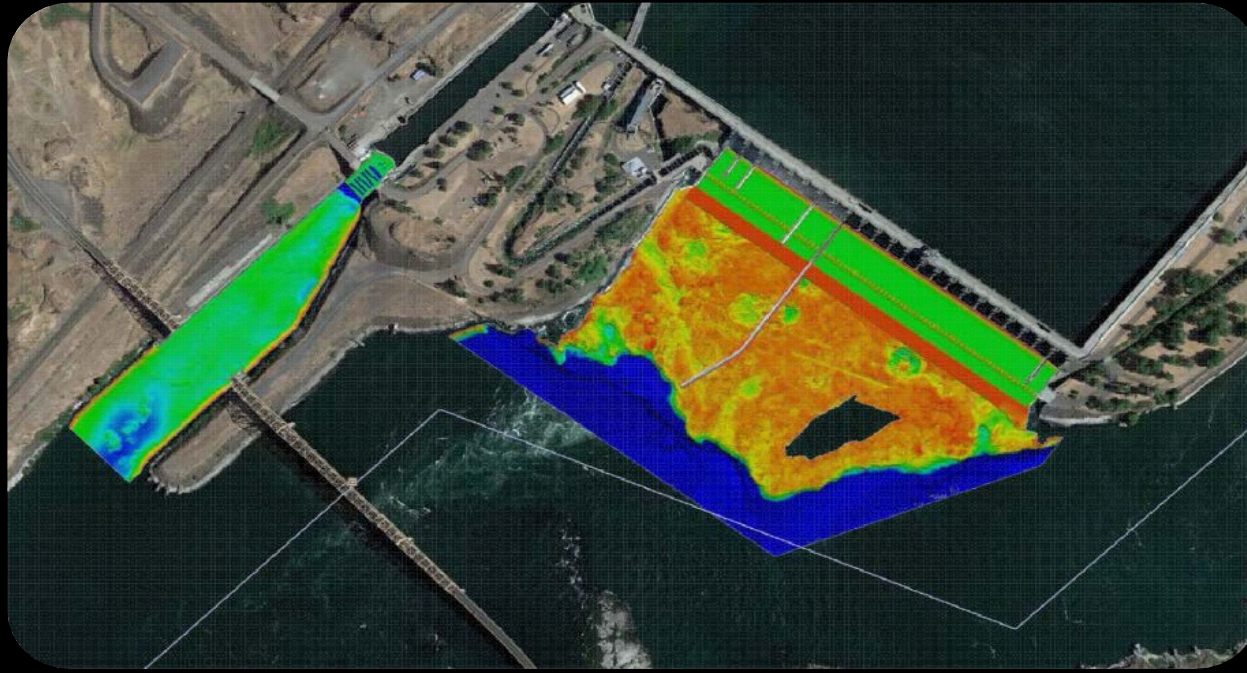
Figure 8. MBES coverage attained at The Dalles Dam spillways, stilling basin, and downstream approach to the navigation lock (November 6-7, 2018). Note data gap in south spillway due to extreme shallow water depths.

It is important to note that an approximately 150-ft by 300-ft ovular area within the south spillway tailrace was not survey-able at the time of the survey due to shallow waters. In this area water depths were 3 feet or less. The survey coverage is illustrated qualitatively in Figure 8 where warmer colors (i.e., reds) indicate shallow water depths and cooler colors (i.e., blues) indicate deeper water depths.
