The Dalles Dam Fishway Status Report

05/19/19

Inspection Period: May 12 - May 18, 2019

US Army Corps
of Engineers
Portland District

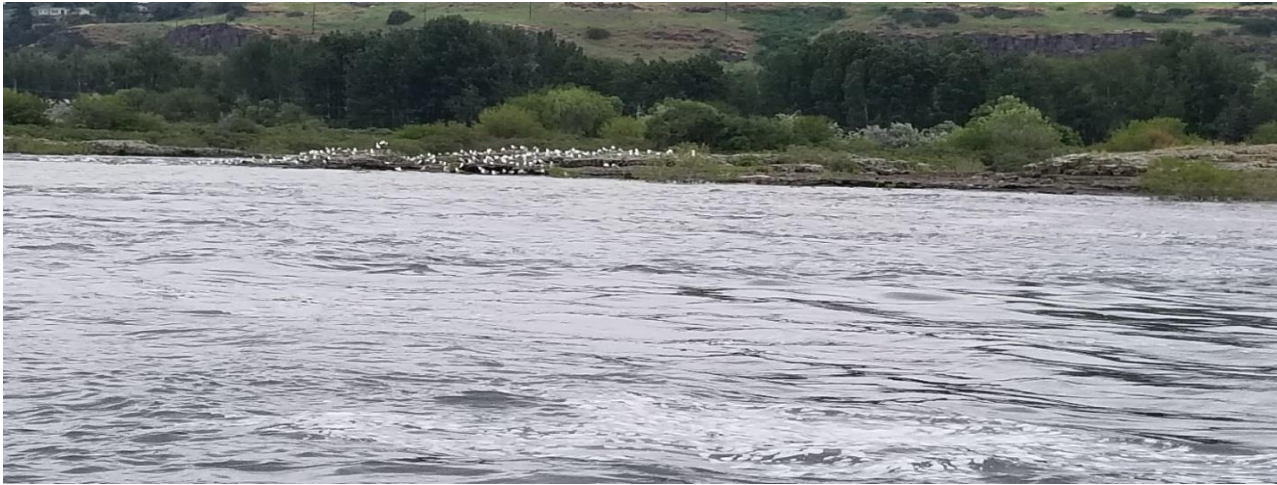
Gull loafing rock downstream of bridge before laser test.

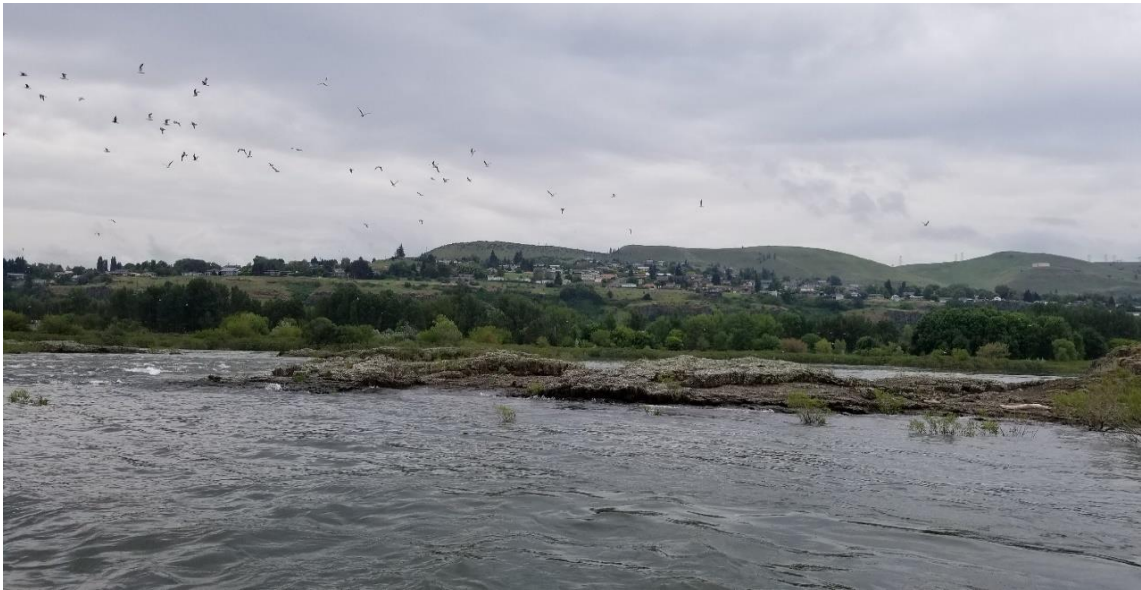
Gull loafing rock after laser test.
