The Dalles Dam Fishway Status Report

Inspection Period: May 19 - May 25, 2019

THE DALLES DAM

US Army Corps
of Engineers
Portland District

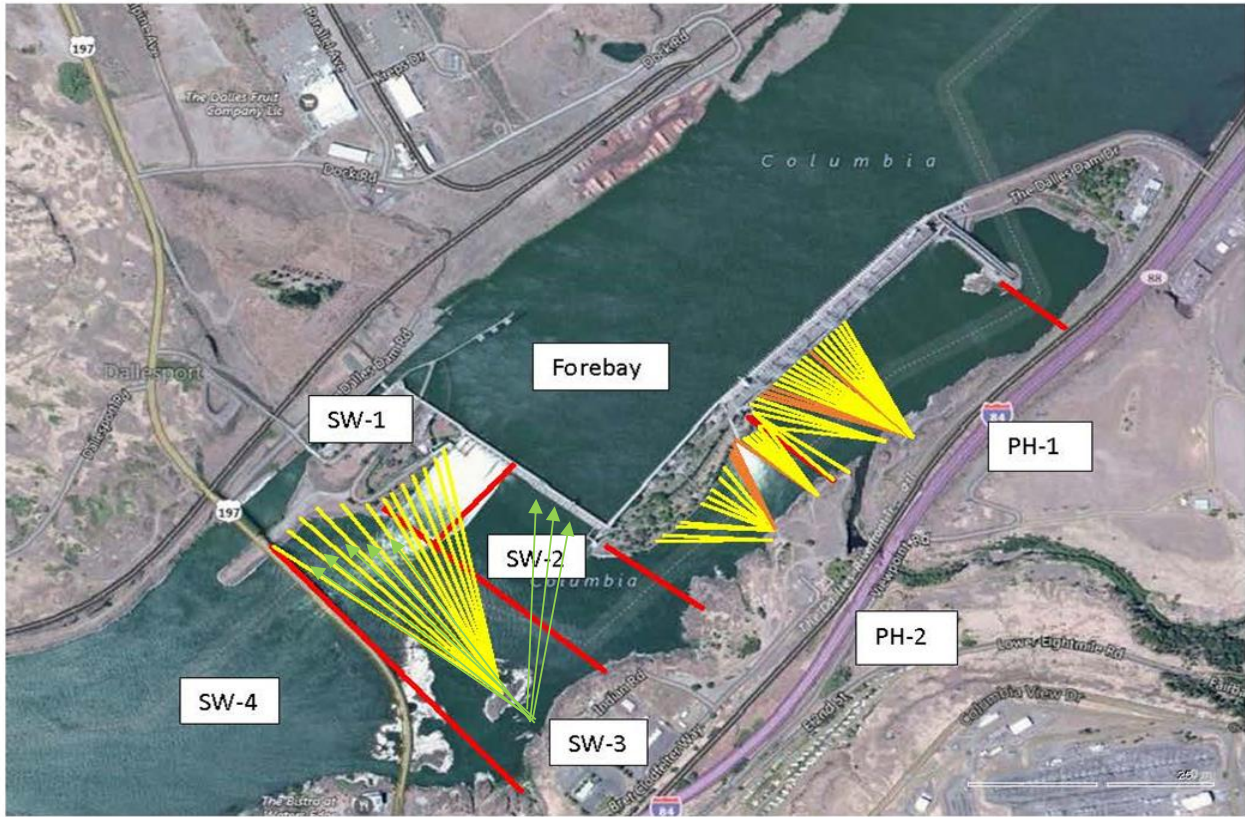
Orange lines = down or missing wires

→ Additional avian lines installed 9/2018

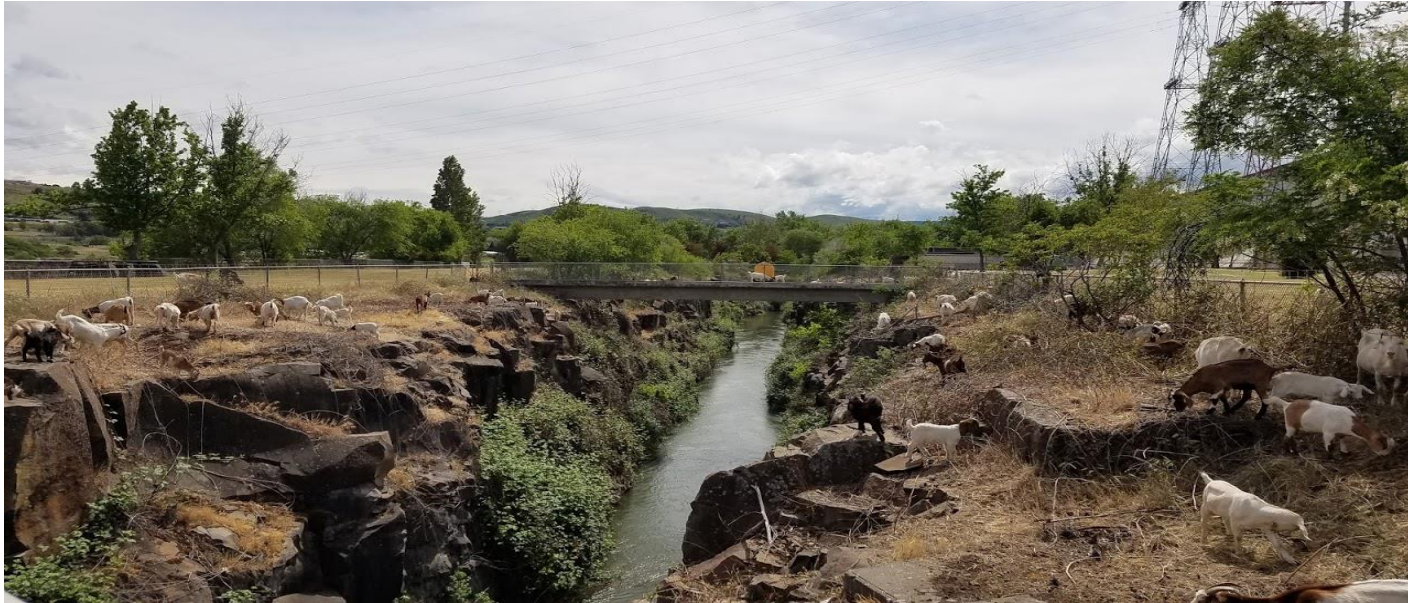
Goat successfully removing vegetation from upper channel. Limitations to waterline access.

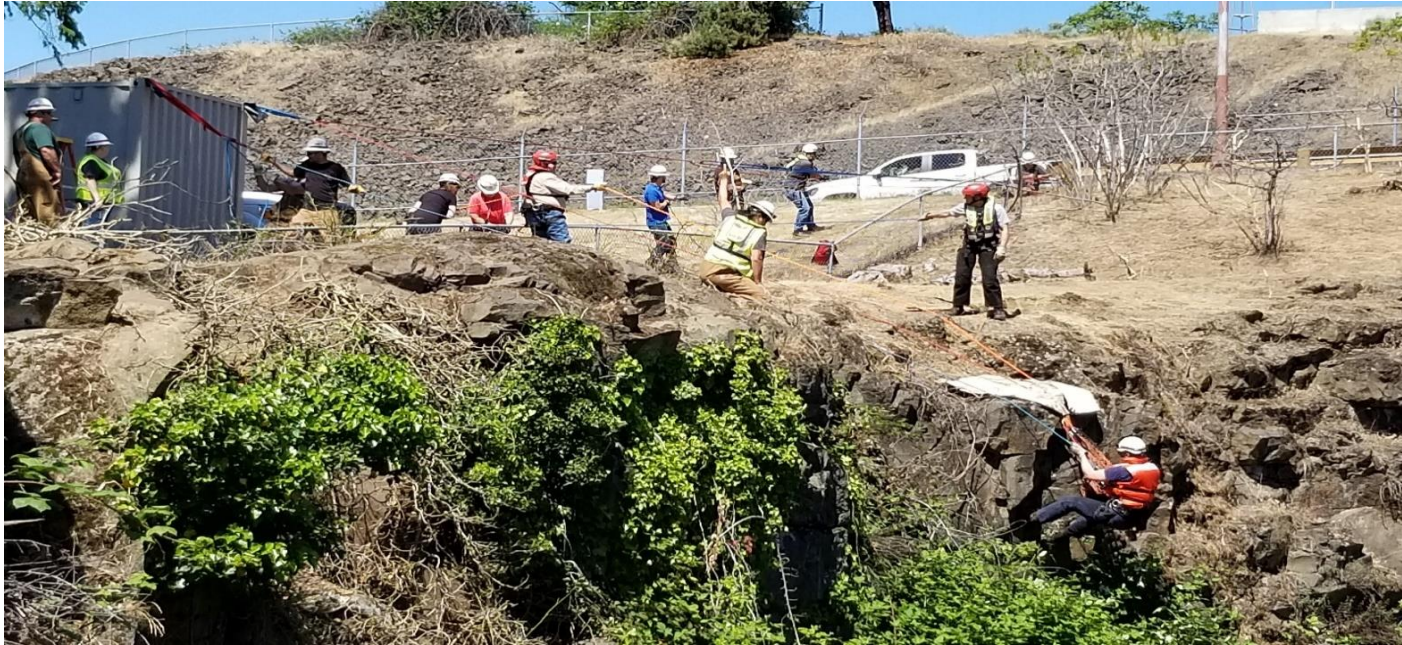
Goat herders dog fell in north fishladder. Project Emergency Response Team used opportunity as training.

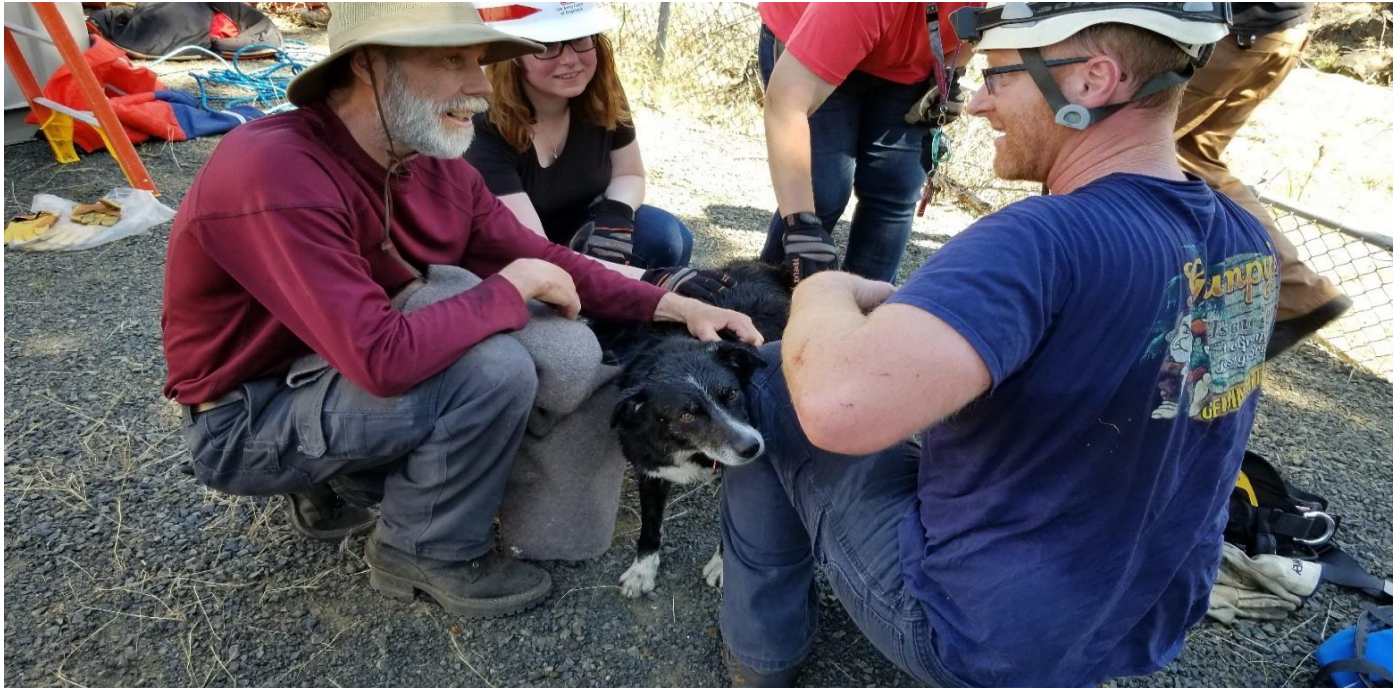
Happy ending by all.
