The Dalles Dam Fishway Status Report

Inspection Period: June 02 - June 08, 2019

THE DALLES DAM

US Army Corps
of Engineers
Portland District

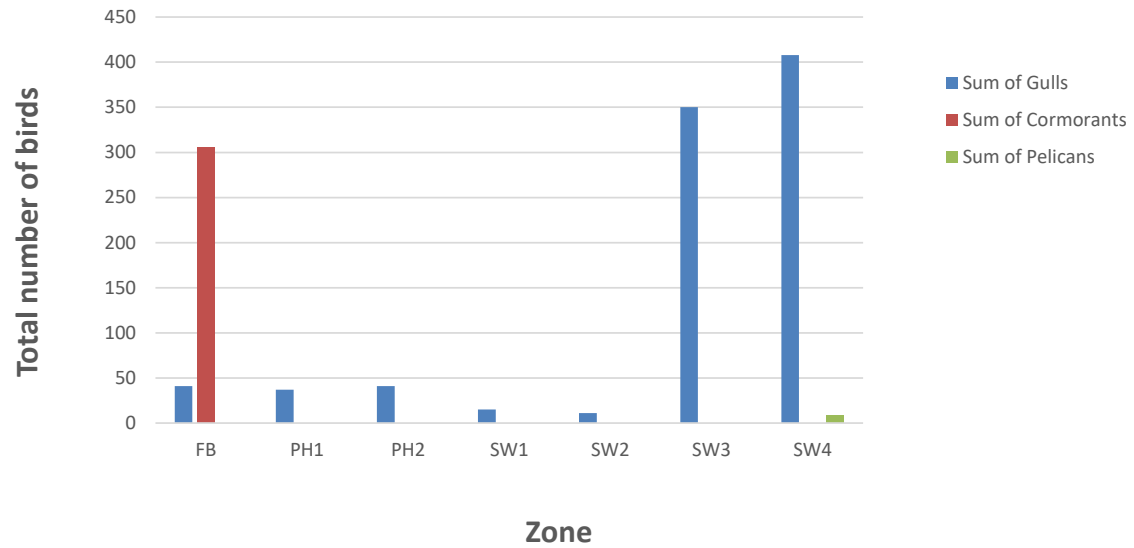
Bird Observations by Zone 6/2-6/8

USDA hazing from boat and shore. Increase in gull numbers in powerhouse tailrace and within spillway avian lines. Also some activity in powerhouse tailrace.

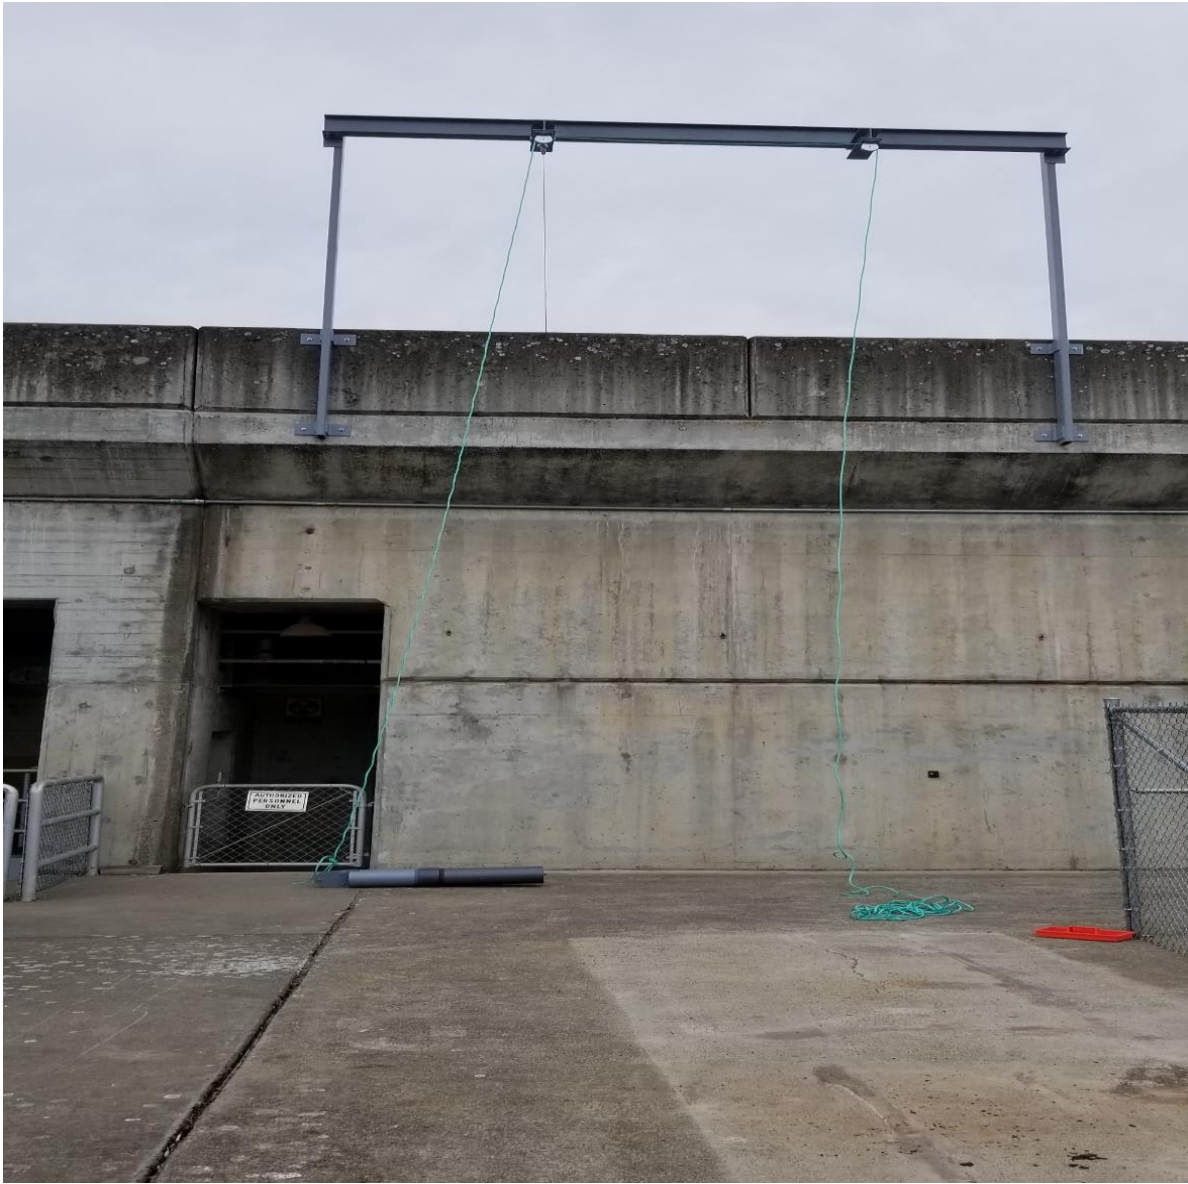
Tribal lamprey trapping - New improved hoist system installed, thanks to ingenuity of project engineer. Test lifts were successful.

Hoist frame at east fishway exit for tribal lamprey trapping to lift to forebay deck
