The Dalles Dam Fishway Status Report

Inspection Period: June 09 - June 15, 2019

THE DALLES DAM

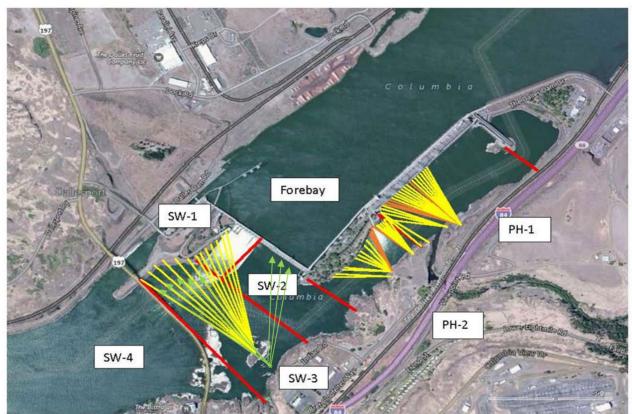
Red lines = avian zones

Yellow lines = current wires

Orange lines = down or missing wires

Additional avian lines installed 9/2018

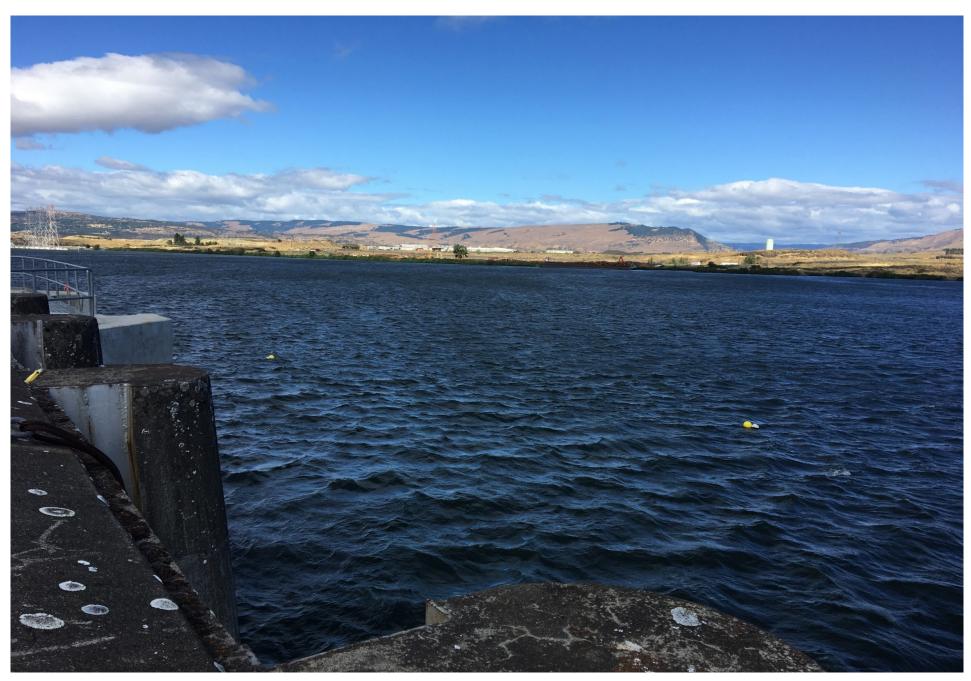
Floating temperature profile strings in the BRZ-East Exit Temperature profile data to be analyzed for thermal statification

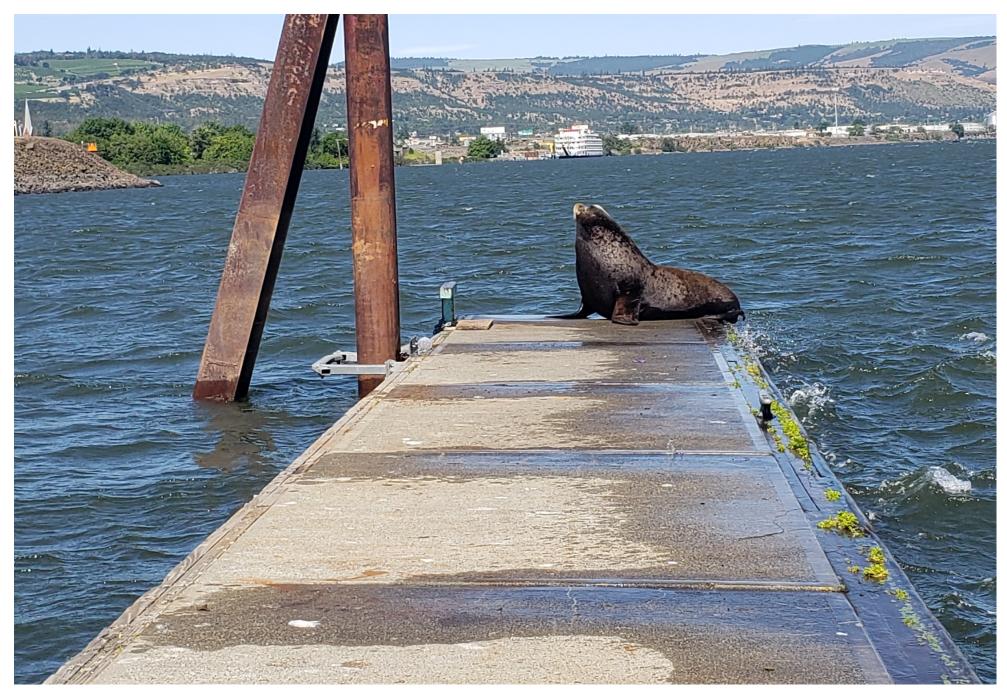
Sea Lion observed by USDA at The Dalles Marina
