# The Dalles Dam Fishway Status Report

06/29/19

Inspection Period: June 23 - June 29, 2019

US Army Corps  
of Engineers  
Portland District

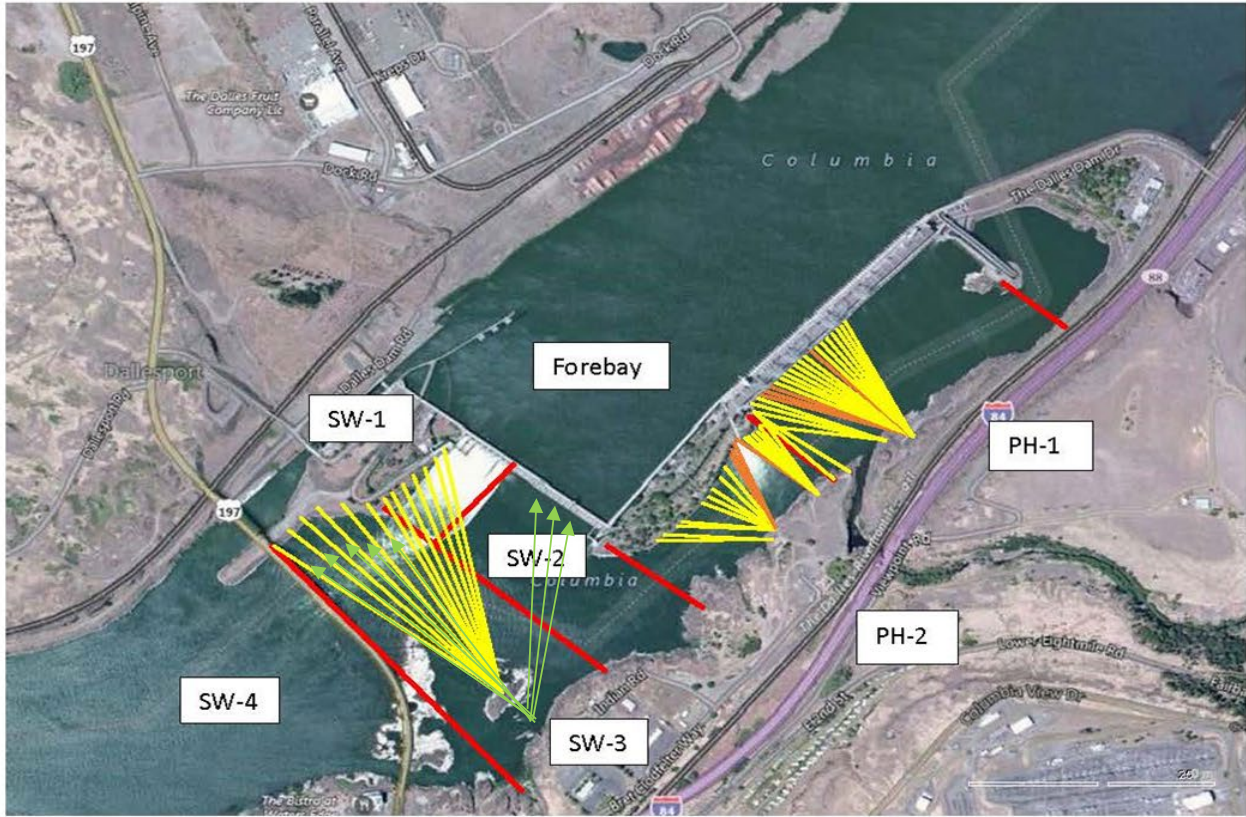
Additional avian lines installed 9/2018

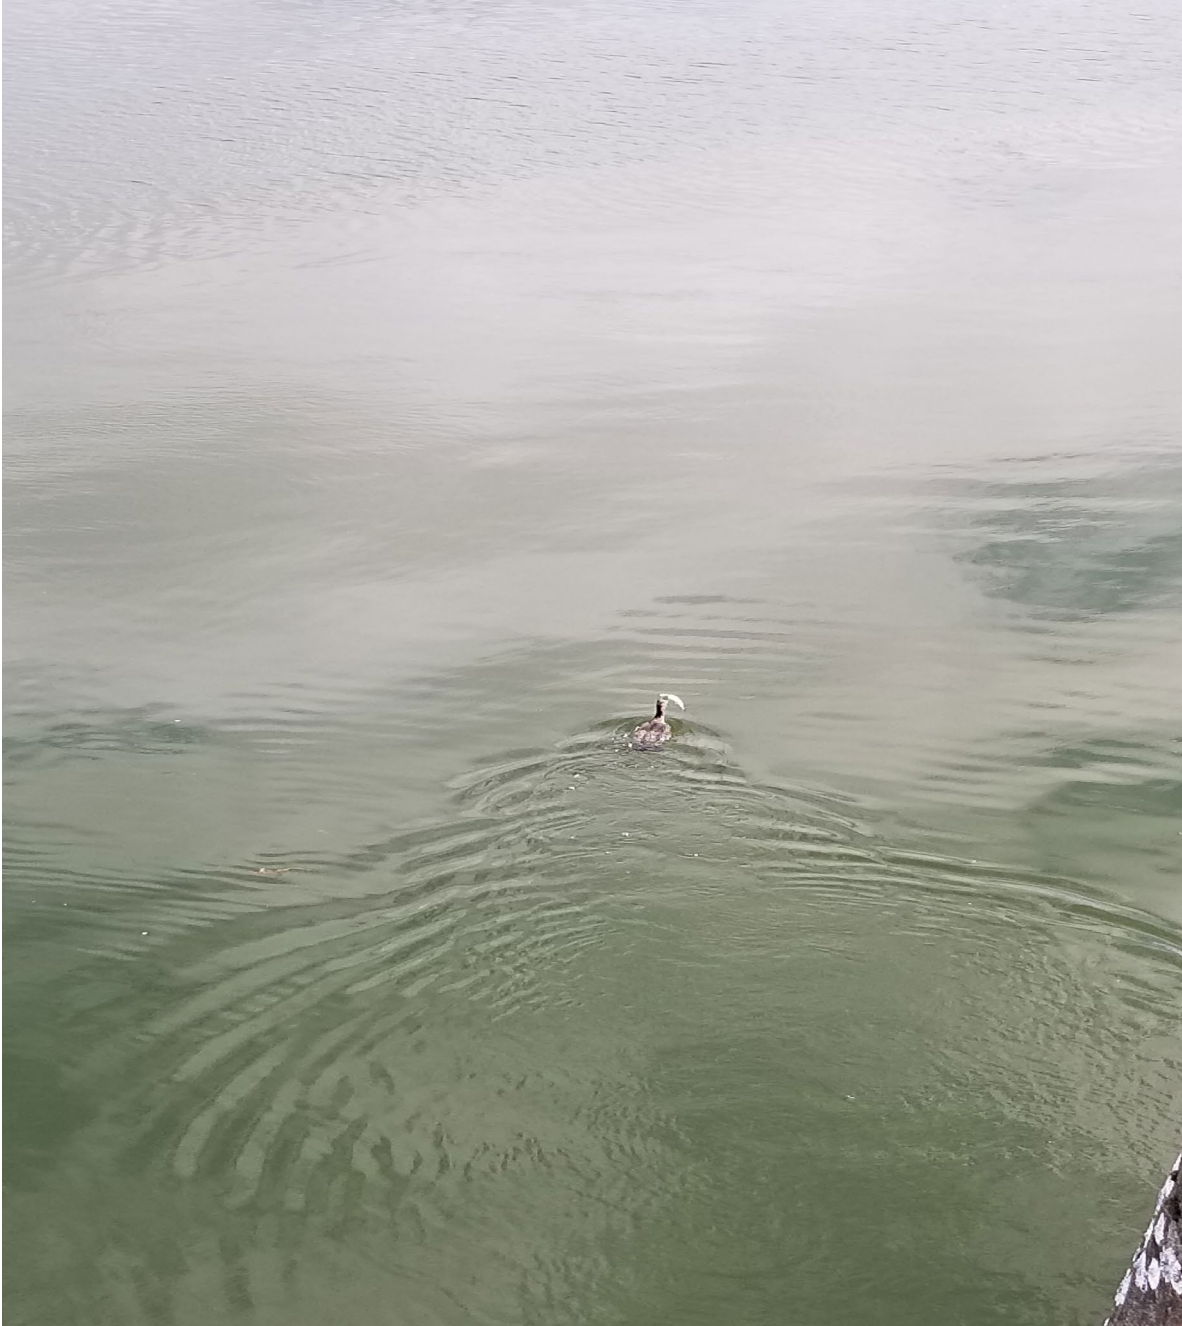
Cormorants foraging increase near east ladder exit. Hazing efforts increased.
