The Dalles Dam Fishway Status Report

Inspection Period: July 7 - July13, 2019

THE DALLES DAM

US Army Corps
of Engineers
Portland District

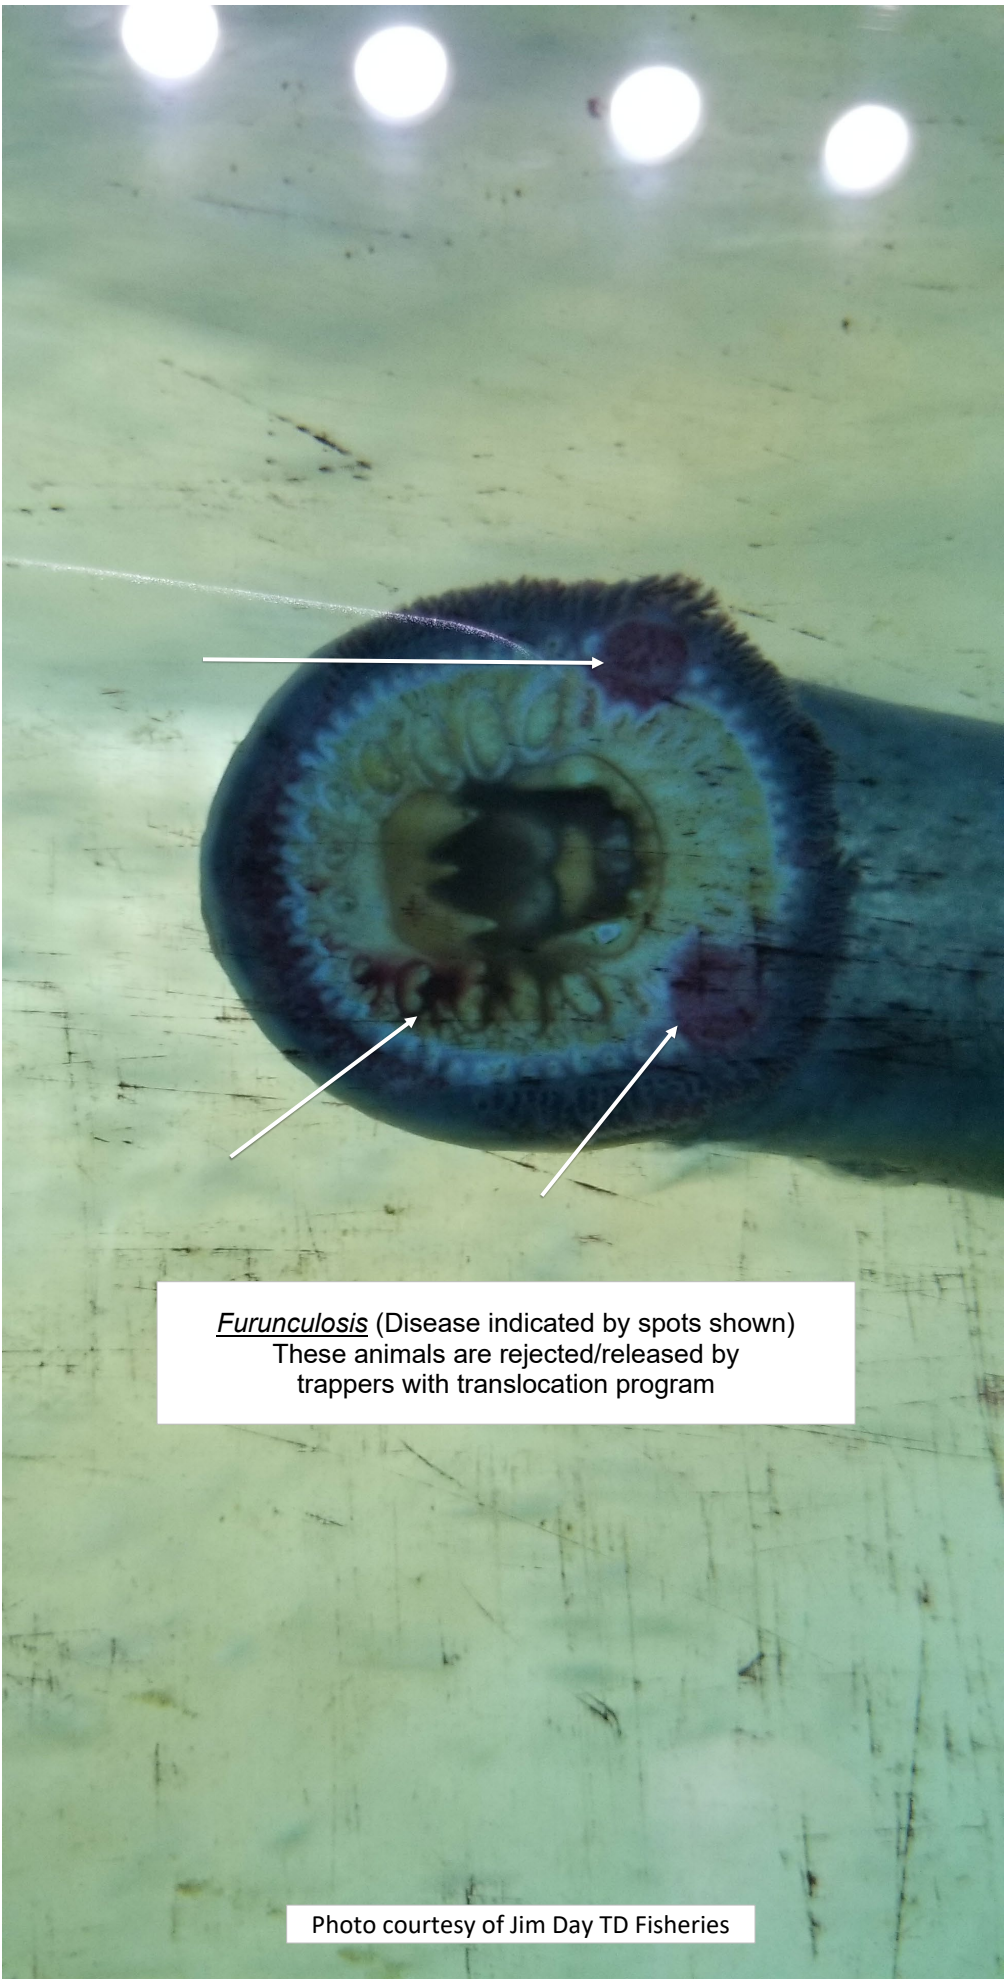
Furunculosis (Disease indicated by spots shown)

These animals are rejected/released by trappers with translocation program
