The Dalles Dam Fishway Status Report

Inspection Period: July 14 - July 20, 2019

THE DALLES DAM

US Army Corps
of Engineers
Portland District

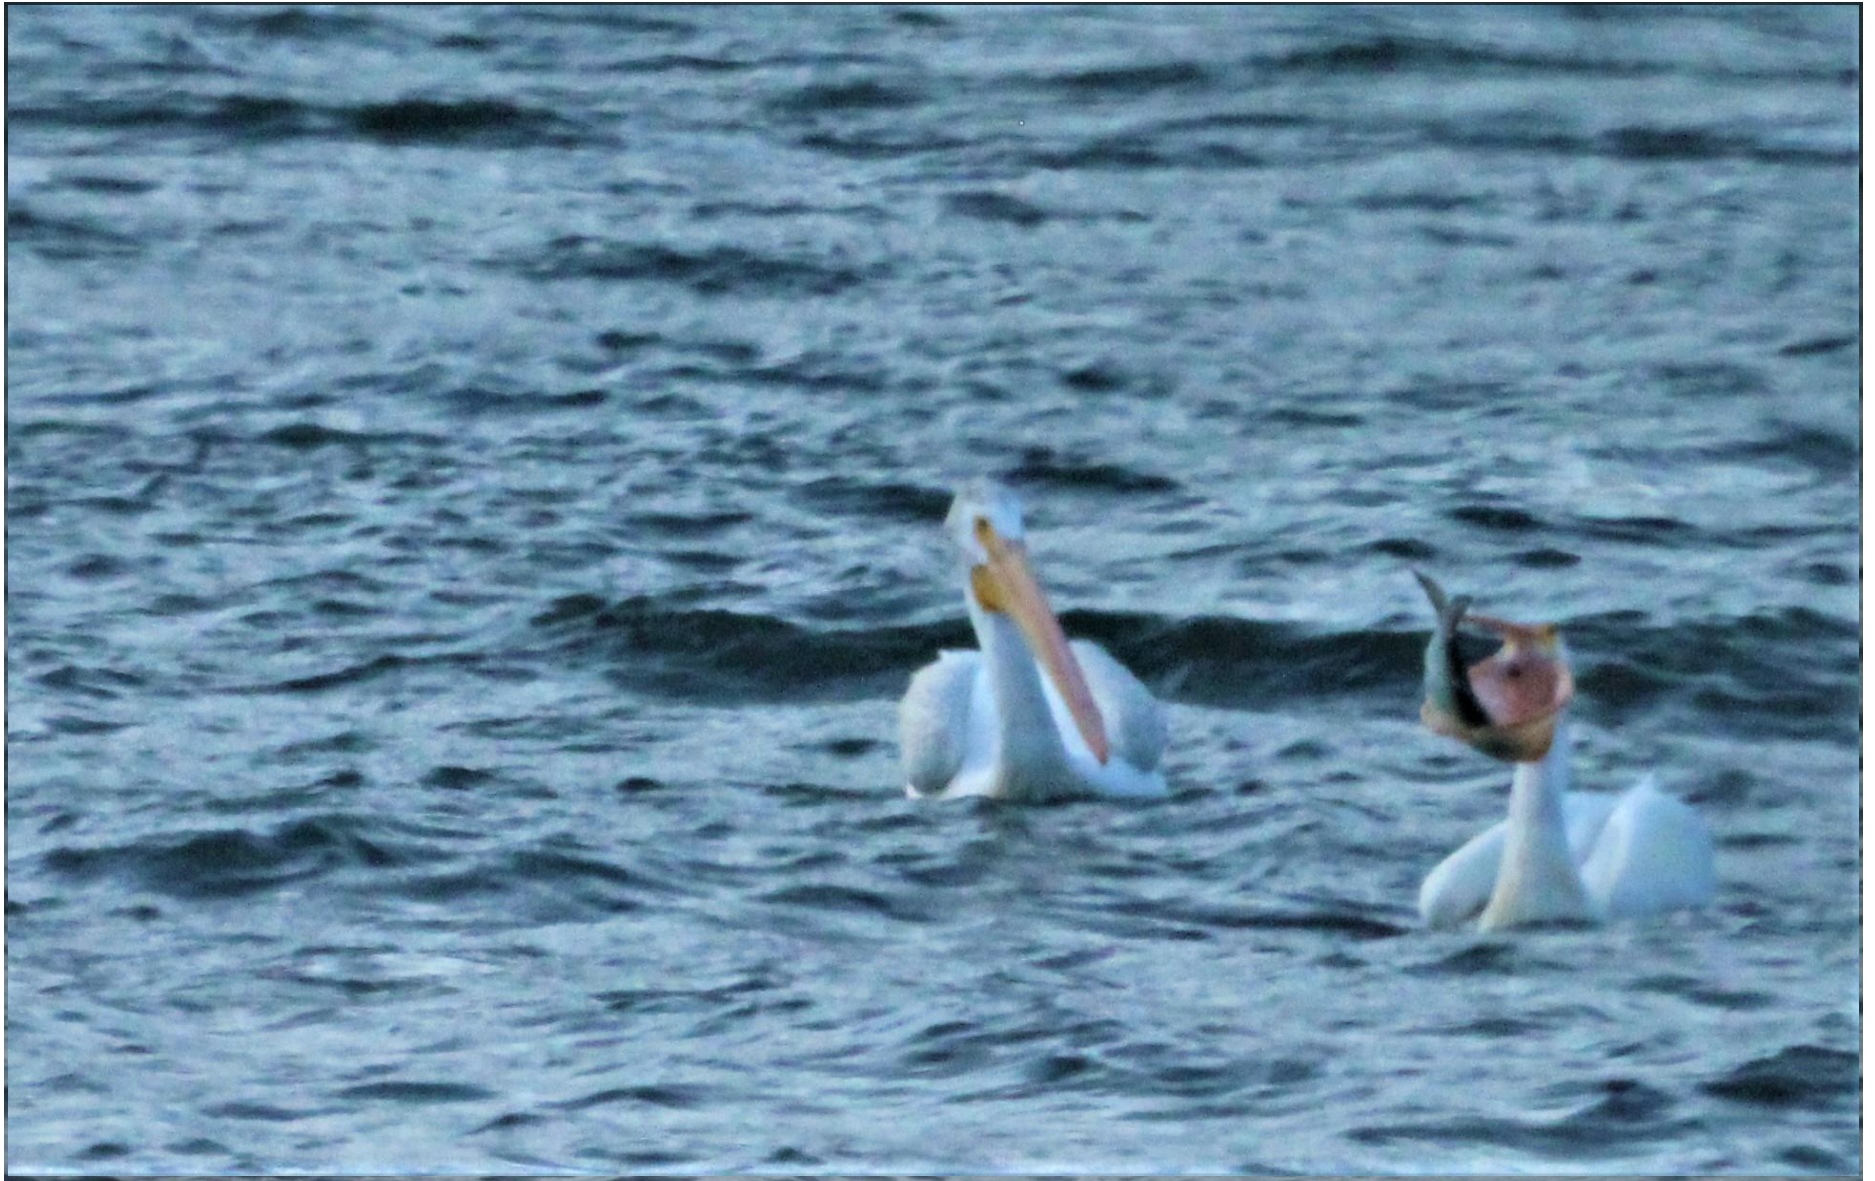
Photo from Friday 7/12 in SW4.

Dip and tip ratio stable, about 1 fish tipped every 5 minutes of dipping. All but one tip confirmed shad.
