The Dalles Dam Fishway Status Report

Inspection Period: 12/15-12/21, 2019

THE DALLES DAM

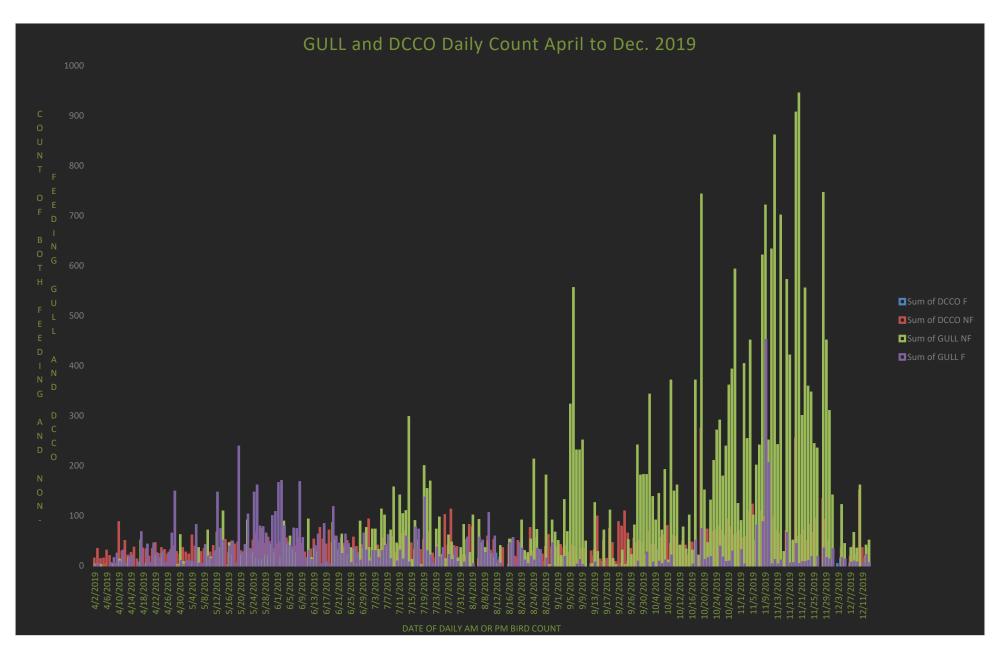
Note increased numbers of birds feeding on salmon in May as opposed to non feeding on juvenile shad in the fall. Daily fluctuations may be due to AM versus PM daily count time.

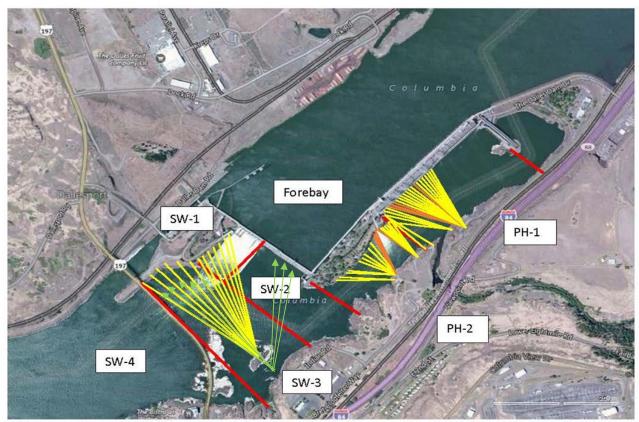
Orange lines = down or missing wires

Additional avian lines installed 9/2018
