The Dalles Dam Fishway Status Report

Date: 11/01/2013
 Inspection Period: 11/24 to 11/30/2013

THE DALLES DAM

**US Army Corps
 of Engineers**
 Portland District

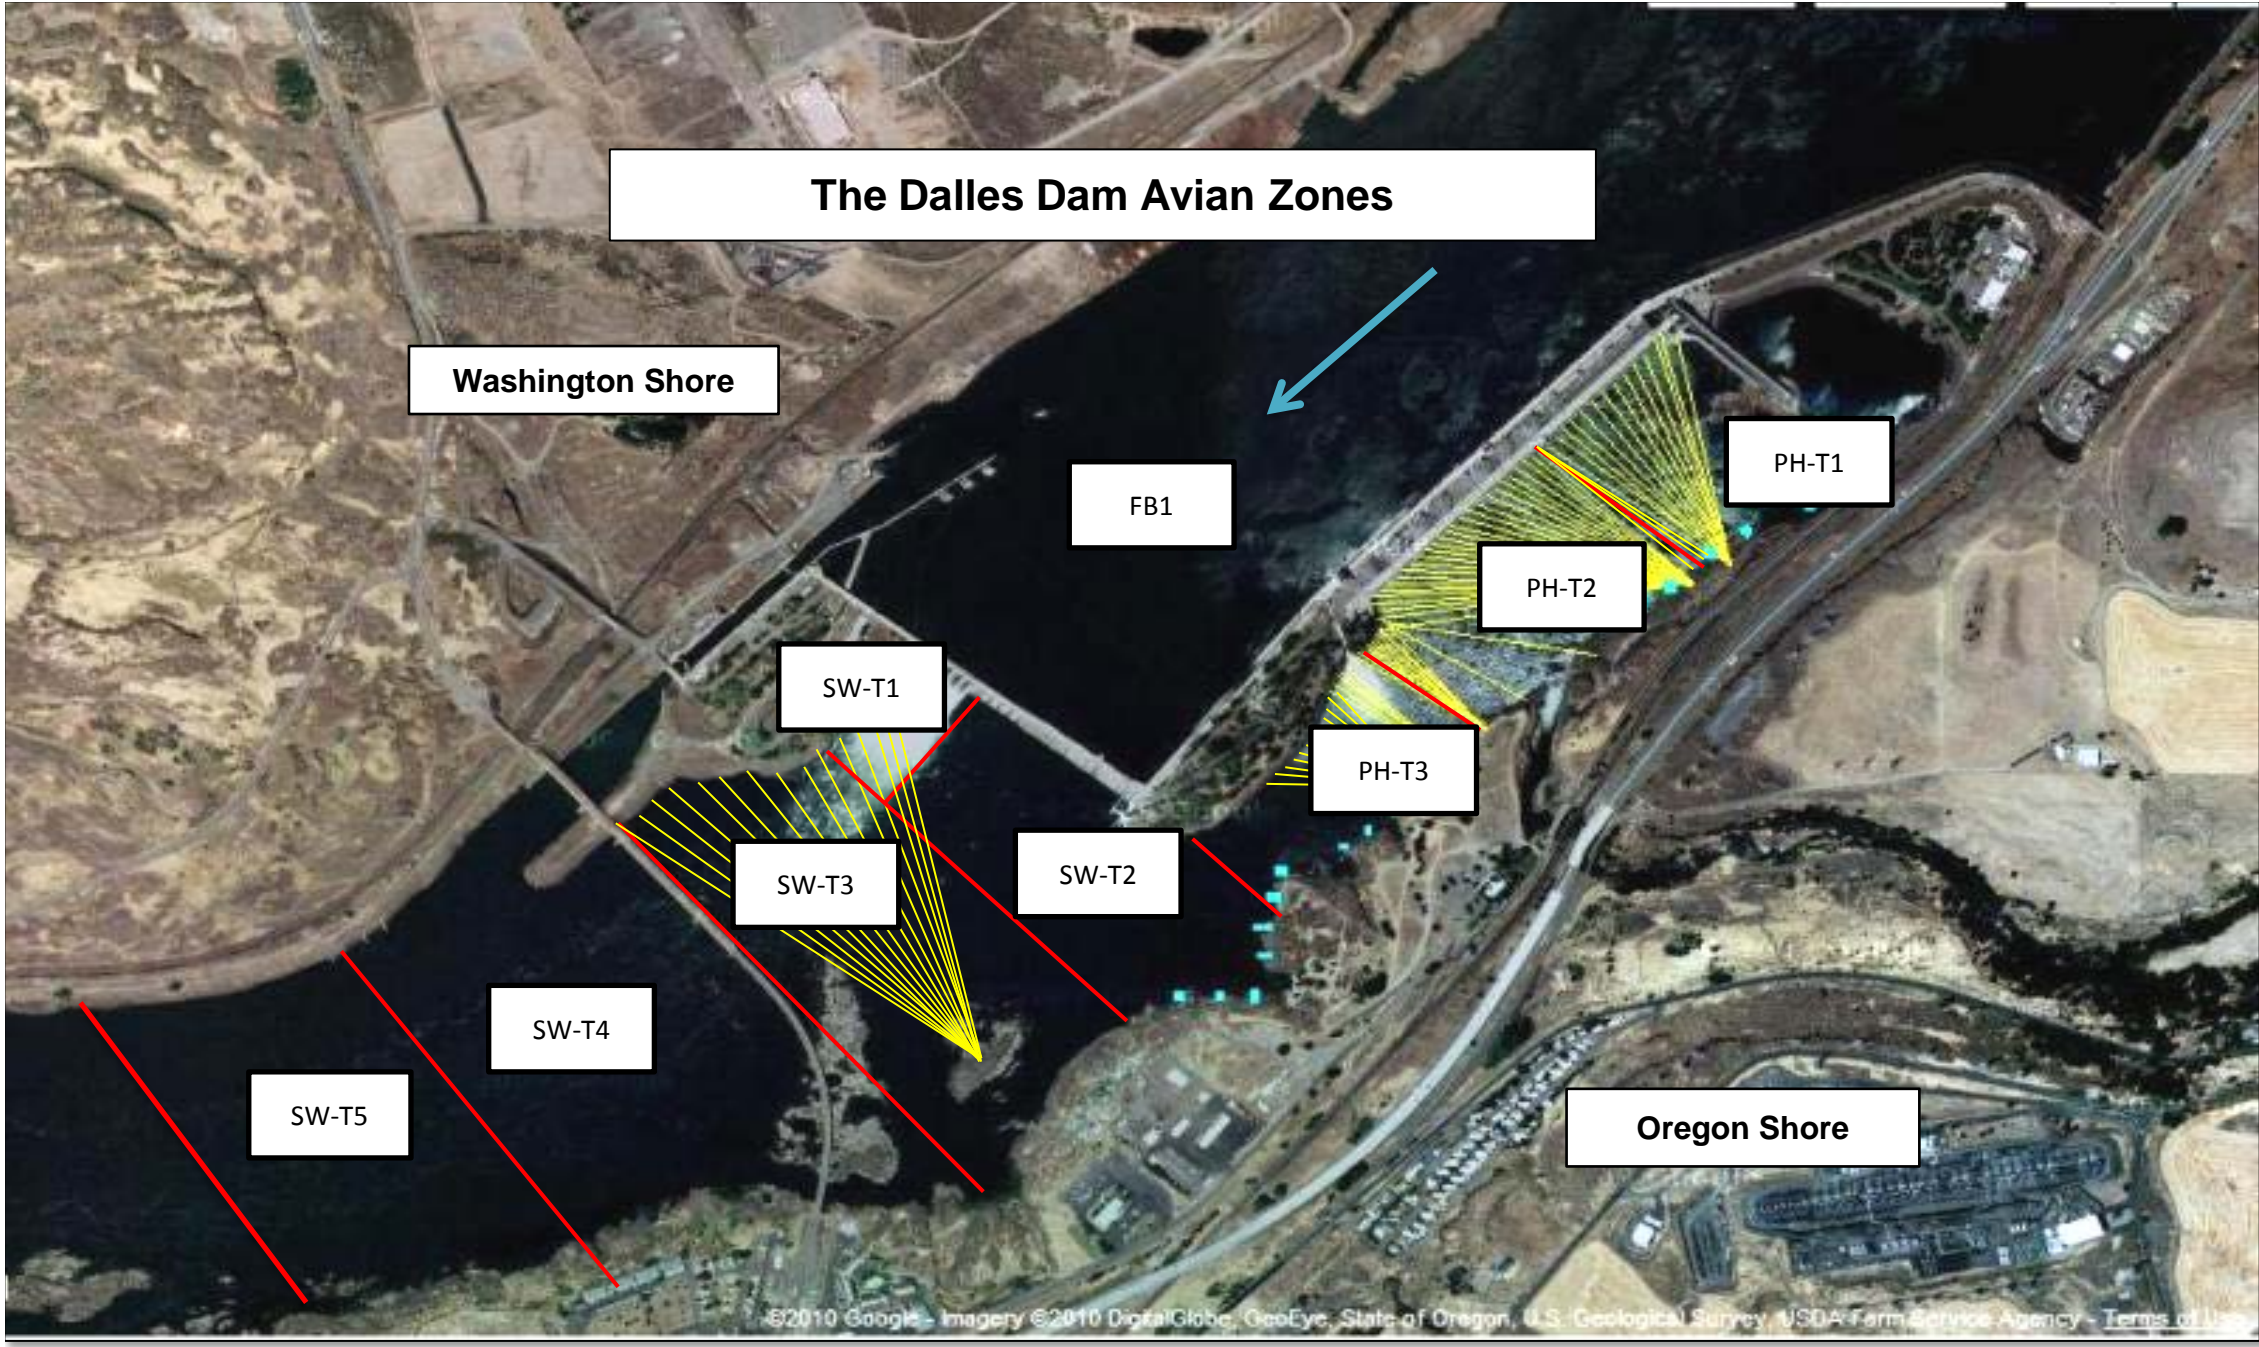
The Dalles Dam Avian Zones

Bird observation data collected twice daily. There are mostly gulls and cormorants around the project, with grebes in the forebay. Most foraging occurring at west end of the powerhouse (PHT2) and downstream of sluiceway outfall (PHT3).

See avian zones map and distribution tabs. No sea lion sightings this week.

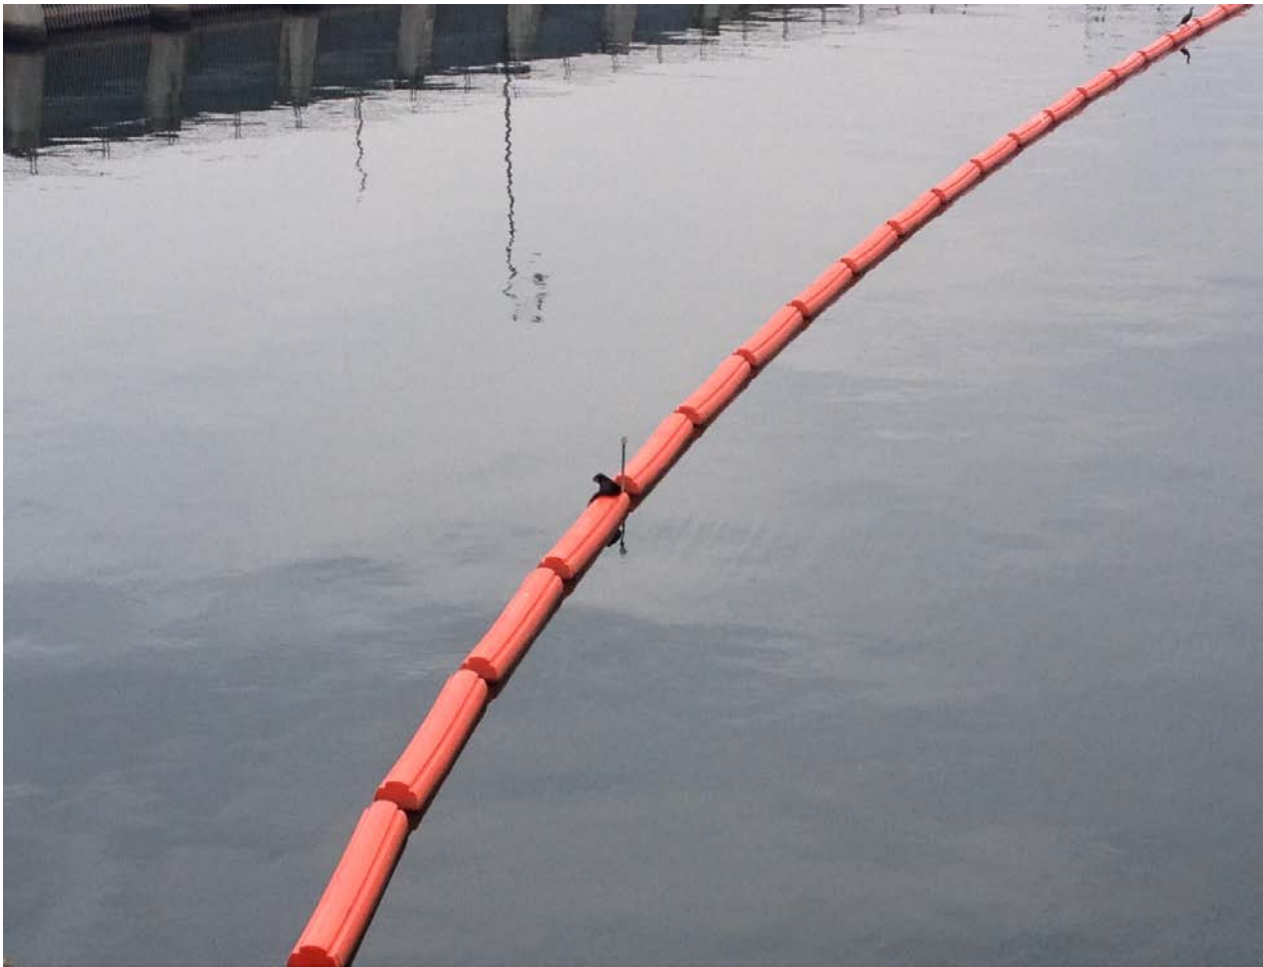
Resident otter near north fishway exit.
