The Dalles Dam Fishway Status Report

Date: 02/09/2014
 Inspection Period: 02/02/2014-02/08/2014

THE DALLES DAM

US Army Corps
 of Engineers
 Portland District

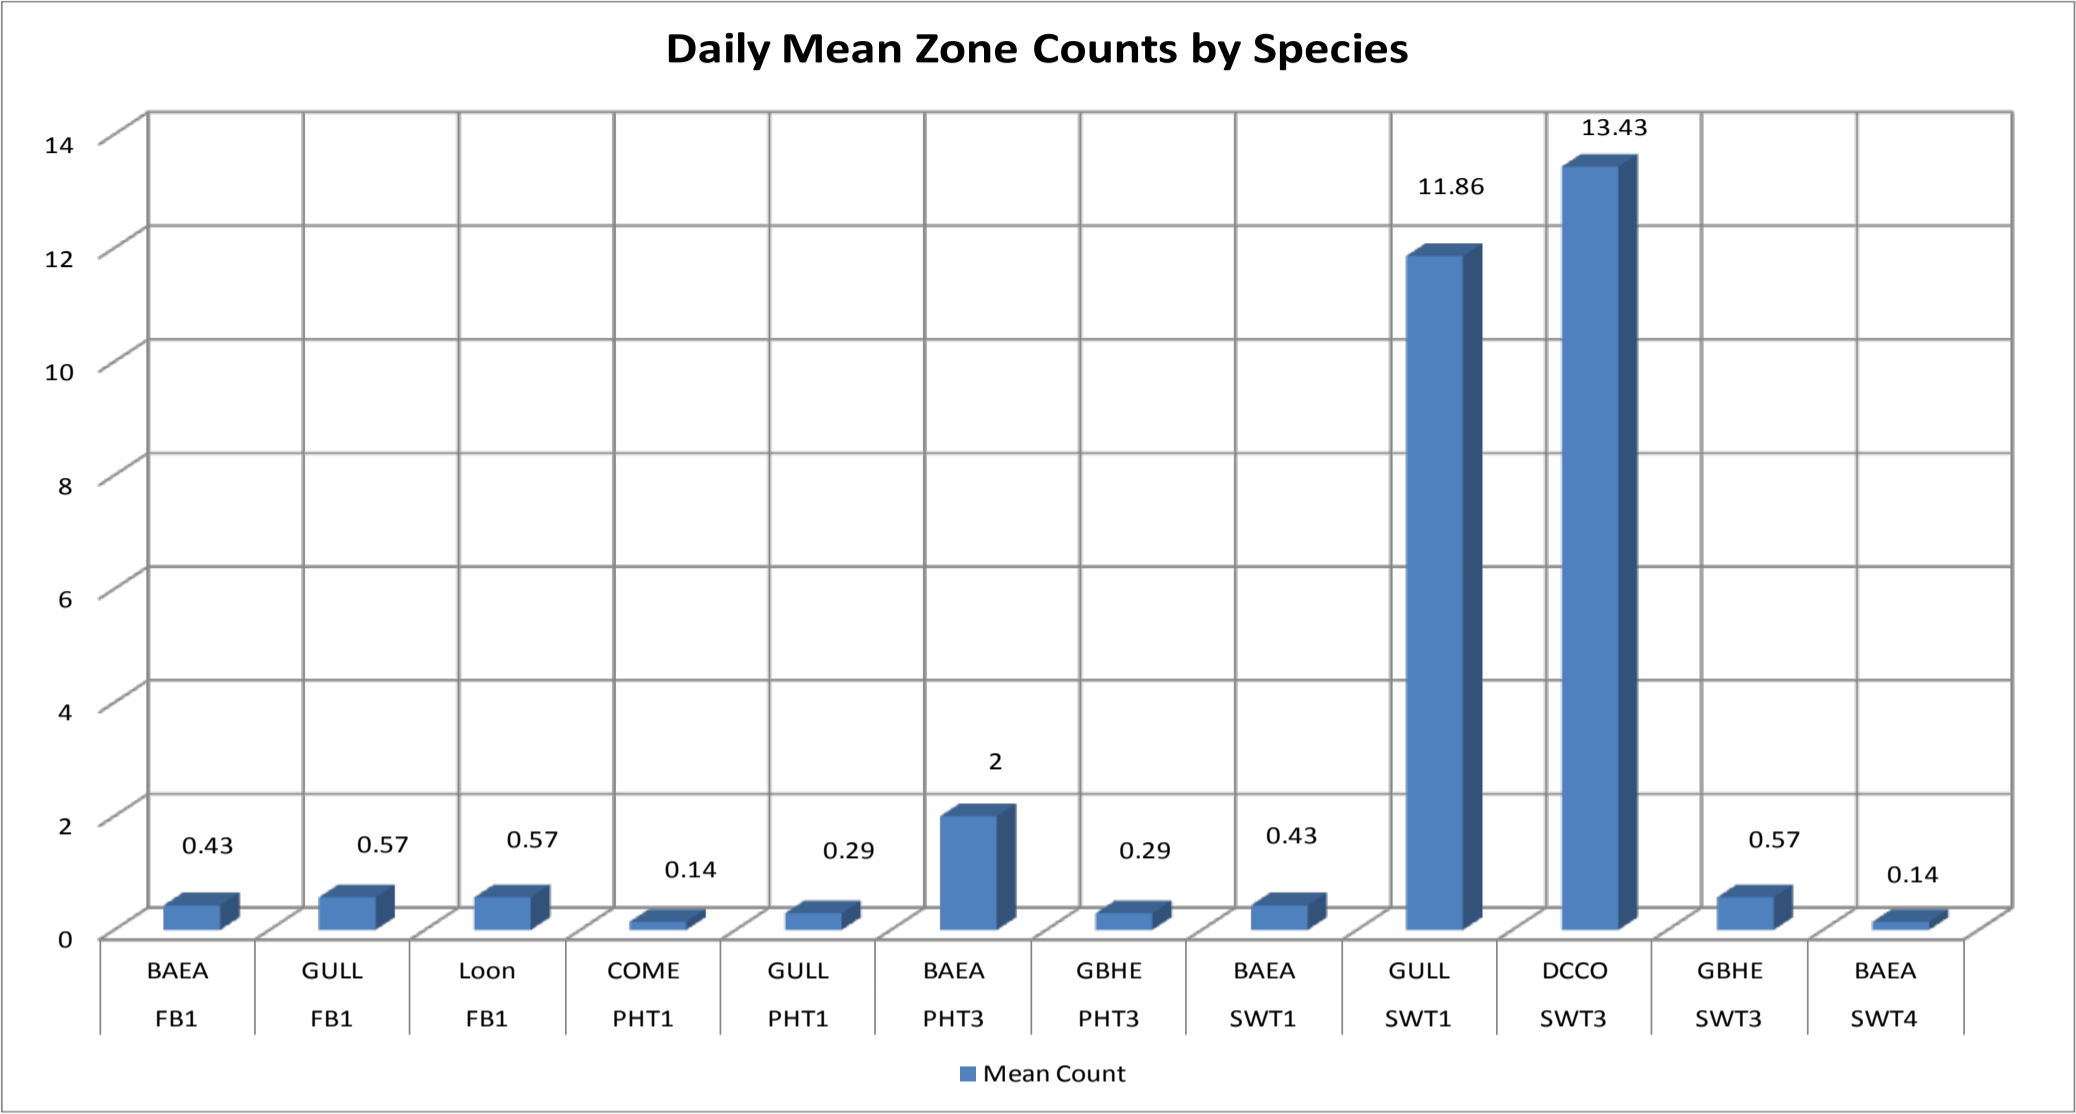
Bird observation data collected once daily. Fewer eagles foraging/roosting at Westick park. Great blue herons scavenging on shad carcasses below roosting trees. See avian zones map and distribution details.

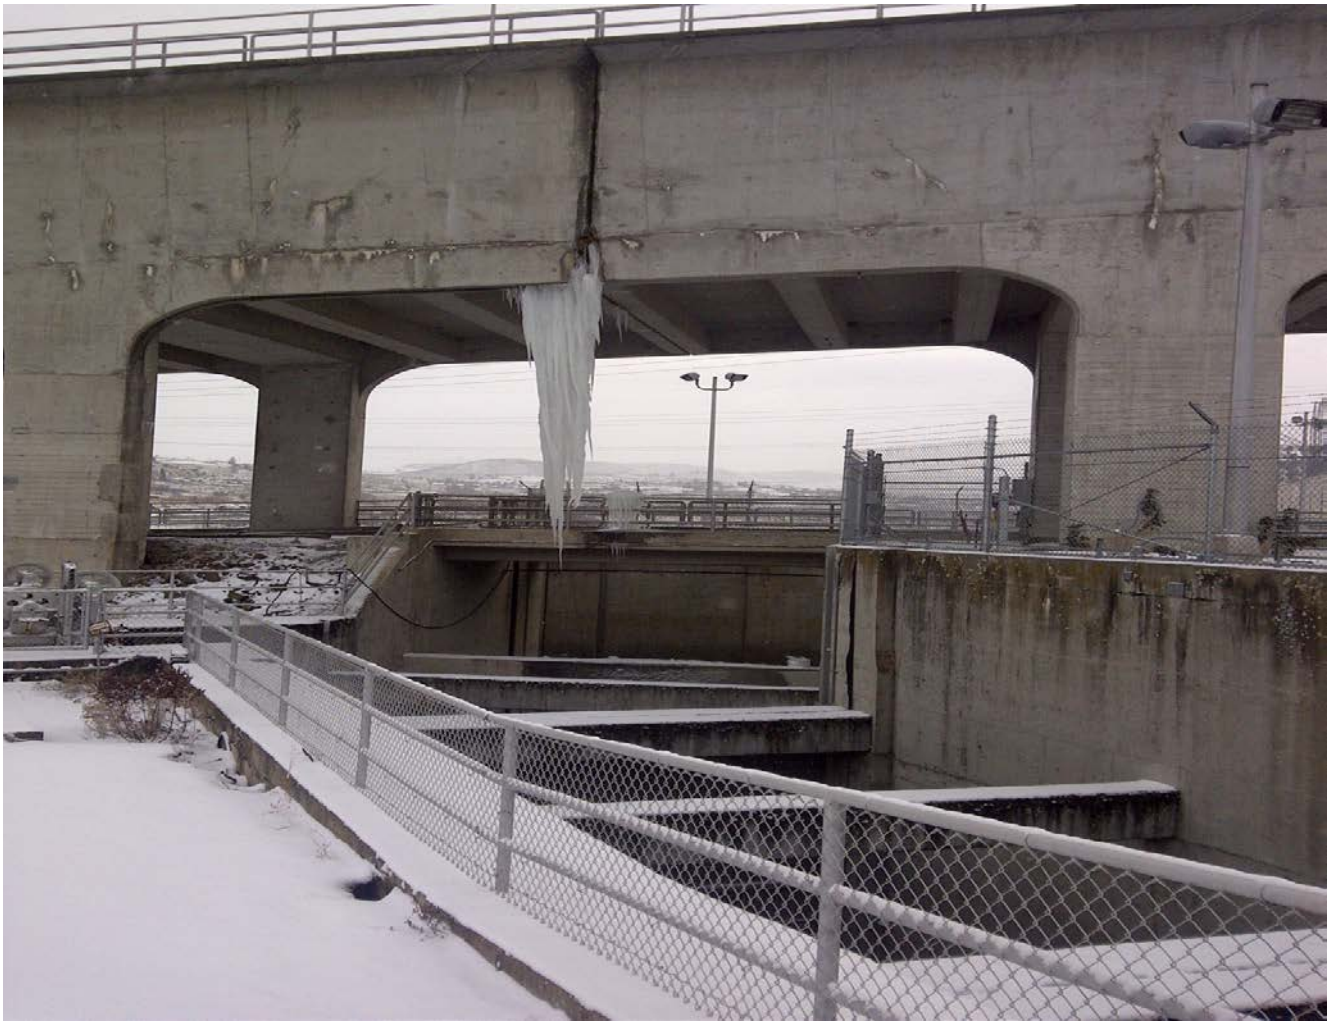
New ice climbing feature forming under east fishladder. Small leak in expansion joint which normally seals as air temperature increases.
