The Dalles Dam Fishway Status Report

Date: 02/17/2014

Inspection Period: 02/09/2014-02/15/2014

THE DALLES DAM

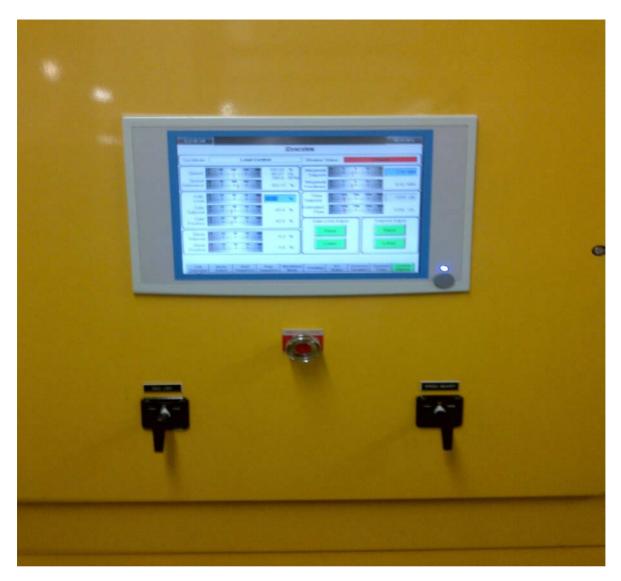
Display for newly installed digital governors on both fish units, replacing original mechanical ones. This upgrade was completed on all powerhouse units and will increase the reliability. It will also provide better control on discharge with changing net head.
