The Dalles Dam Fishway Status Report

Date: 6/22/2014 **Inspection Period:** 6/15/2014 to 6/21/2014

THE DALLES DAM

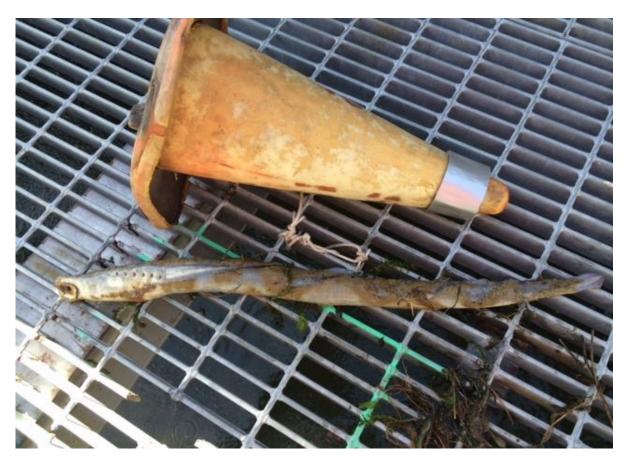
First recorded lamprey mortality removed from downstream picket lead at east counts station. Investigation underway. Memo provided to FPOM.

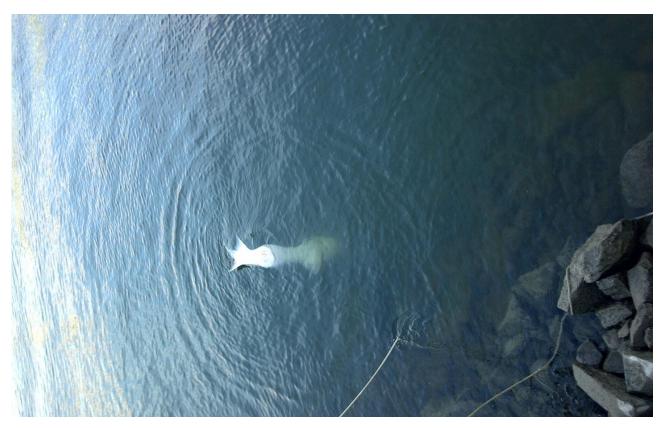
Dying sturgeon found in downstream entrance to navlock with bloated stomach. Cause unknown. Consulted USGS - possible cause from being pulled up from depth by angler.
