The Dalles Dam Fishway Status Report

Date: 7/13/2014
 Inspection Period: 7/6/2014 to 7/12/2014

THE DALLES DAM

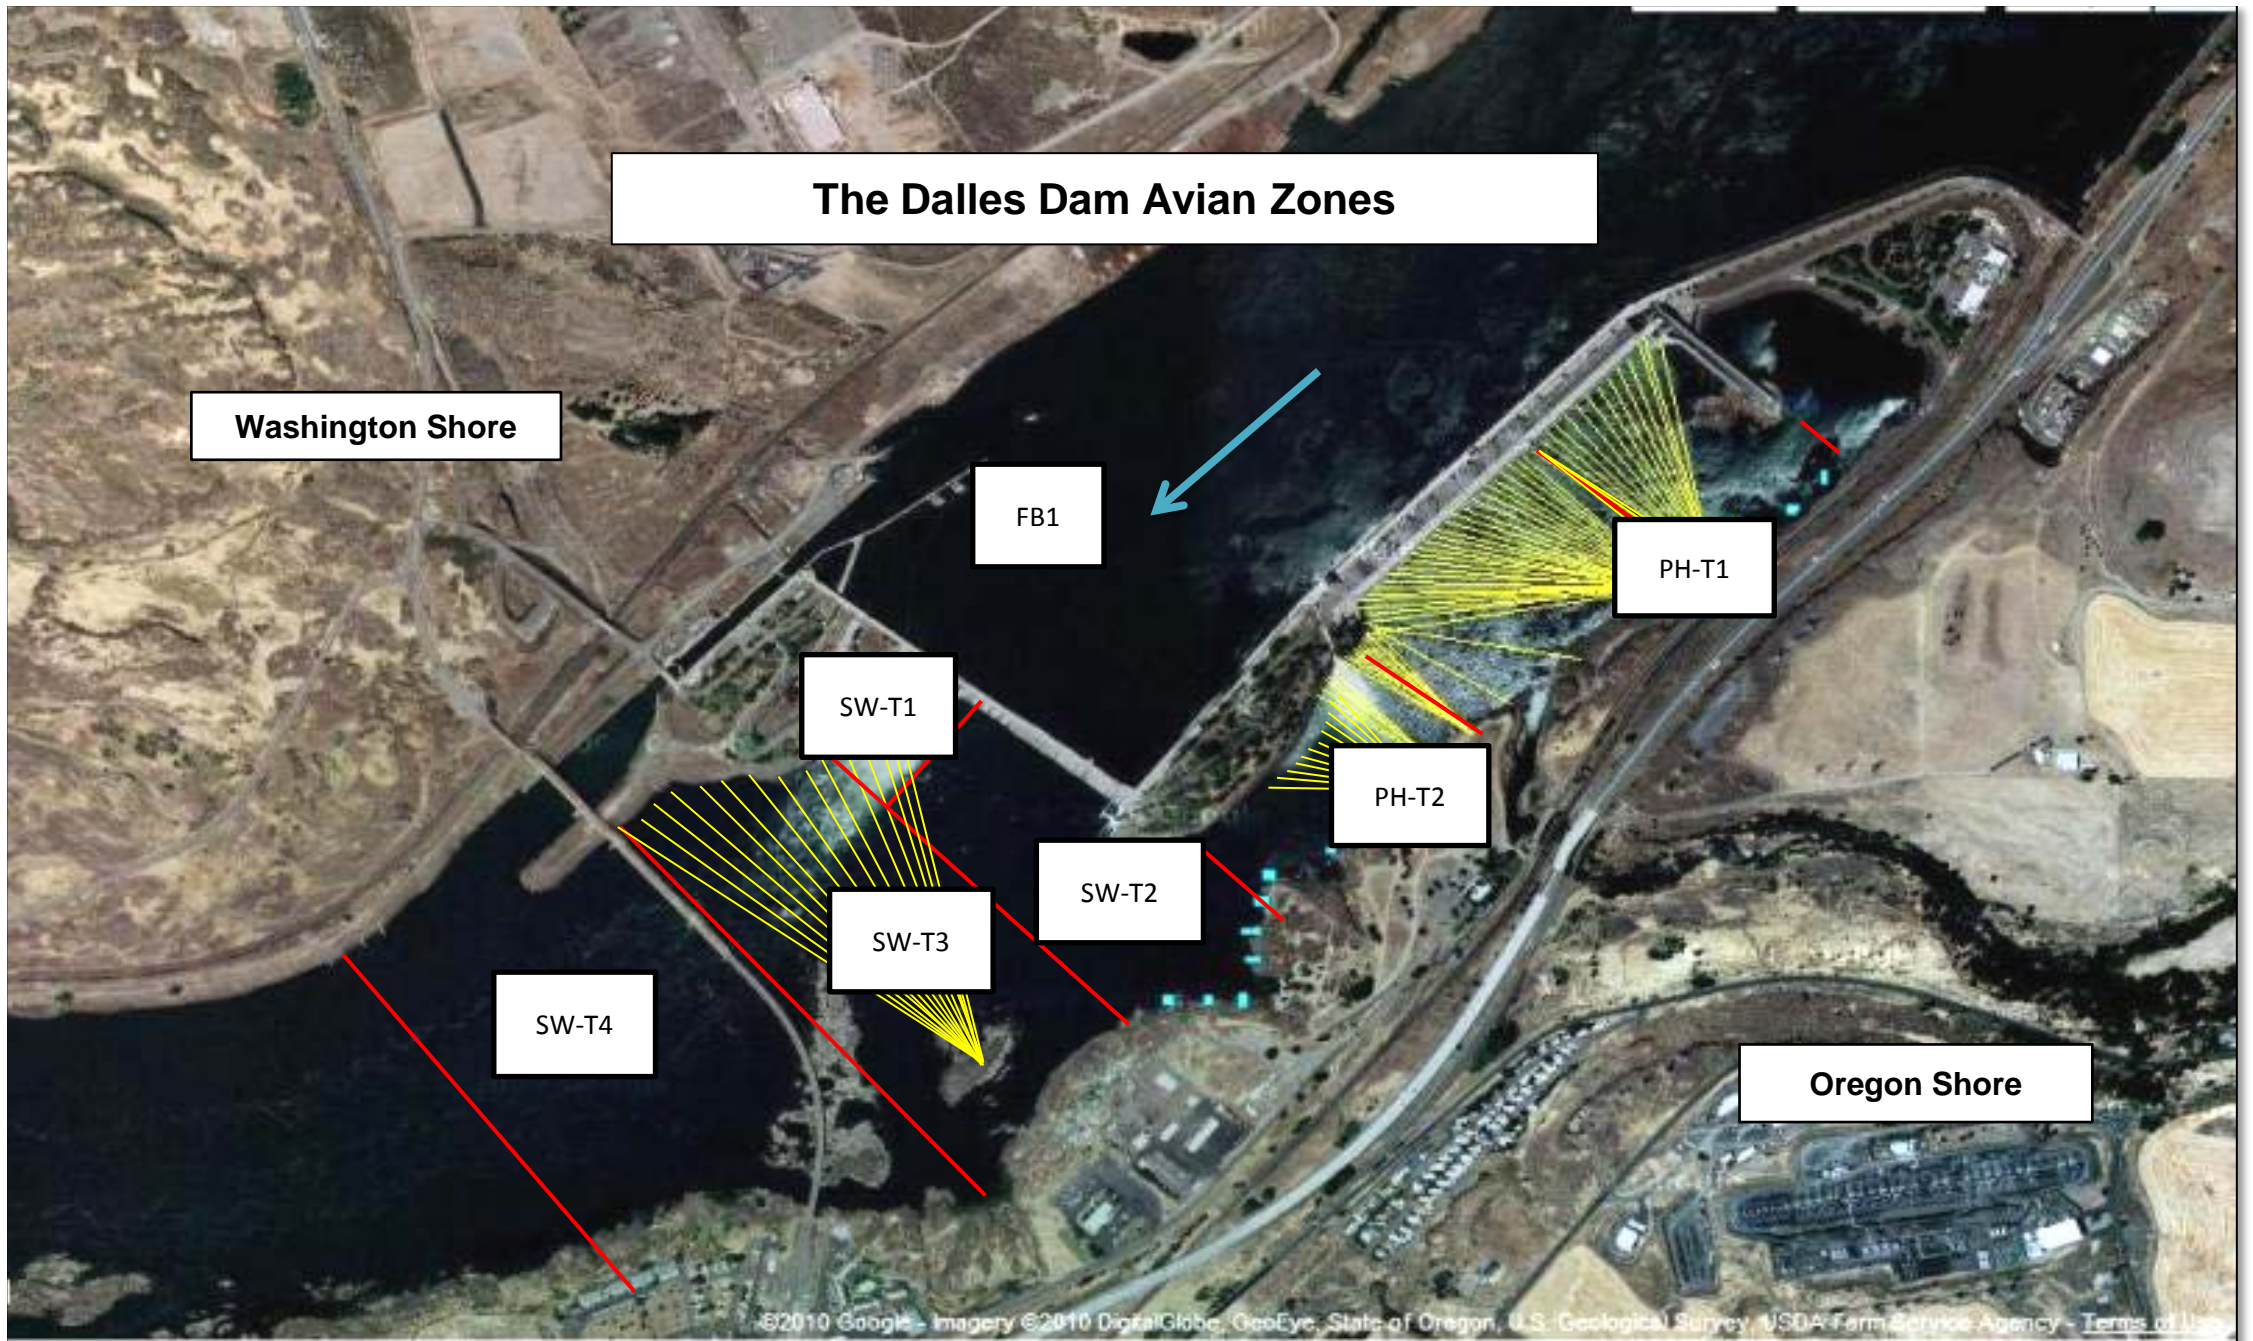
Gulls observed primarily downstream spillway. Approximately 65% of gulls return 10 minutes after hazing.

Hazing activity primarily in SW-T3 and SW-T4
