The Dalles Dam Fishway Status Report

Date: 8/10/2014
 Inspection Period: 8/3 to 8/9

THE DALLES DAM

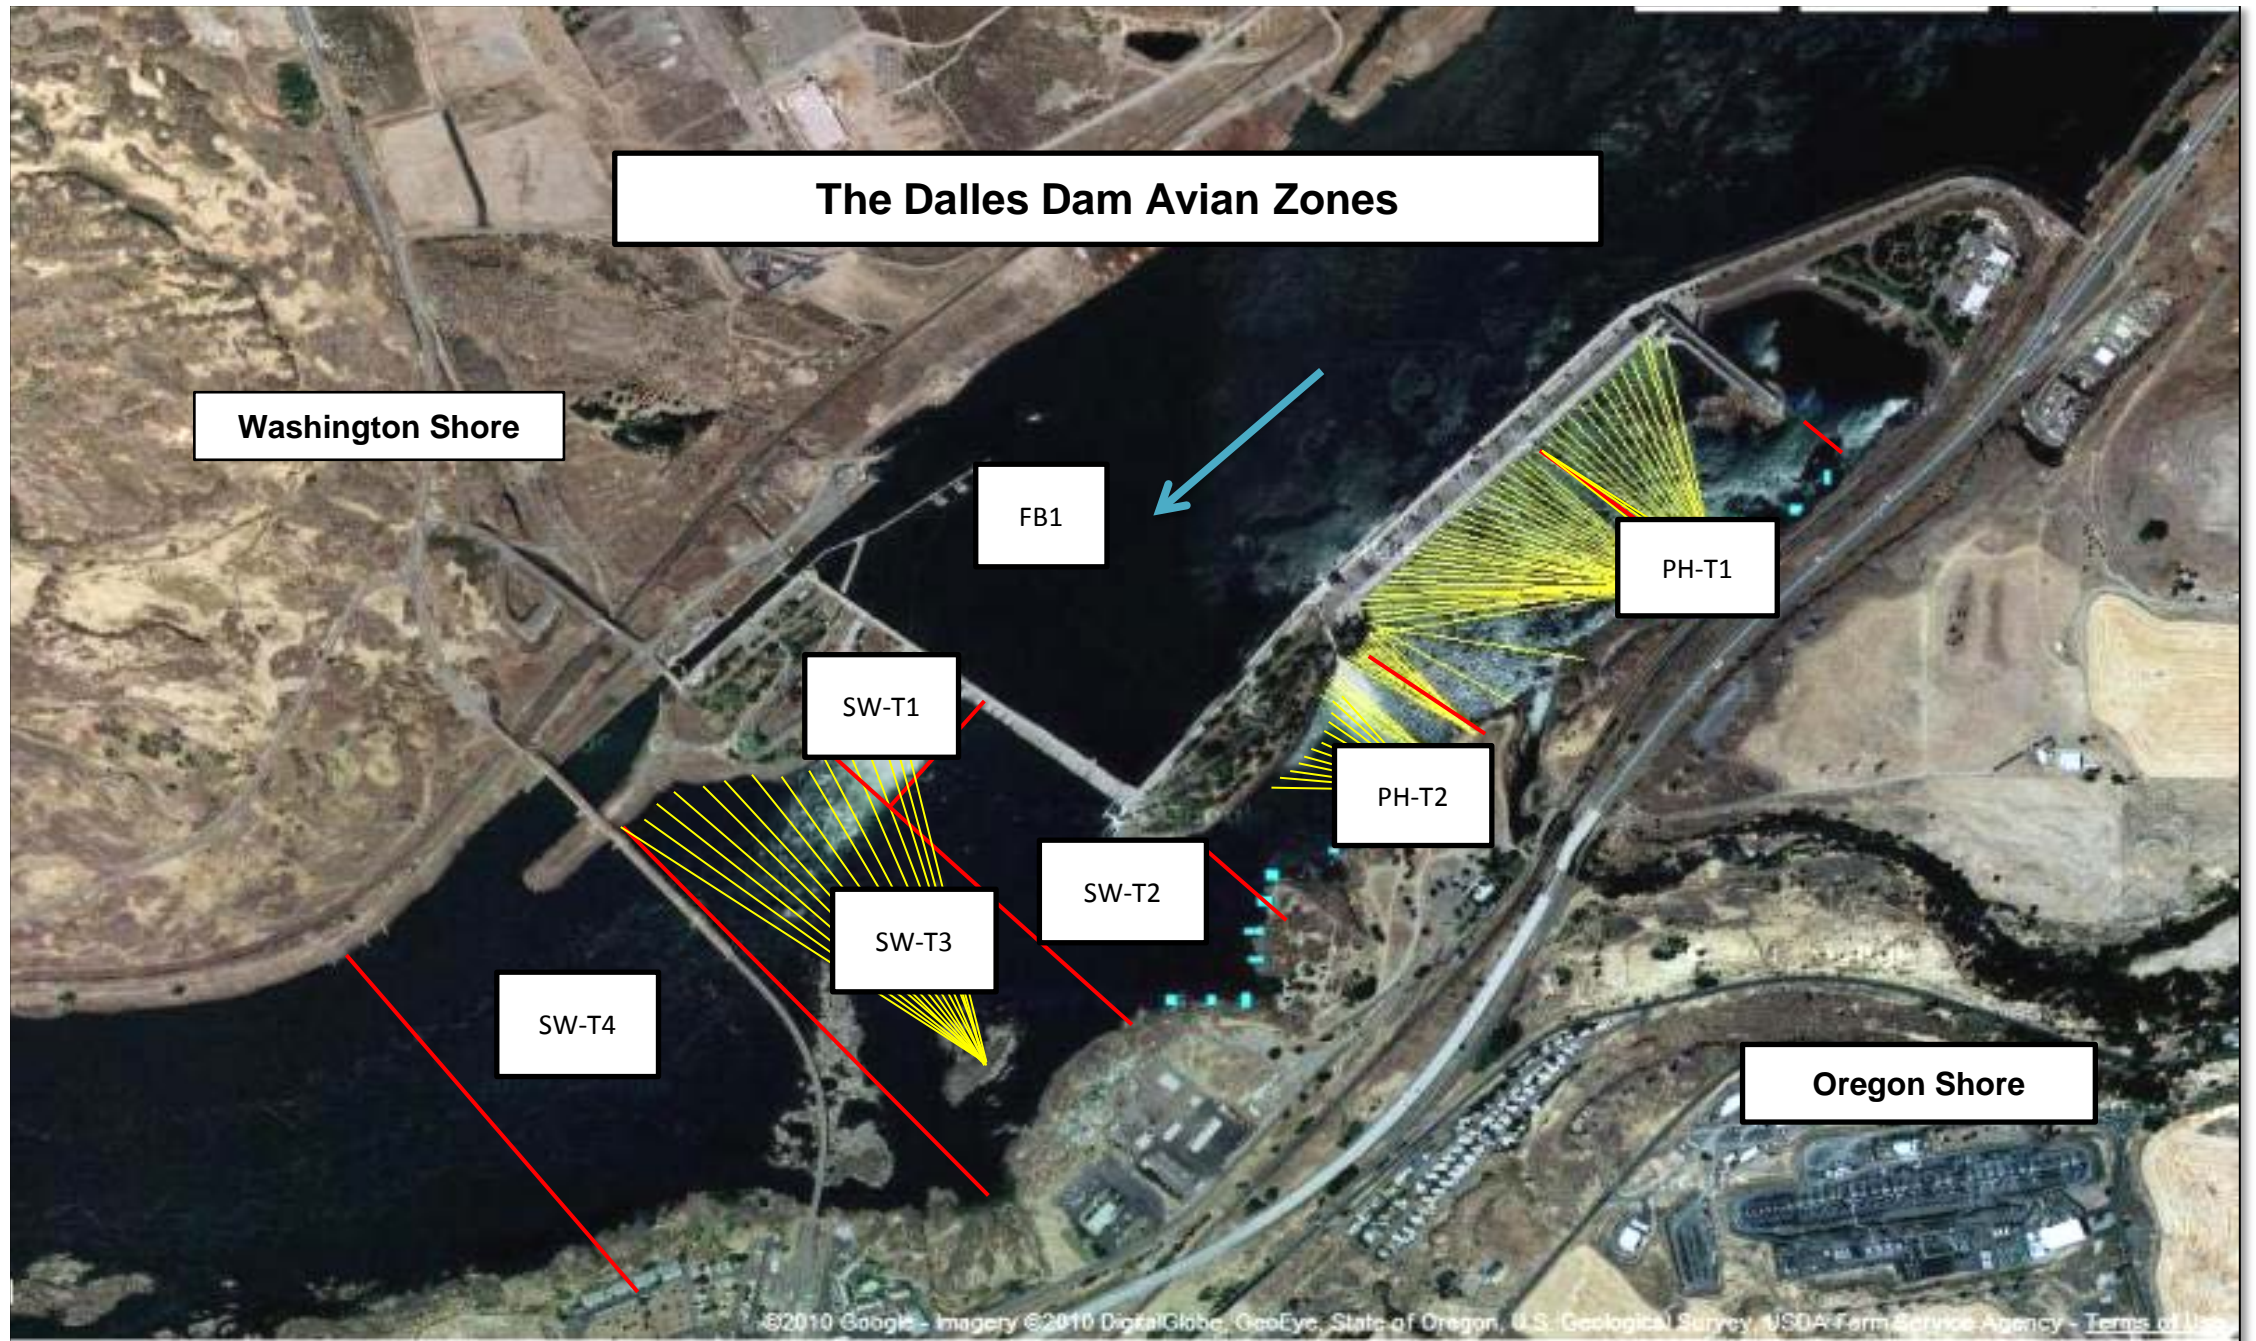
Hazing activity primarily in SW-T3 and SW-T4

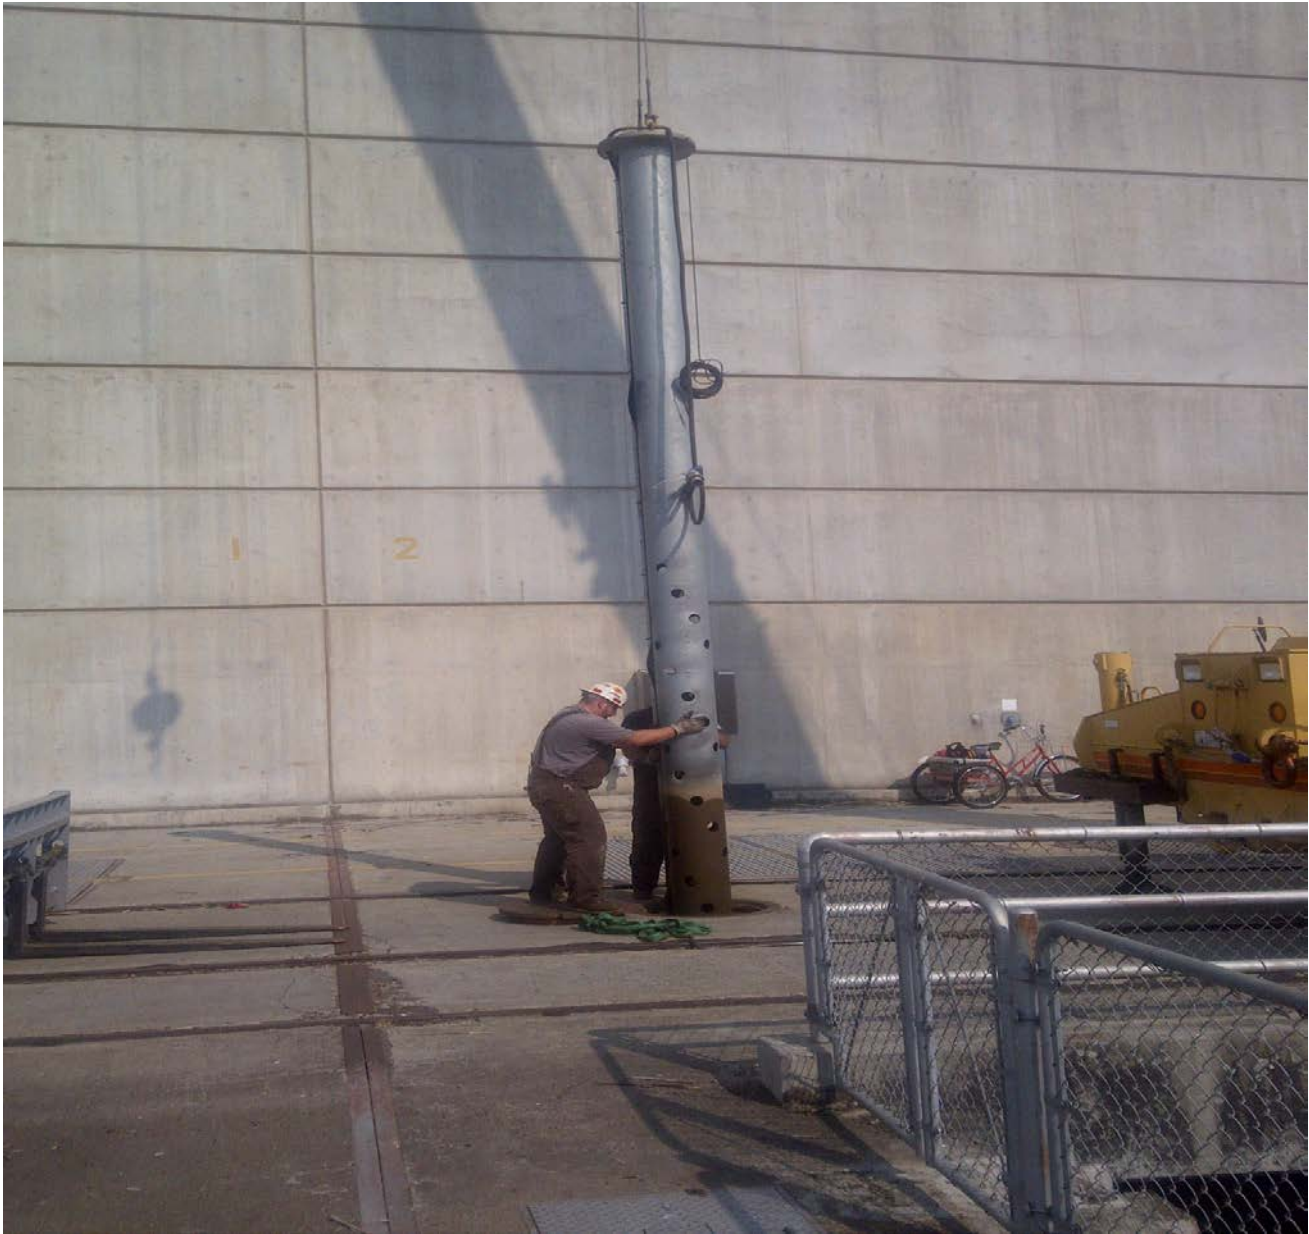
North fishway pump motor replacement delivered. Installation starting. To be installed prior to Jan 2015 dewatering.
Collection channel pump #1 removed 8/4 for motor failure repair. Refer to Pic tab. Repair underway.
Parts on order for install of equalizing valve on PUD intake bulkhead for next winter dewatering.
East entrance weir E3 sticking in guide. To be addressed this winter. Does not affect criteria operation.
Permanent boom to be purchased for protecting east fishway from upstream oil spills. Specs determined. Purchase underway.
Midseason ROV inspection fishway grating completed 8/4. East fishway fish units off 0630-1130. North fishway PUD will be off ~2 hrs PM. All were OK.
Bathymetry survey conducted at east end of Powerhouse tailrace 8/4 for possible debris issues near bulkhead guides.
Long term repair plans funding dependent; Upgrade east exit weirs 154-157, awaiting PM assignment to stabilize north ladder rock walls, remove collection channel diffusers, replace all entrance weir wheels with plastic composite wheels and repair/modify all east fishway dewatering pumps.

Removal of failed collection channel dewatering pump. One of 10 total pumps.

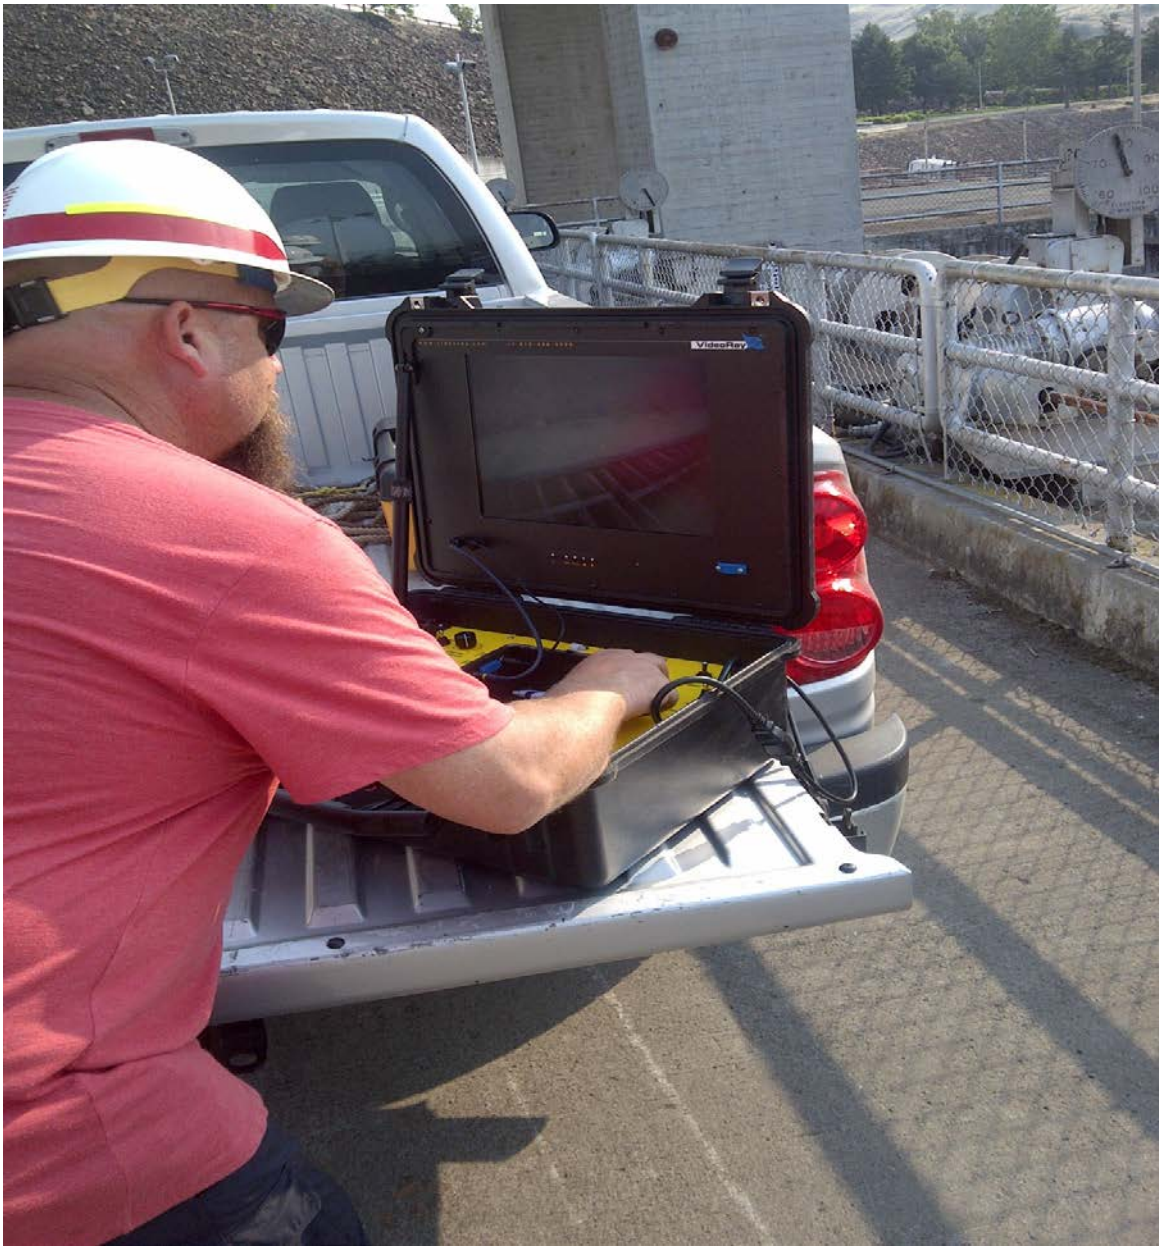
1.1	10.0	1.3	7.0	13.6	9.6	9.6	1.4	9.1	9.1		1.6	8.9	8.9					
	1.2	10.0	1.3	7.0	13.6	9.6	9.6	1.6	9.0	9.1		1.6	9.0	9.0					
8/4/14	No SCADA		Or AM inspection, Fish units off 0600-1128 due to diffuser grating inspection via ROV					and Bathymetry mapping				39.9

ROV inspection of fishway grating Aug 4.
