# The Dalles Dam Fishway Status Report

Date: 8/25/2014  
 Inspection Period: 8/17/2014 to 8/23/2014

## THE DALLES DAM

**US Army Corps  
 of Engineers**  
 Portland District

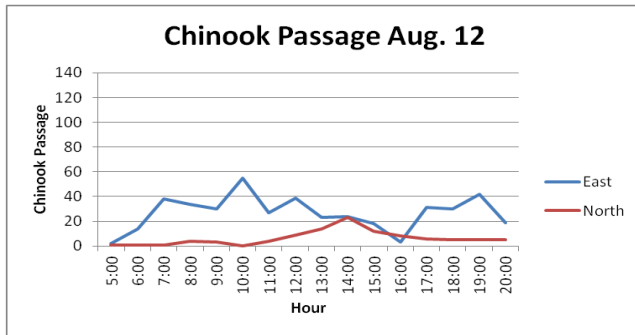
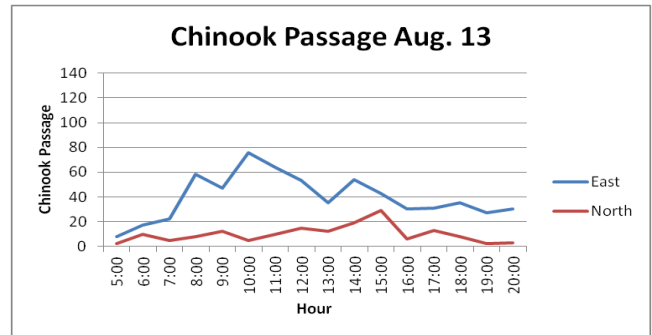
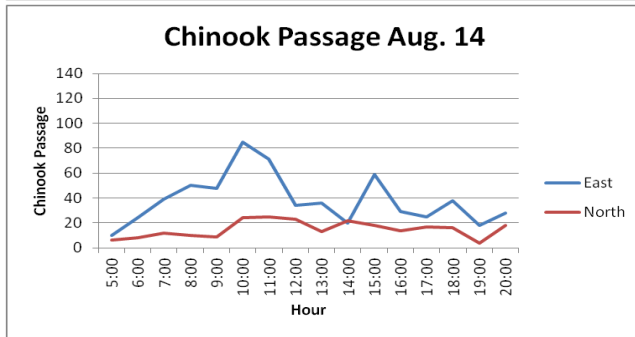
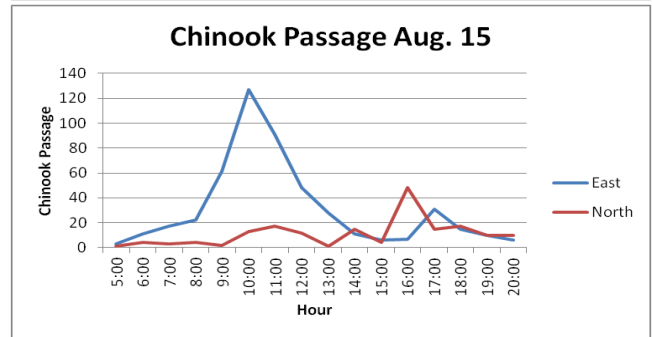
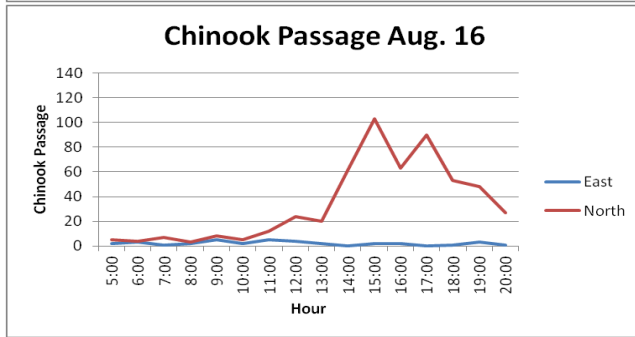
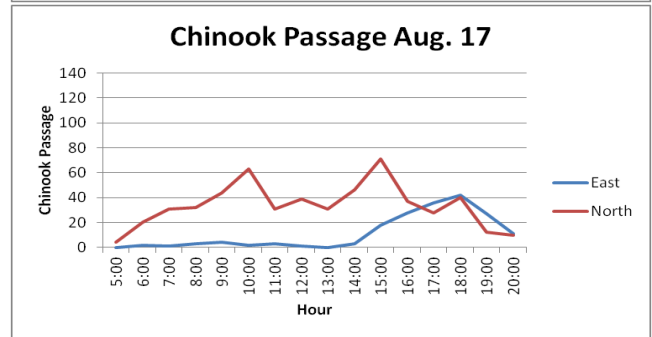
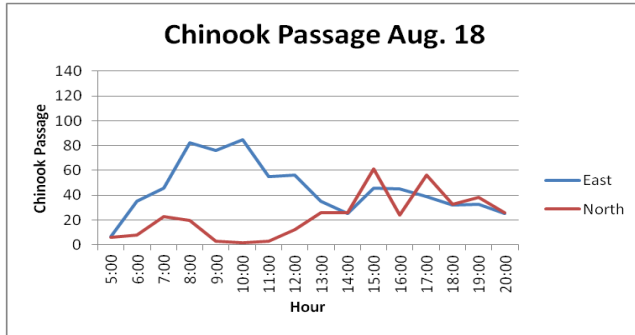
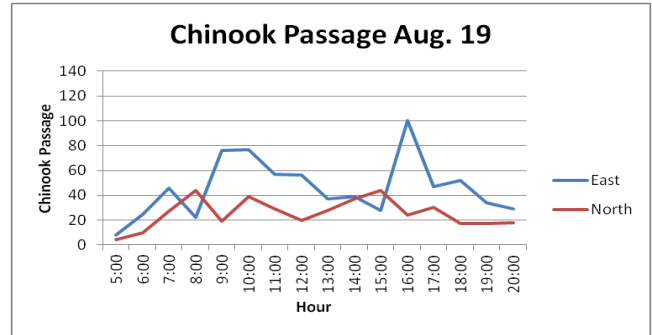
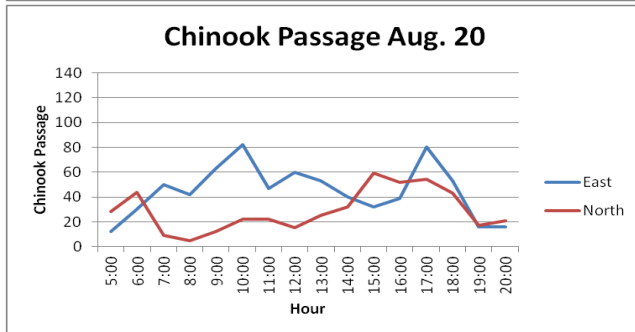
## Hourly chinook passage (FU's outage time period 8/15 to 8/17)

Hourly fish passage was analyzed for the outage time period. There was a noticeable decrease in TDA-E passage use during one fish unit operation (2600cfs flow). This decrease became worse when the second fish unit was forced out of service. There was a noticeable shift to TDA-N, however there was a delay the first morning when both fish units were OOS. Refer to three day Chinook and Steelhead graphs (below) for details.

There was a noticeable shift to the north ladder, however there was a delay the first morning when both fish units were OOS.

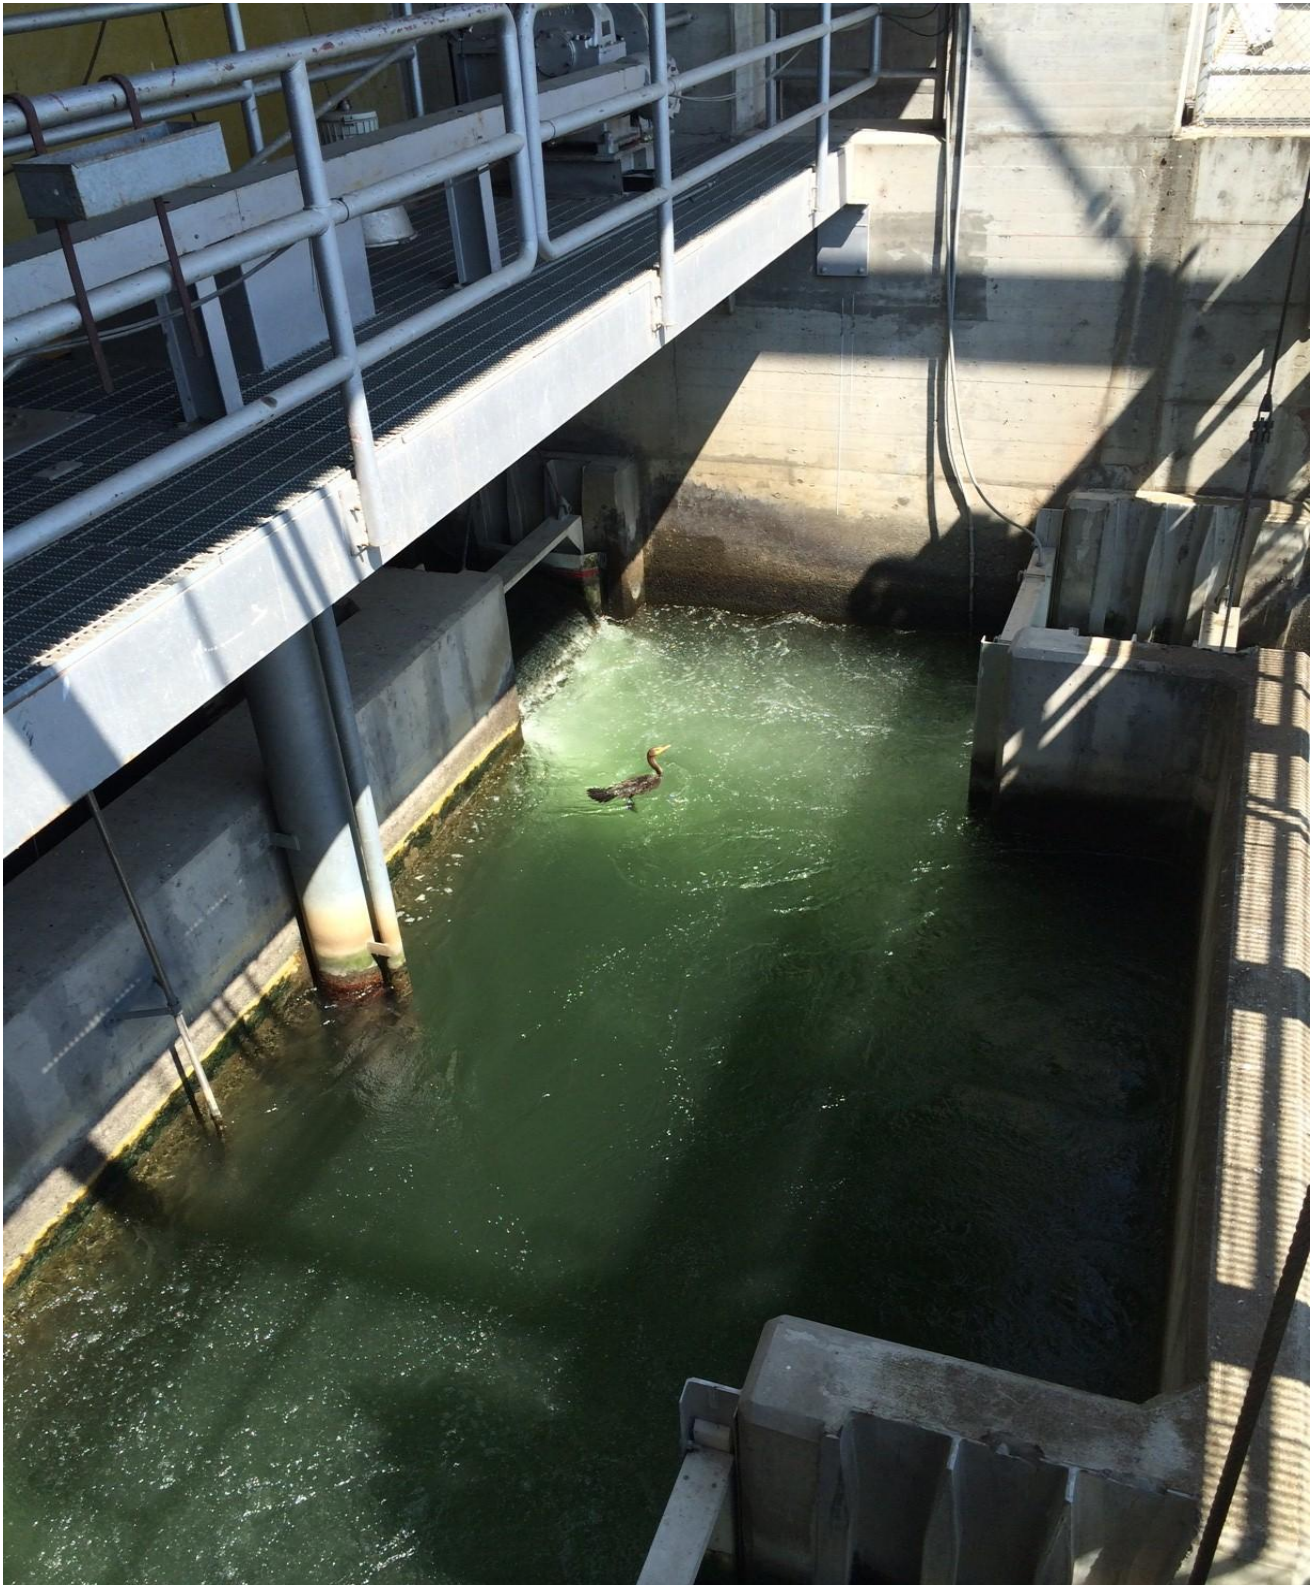
Cormorants continue to forage in forebay near east fishway exit. Easily hazed by walking on forebay deck.
