The Dalles Dam Fishway Status Report

10/11/2014 Inspection Period: 10/5/2014 to 10/11/2014

US Army Corps of Engineers
Portland District

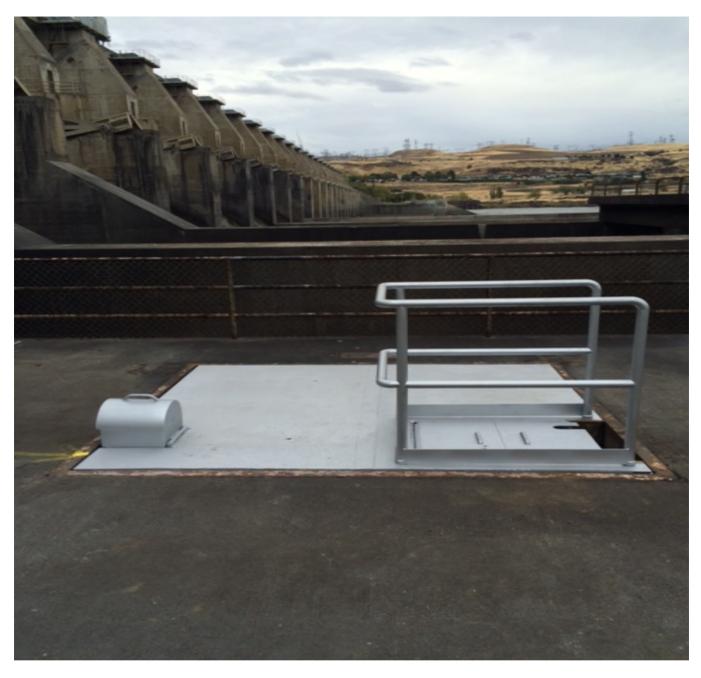
North fishway pump motor replacement installed. Refer to pic tab

New north fishway dewatering pump motor with protective access hatch
