The Dalles Dam Fishway Status Report

11/8/2014
 Inspection Period: 11/2//2014 to 11/07/2014

THE DALLES DAM

**US Army Corps
 of Engineers**
 Portland District

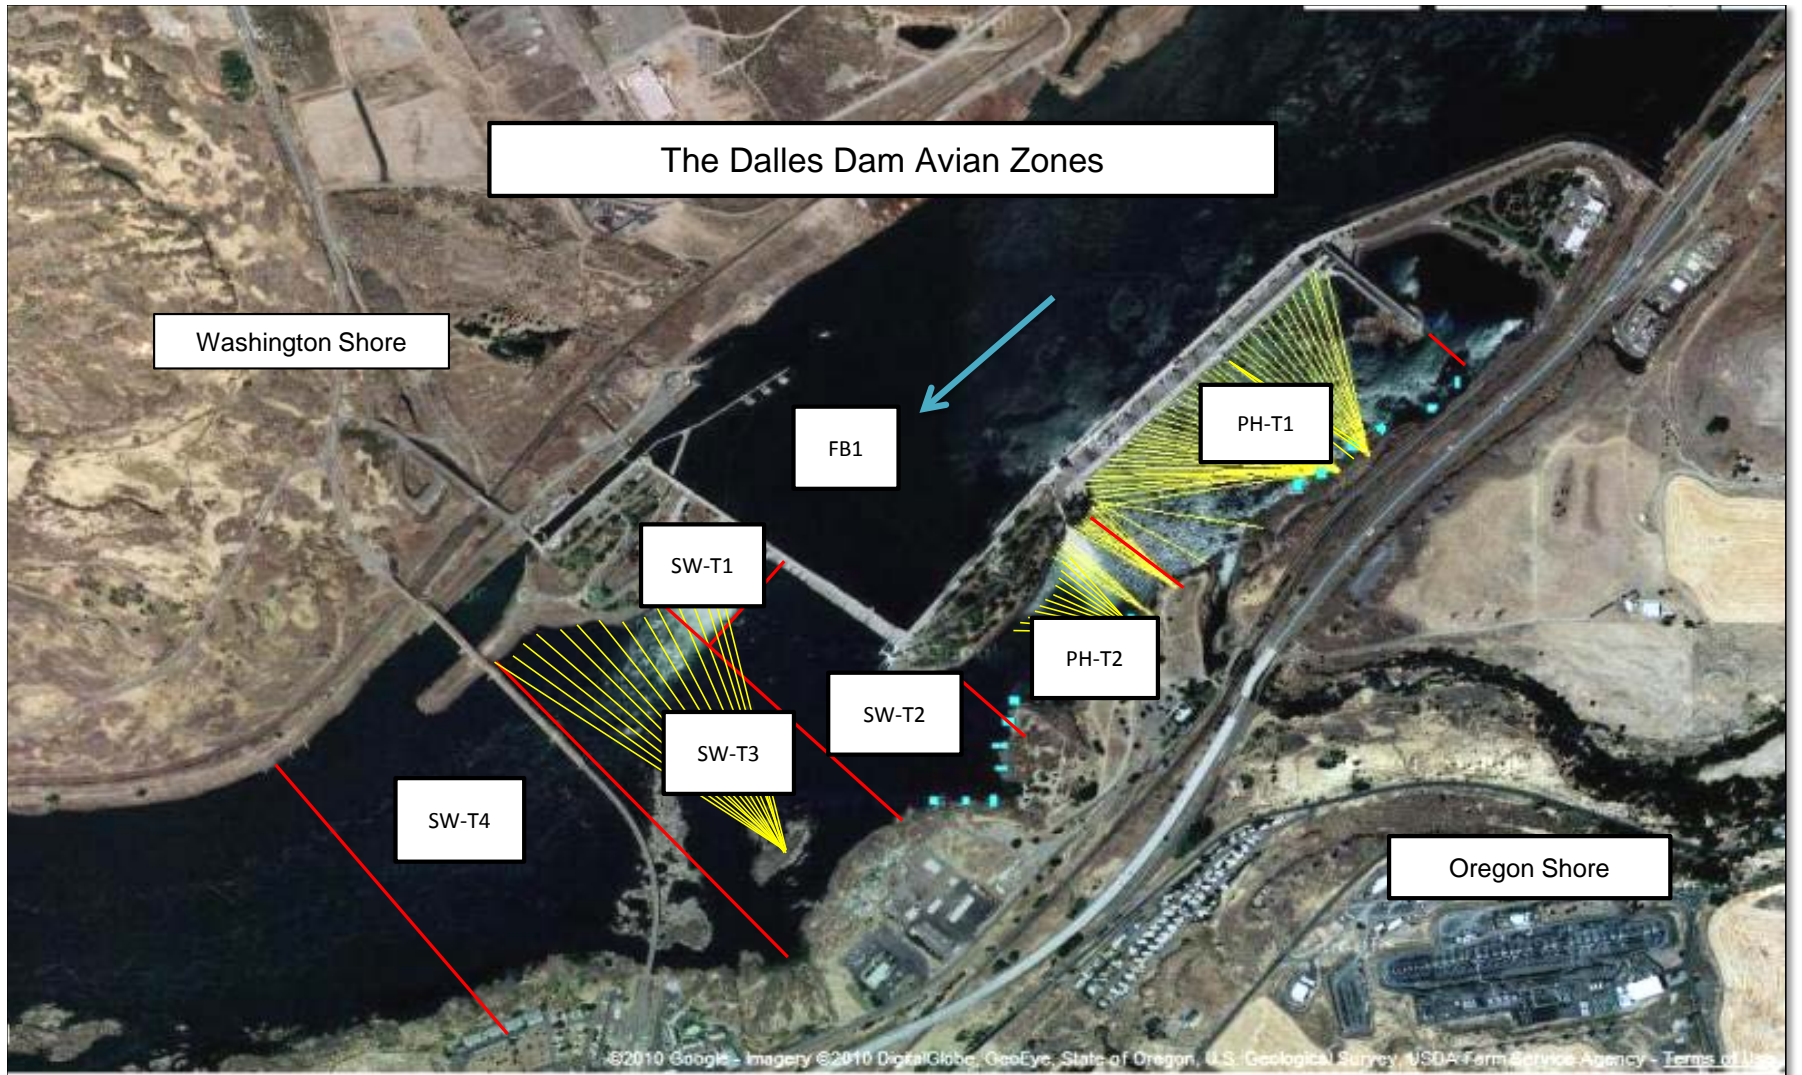
Bird observation data collected once daily. Refer to Avian Zone Map. Piscivorous birds targeting juvenile shad.

Avian lines in yellow, zones in red.

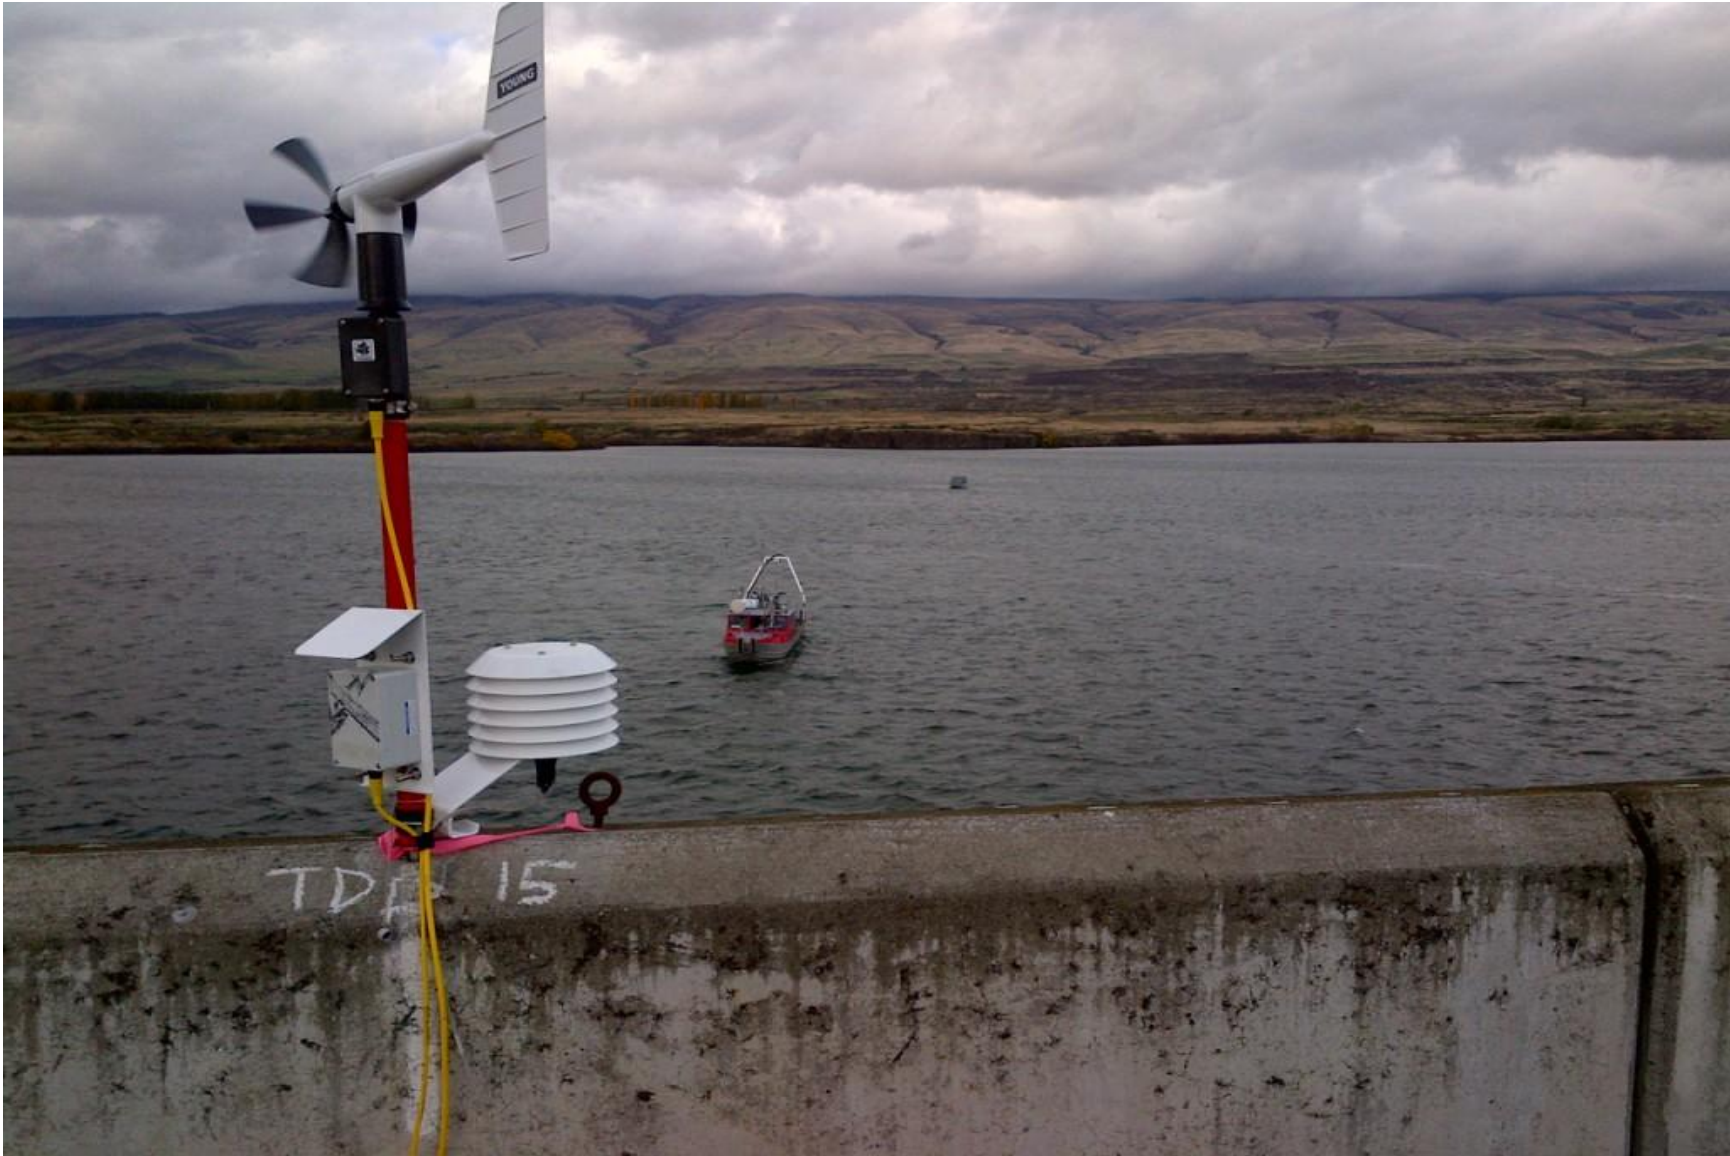
EFL Backup; Plans/Specs 60% review underway. Includes 10'pipe from forebay to AWS. A 1400cfs winter test planned. Flow survey via boat Nov 4-6 to prepare for winter '15/'16 construction. See picture.

Water velocity survey at the forebay east fish ladder exit for emergency auxiliary water supply Nov 4th.
