The Dalles Dam Fishway Status Report

12/6/2014
 Inspection Period: 11/30/2014 to 12/6/2014

THE DALLES DAM

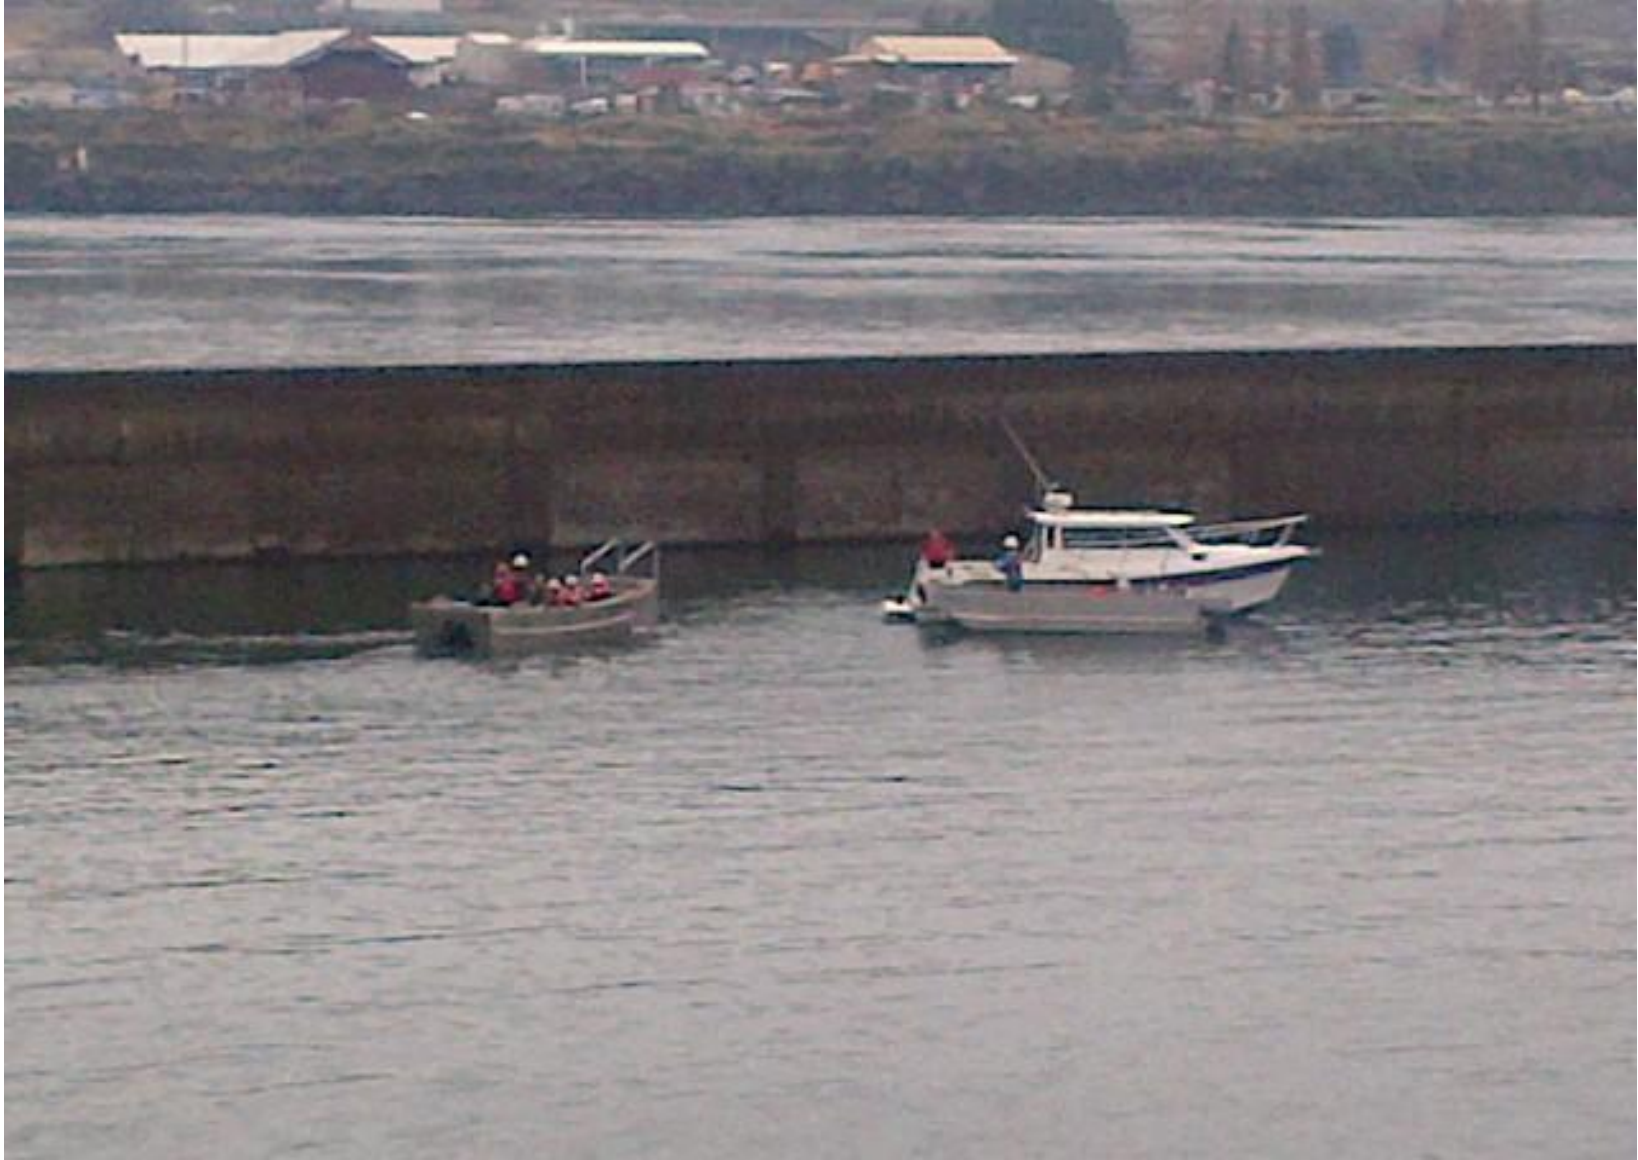
East fishway winter maintenance started Dec1. Fish units off Dec1. Fishladder dewatered Dec 2. Below tailwater dewatering Dec3. Collection and transportation channels dewatered on Dec 4.
Dive repair planned for spillwall repair 12/03 - 12/08/2014. See picture.
Four collection channel dewatering pumps require removal and rehab. Parts on hand for completion of two. Remaining pumps to be inspected this winter.
Weirs E3 and W1 sticking in guide. Repair during winter fishway outage with wheel replacement and guide repair. Does not affect criteria operation.
Permanent east fishway exit boom delivered. Contractor install before March. Further assessment for oil spill protection continues.
Charter approved for repair of north fishway rock walls. PM assigned. Awaiting start. Planning for winter inspection/assessment.
Exit weir 158 fabrication complete. Installation in progress. Investigating possible on site fabrication of new exit weirs for 154-157.

Contractor divers completing minor repairs to spillwall.
