# The Dalles Dam Fishway Status Report

1/3/2015  
 Inspection Period: 12/28/2014 to 01/03/2015

## THE DALLES DAM

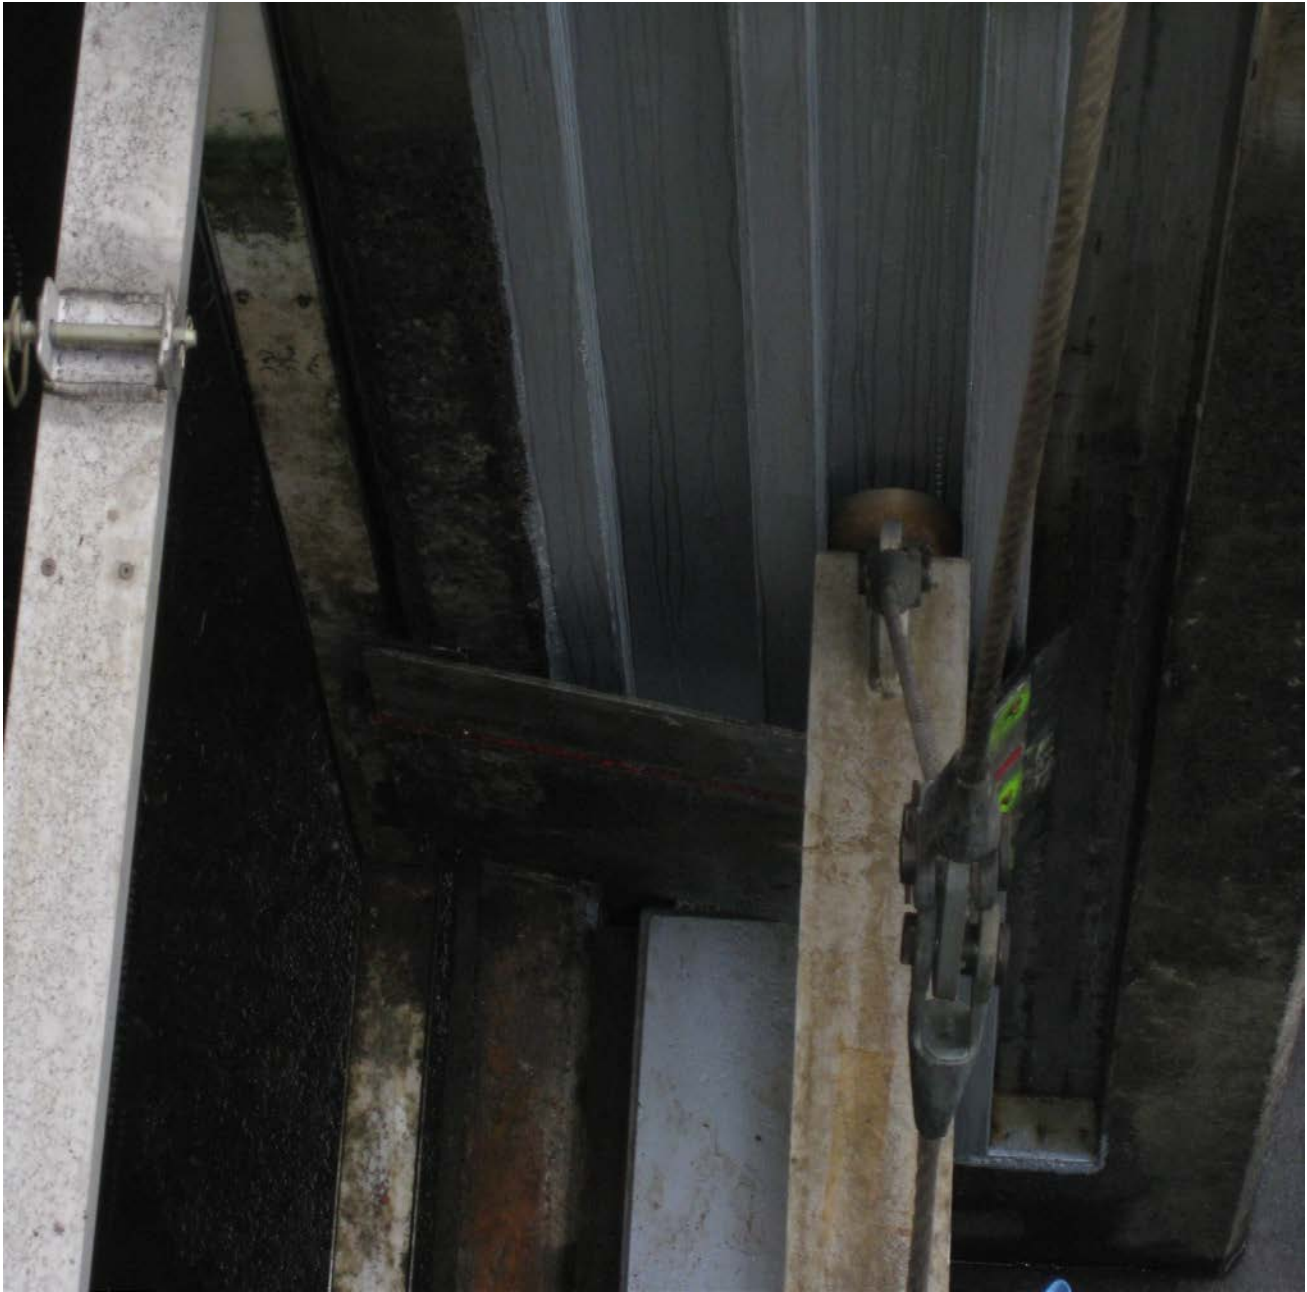
University of Idaho maintaining antennas. Continuing downloads of winter steelhead. East exit weir 158 plate touching half duplex antenna. Confirmed OK.

Newly installed 158 weir. Side plate touching half duplex antenna. Ogee crest cap still needs to be installed.

Exit weir 158 fabrication final assembly complete. Both installed in guides. Making final adjustments.
