The Dalles Dam Fishway Status Report

1/17/2015
 Inspection Period: 1/11/2014 to 1/17/2015

THE DALLES DAM

**US Army Corps
 of Engineers**
 Portland District

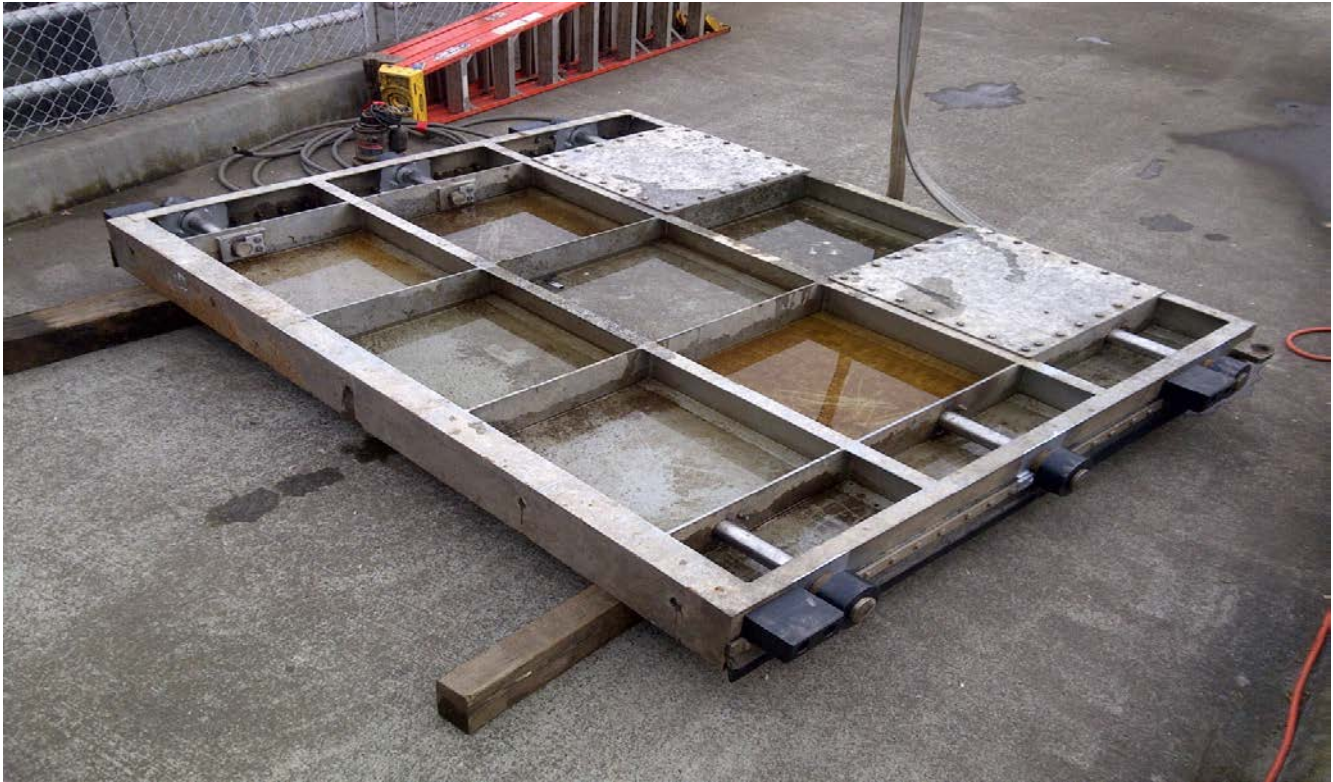
One of 3 east entrance weir E3 leaf wheels replaced and rub block installed.
Ready for installation

Three weirs removed for wheel replacement with high density plastic. Near complete.
