# The Dalles Dam Fishway Status Report

1/31/2015  
 Inspection Period: 1/25/2014 to 1/31/2015

## THE DALLES DAM

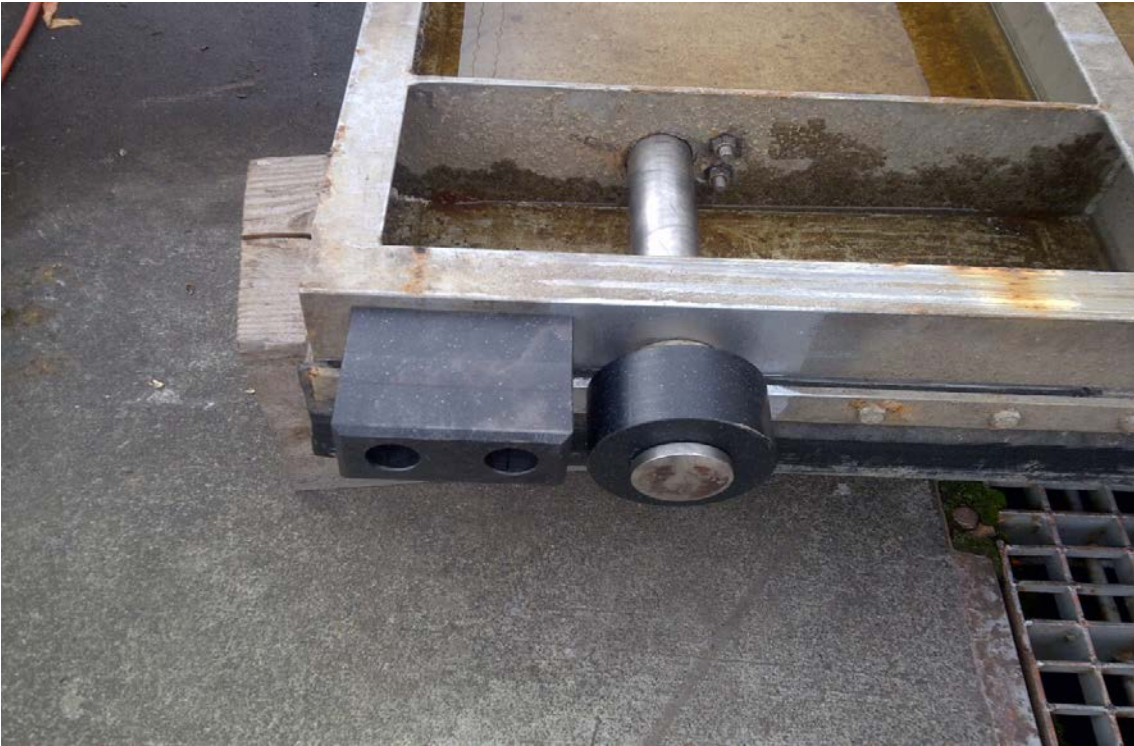
New entrance weir E2 plastic wheel and added rub block to assure alignment.

Three more weirs have new set of high density plastic wheels. All installed and ready for water up.
