The Dalles Dam Fishway Status Report

THE DALLES DAM

2/9/2015
 Inspection Period: 2/1/2015 to 2/7/2015

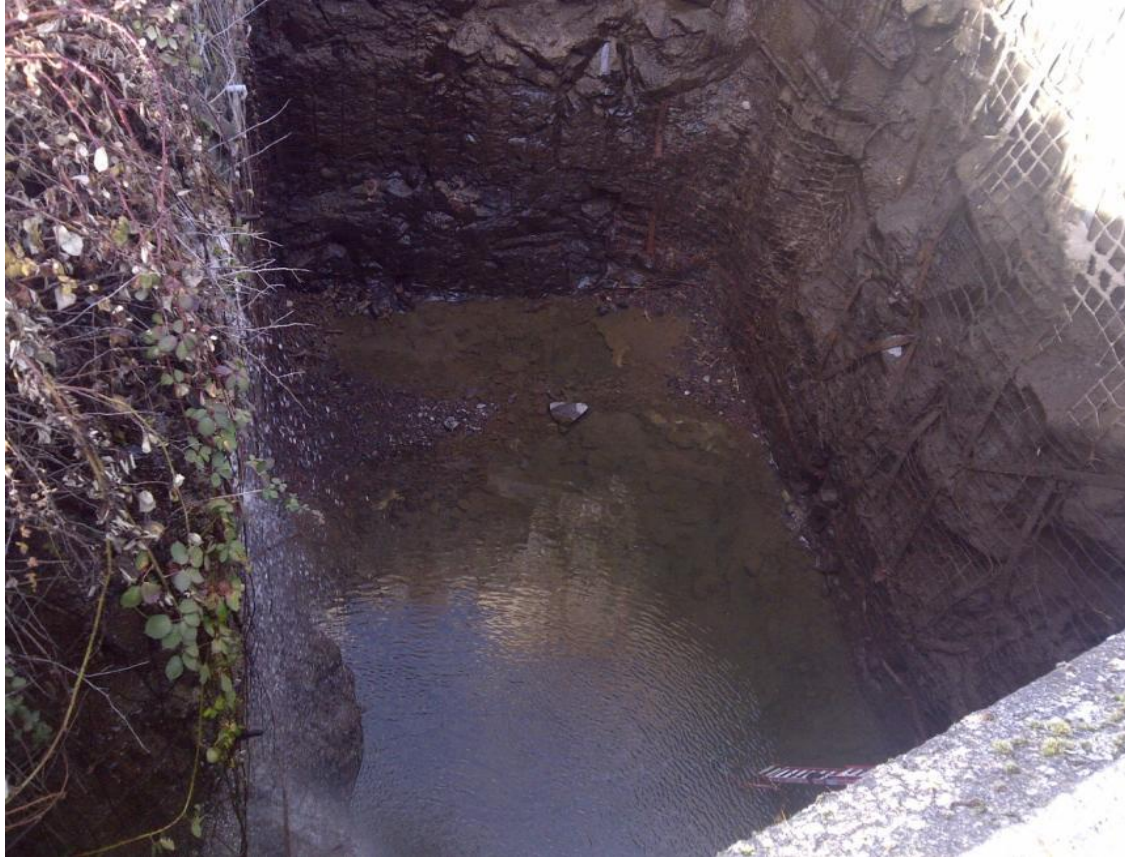
PUD auxiliary water rock plunge pool. To be engineering and geotech inspected Feb 16.
