The Dalles Dam Fishway Status Report

Inspection Period: 3/8/2015 to 3/14/2015

THE DALLES DAM

US Army Corps
of Engineers
Portland District

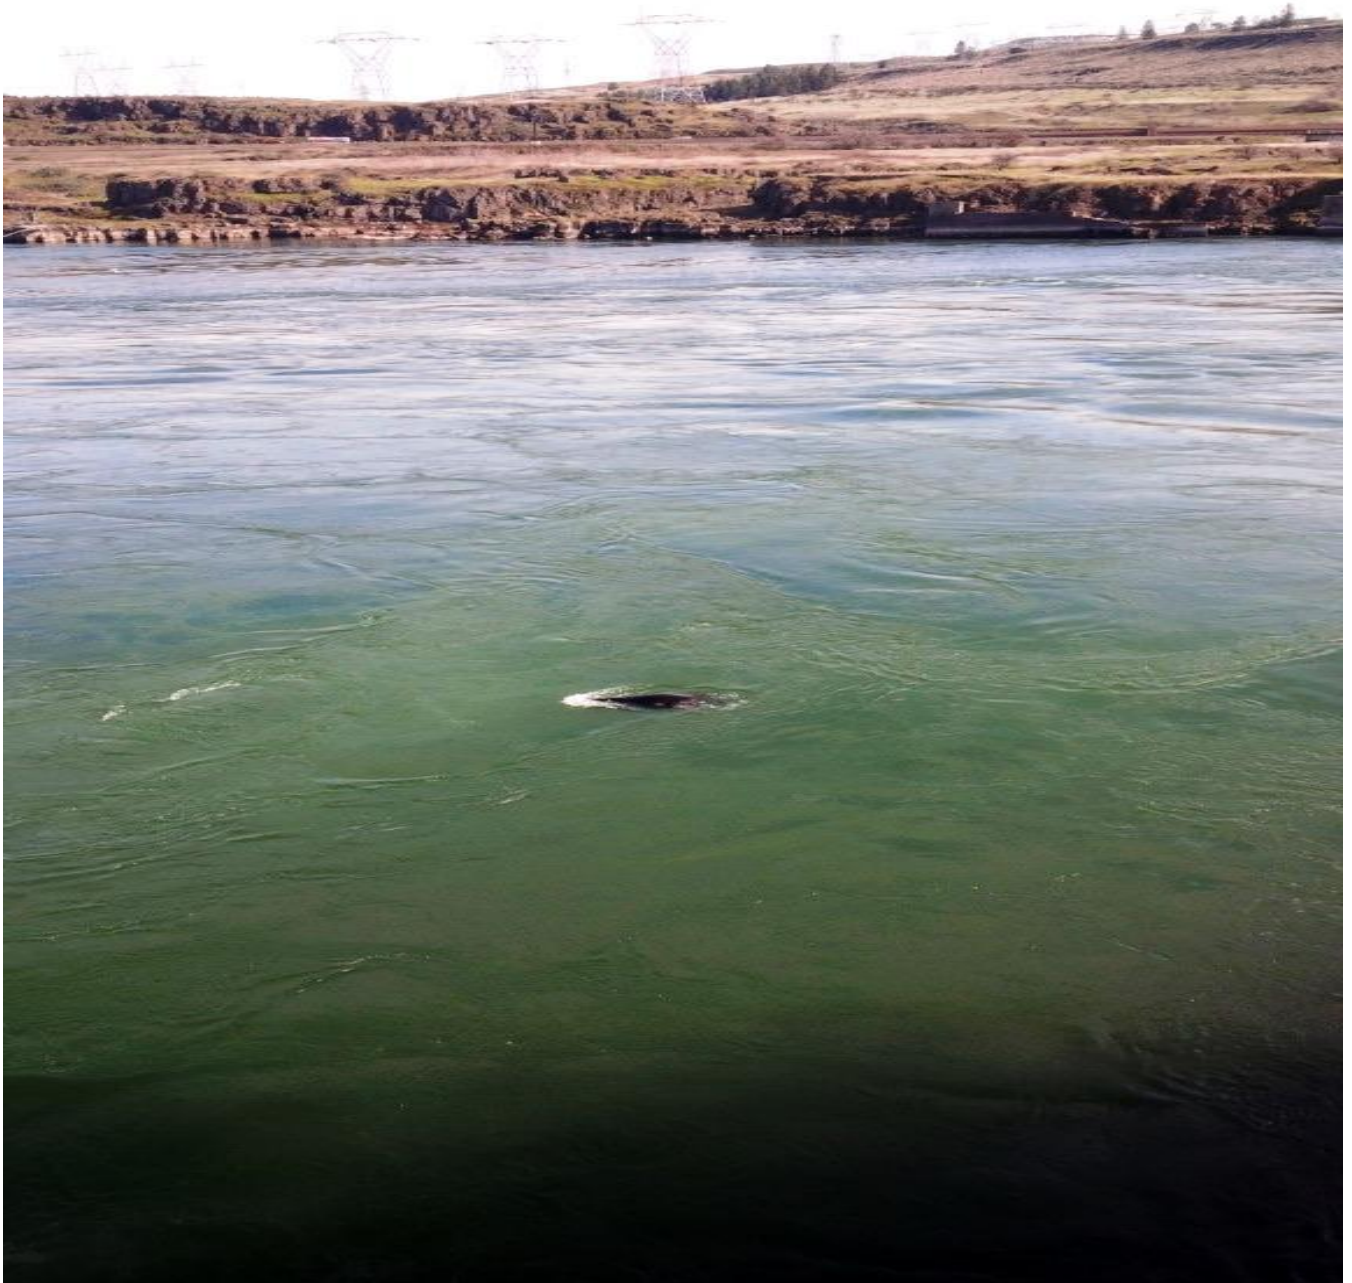
Bird observation data collected once daily. Refer to Avian Zone Map. Sea lion observed near west entrance, no discernible brand observed. see picture.

Sealion is still in the Bonneville pool. Hunts at the west entrance.

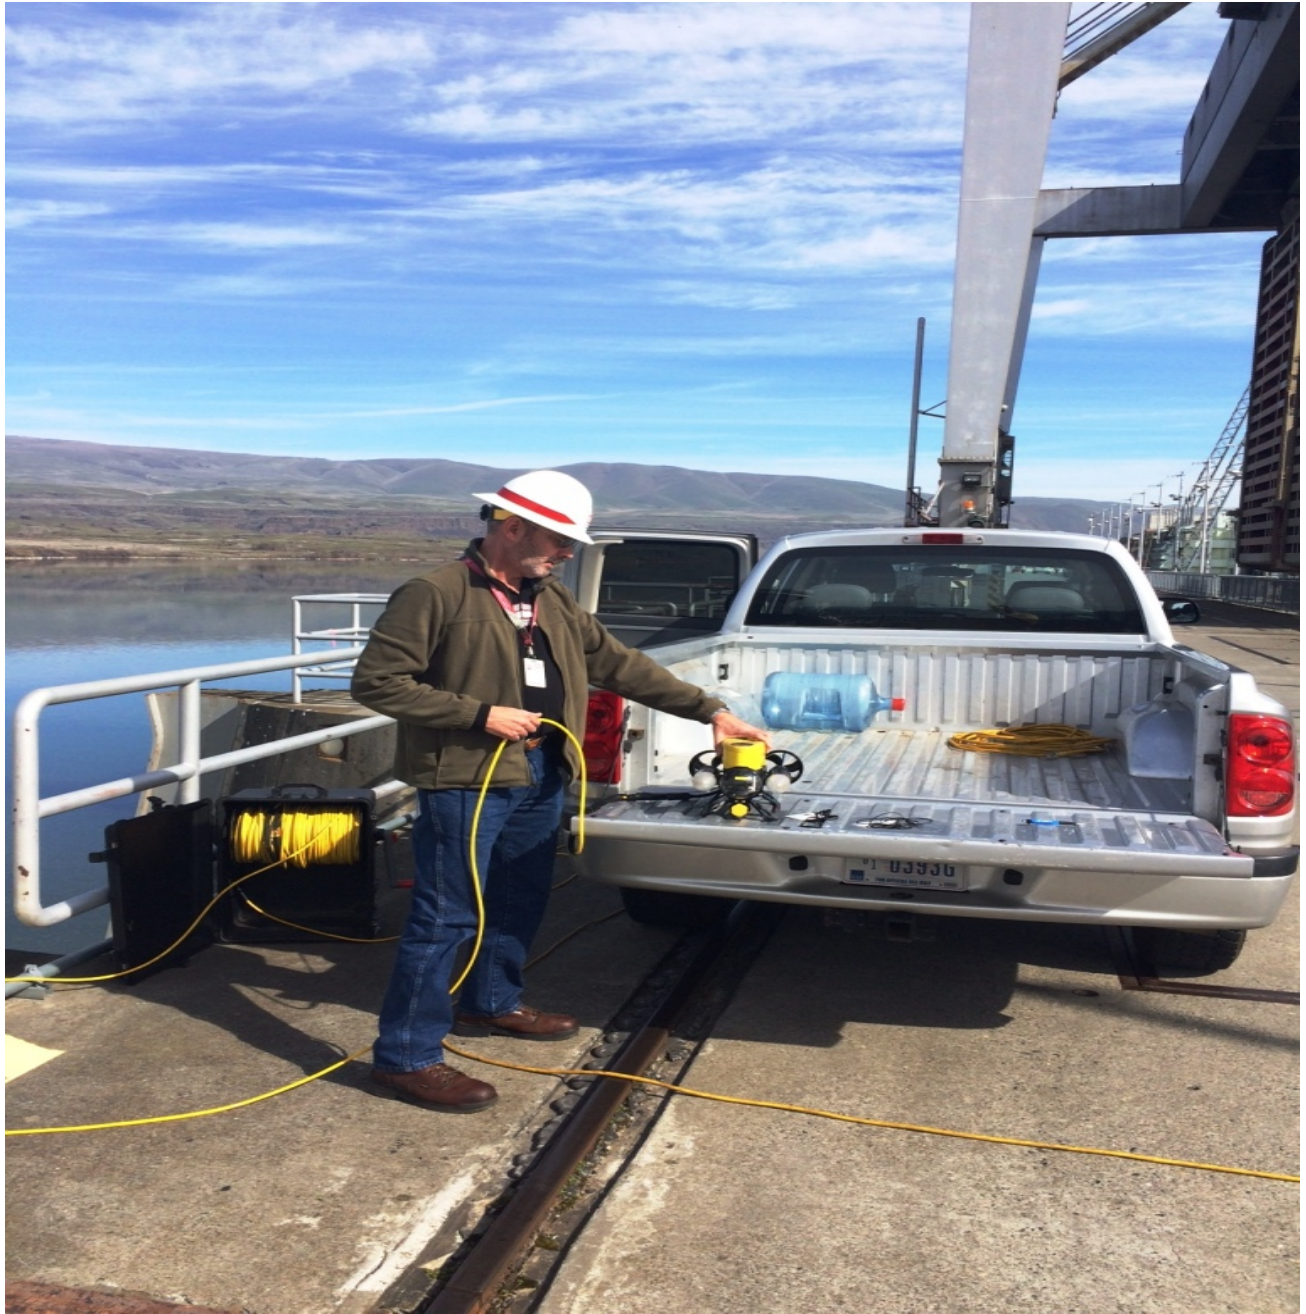
ROV inspection of MU4 and MU15 trash racks 3/10; trashracks clean except for a few sticks. See picture.

ROV inspection of MU4, MU15 trash racks 3/10; trashracks clean except for a few sticks.
