The Dalles Dam Fishway Status Report

3/22/2015

Inspection Period: 3/15/2015 to 3/21/2015

US Army Corps
of Engineers
Portland District

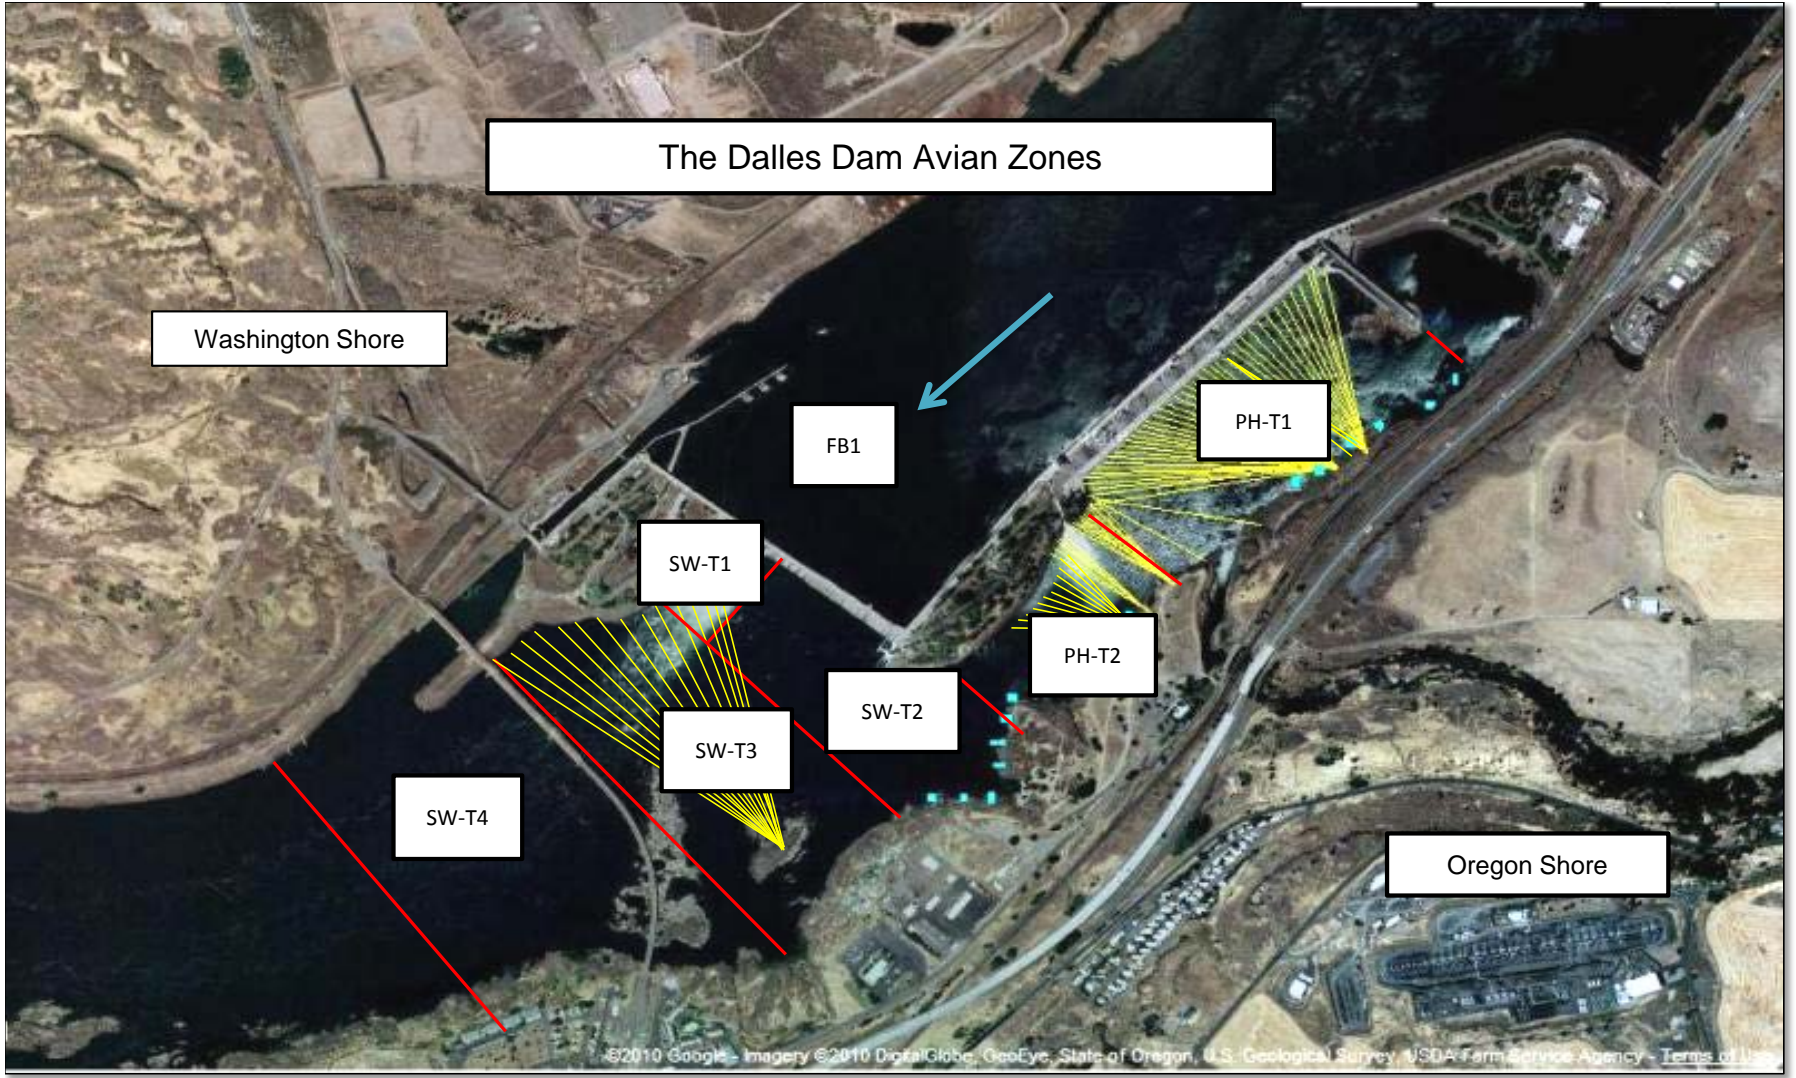
Bird observation data collected once daily. Refer to Avian Zone Map.

Avian lines in yellow, zones in red, river flow in blue.
