# The Dalles Dam Fishway Status Report

10/31/2015

Inspection Period: 10/25/2015 - 10/31/2015

US Army Corps  
of Engineers  
Portland District

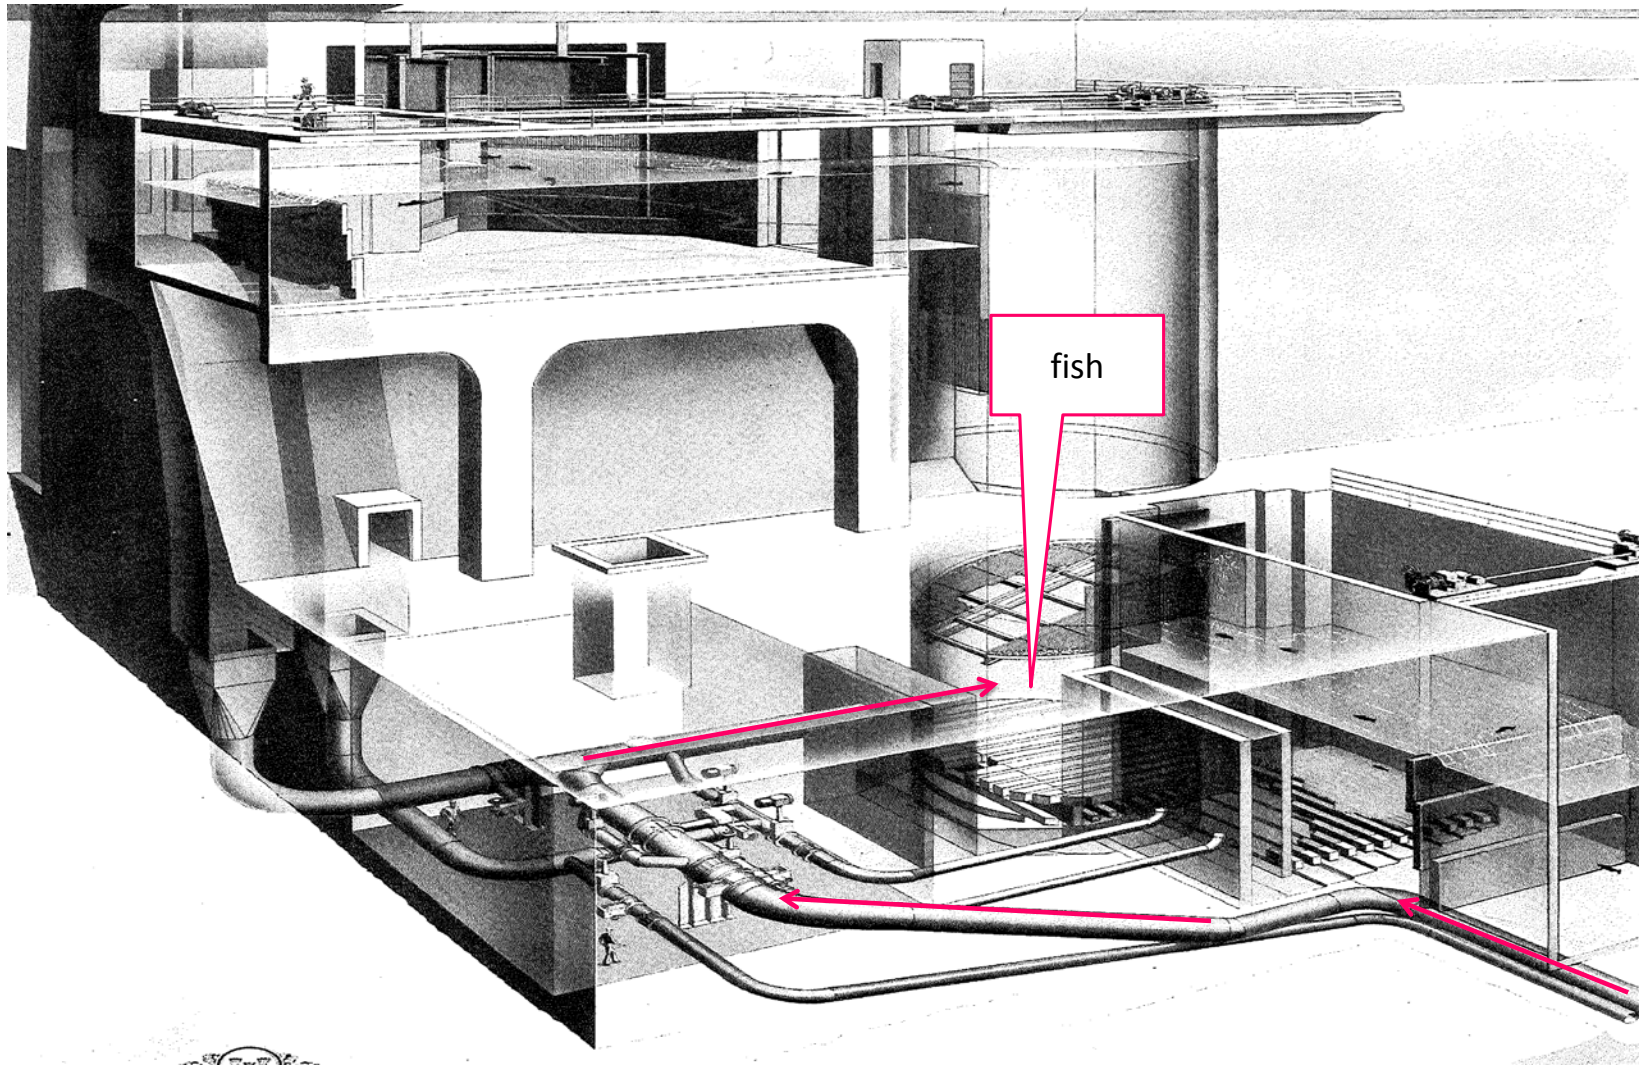
## Fishlock Schematic

**Eight salmonids observed in fish lock. Efforts continue for removal, however safe access is not achievable. Future preventative measures being discussed. Updated MFR provided to FPOM. Refer to pic tab for fishlock schematic.**

Schematic of Fishlock. Fish observed in cylindrical portion of lock. Likely entry from tailrace through pipe (lower right of pic). Bulkheads installed in intake (upper left of pic) to stop leakage flow.
