# The Dalles Dam Fishway Status Report

11/8/2015

Inspection Period: 11/01/2015 - 11/07/2015

US Army Corps  
of Engineers  
Portland District

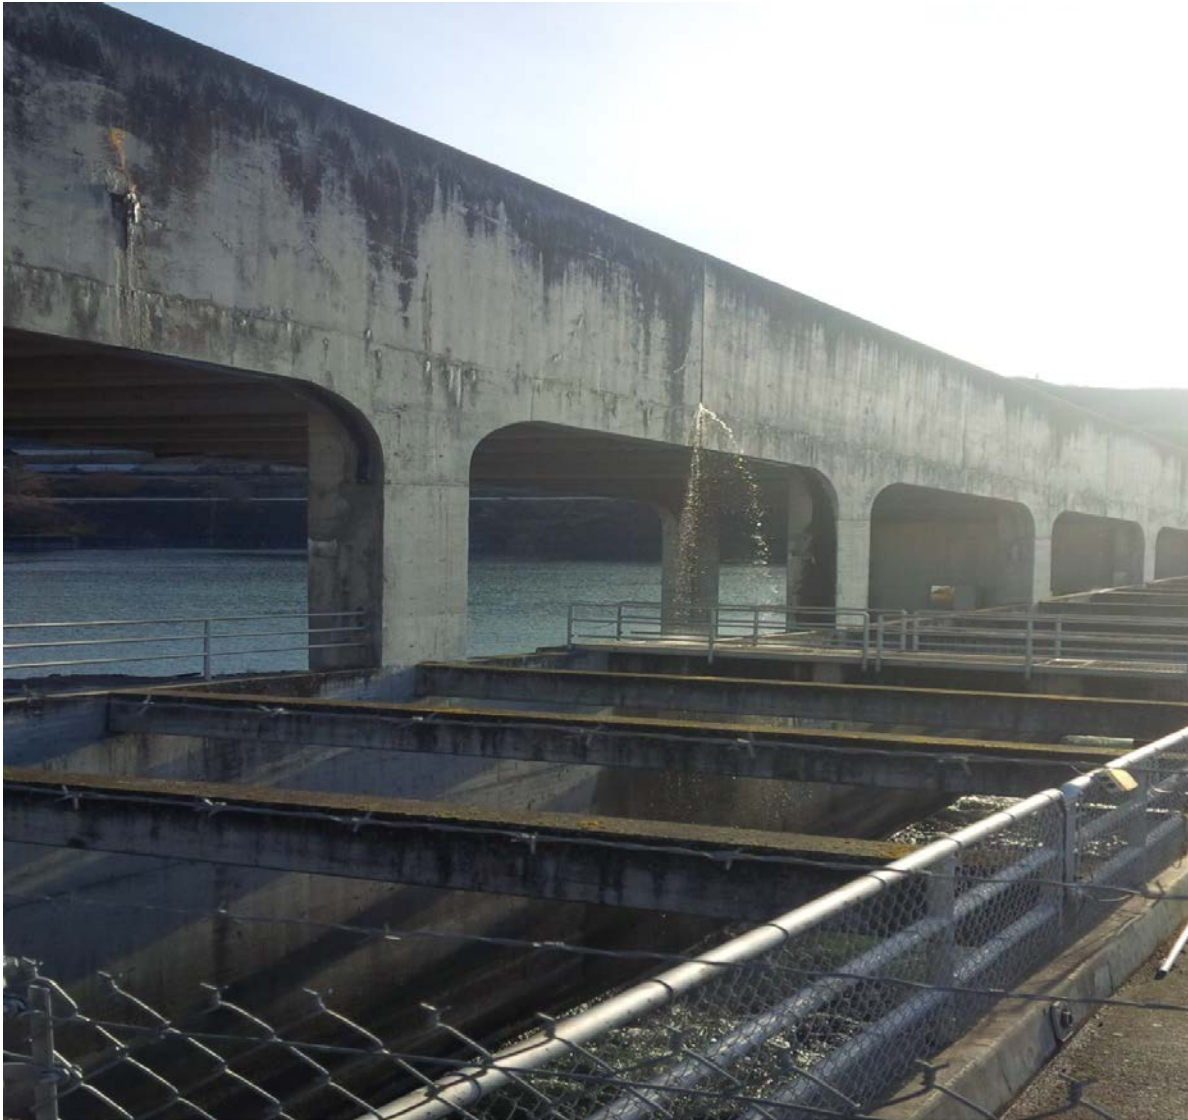
East fishladder expansion joint leakage increasing with decreased temperatures. Repair deferred to next season due to funding constraints. See Pic tab.

Leakage increase from east ladder expansion joint with decreasing temperatures.
