The Dalles Dam Fishway Status Report

11/15/2015

Inspection Period: 11/08/2015 - 11/14/2015

THE DALLES DAM

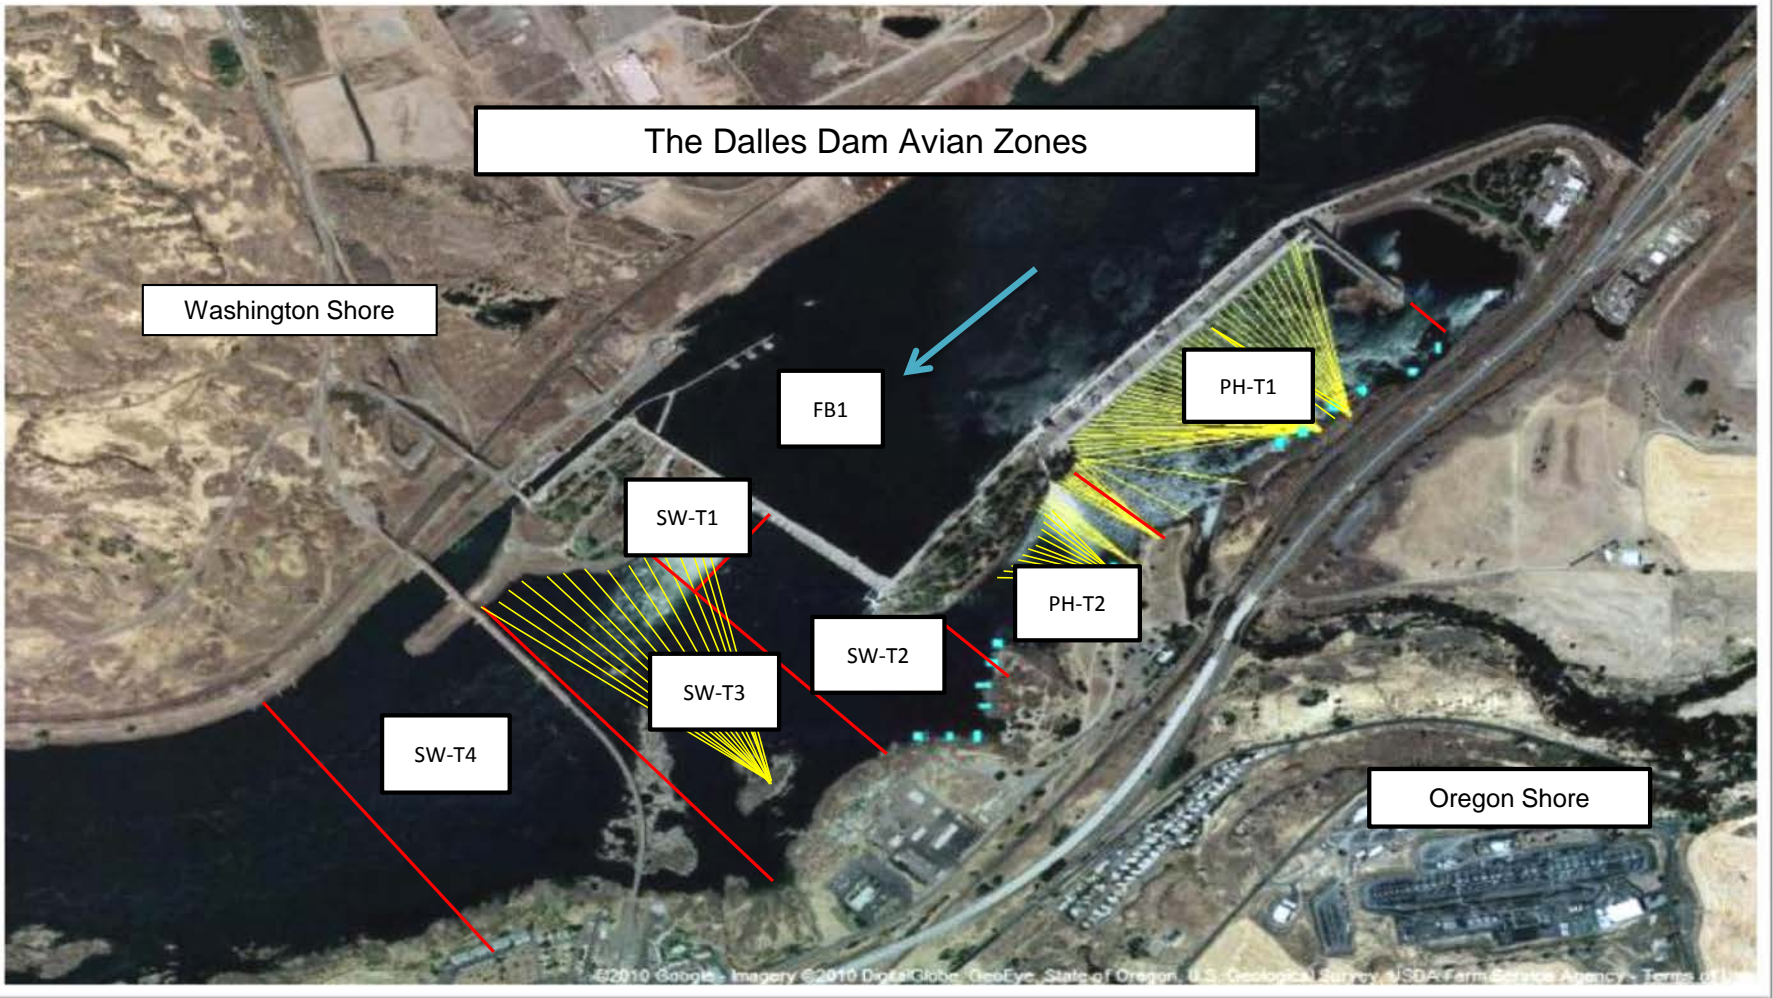
Avian lines in yellow, zones in red, river flow in blue.
