# The Dalles Dam Fishway Status Report

11/21/2015

Inspection Period: 11/15/2015 - 11/21/2015

## THE DALLES DAM

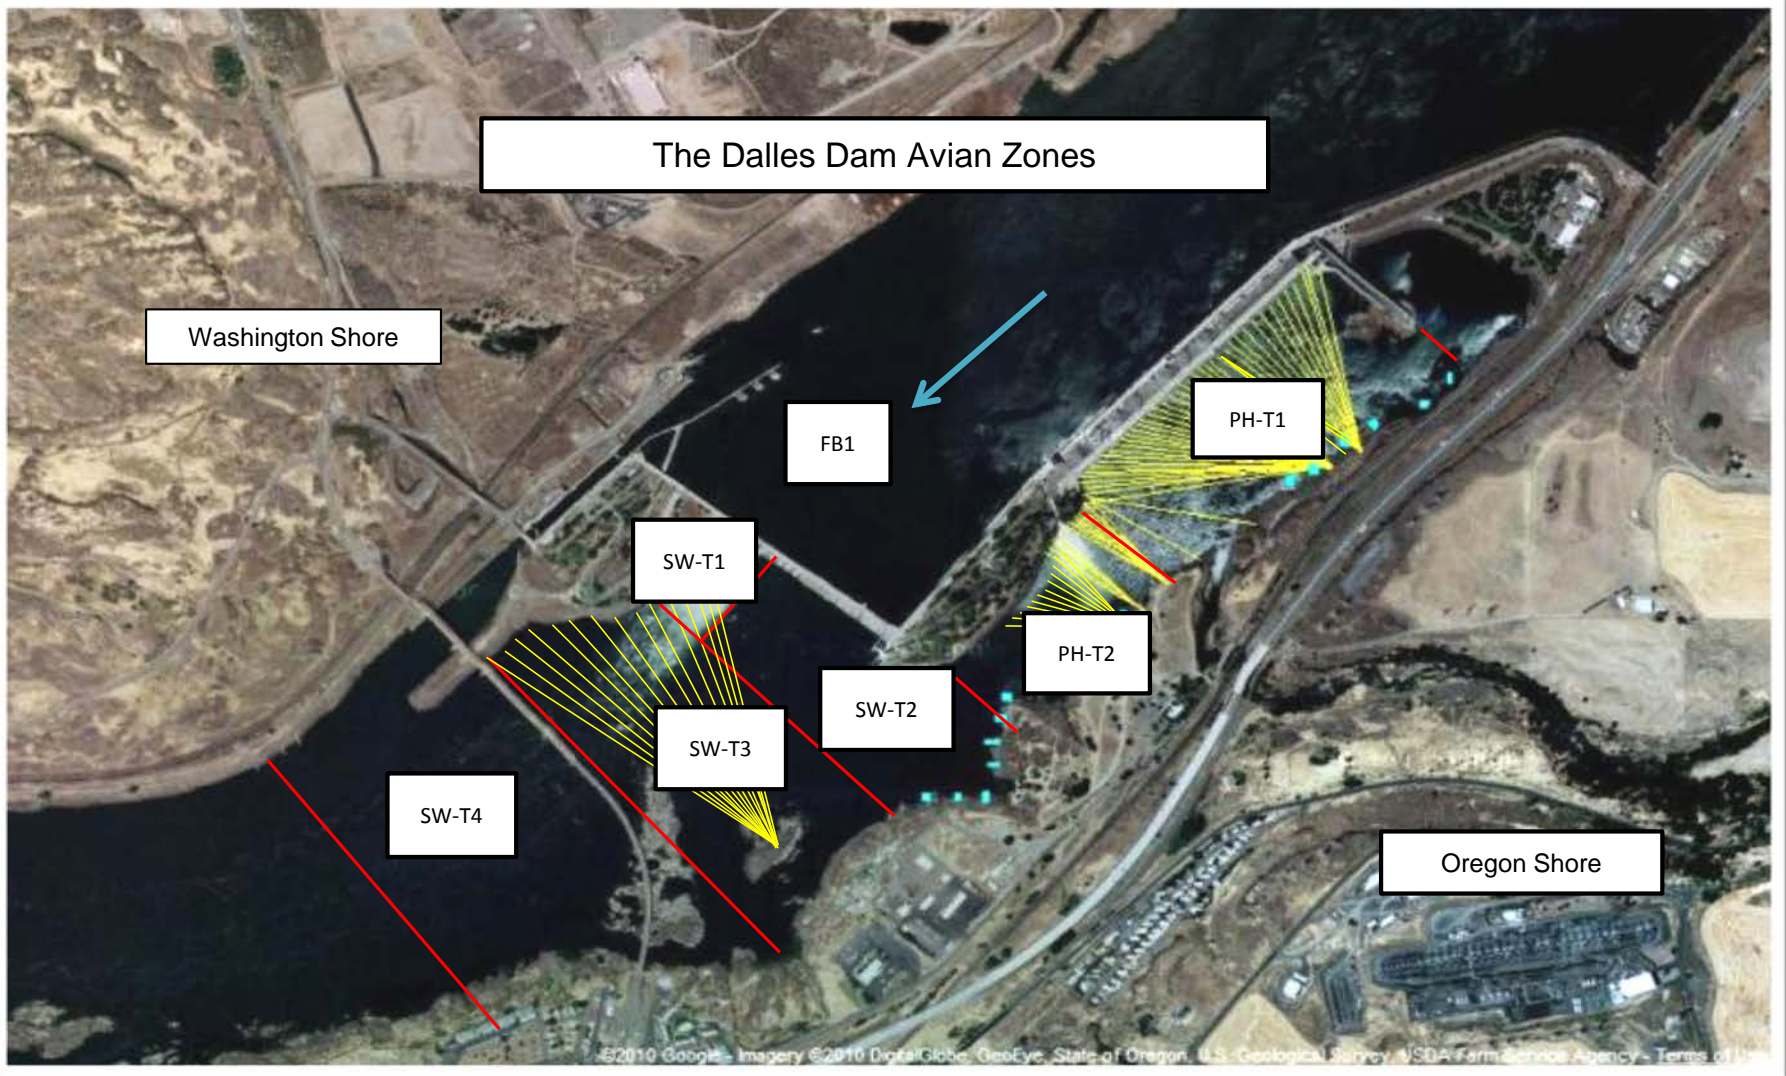
Bird observation data collected once daily. Refer to Avian Zone map.

Avian lines in yellow, zones in red, river flow in blue.
