The Dalles Dam Fishway Status Report

11/28/2015

Inspection Period: 11/22/2015 - 11/28/2015

US Army Corps
of Engineers
Portland District

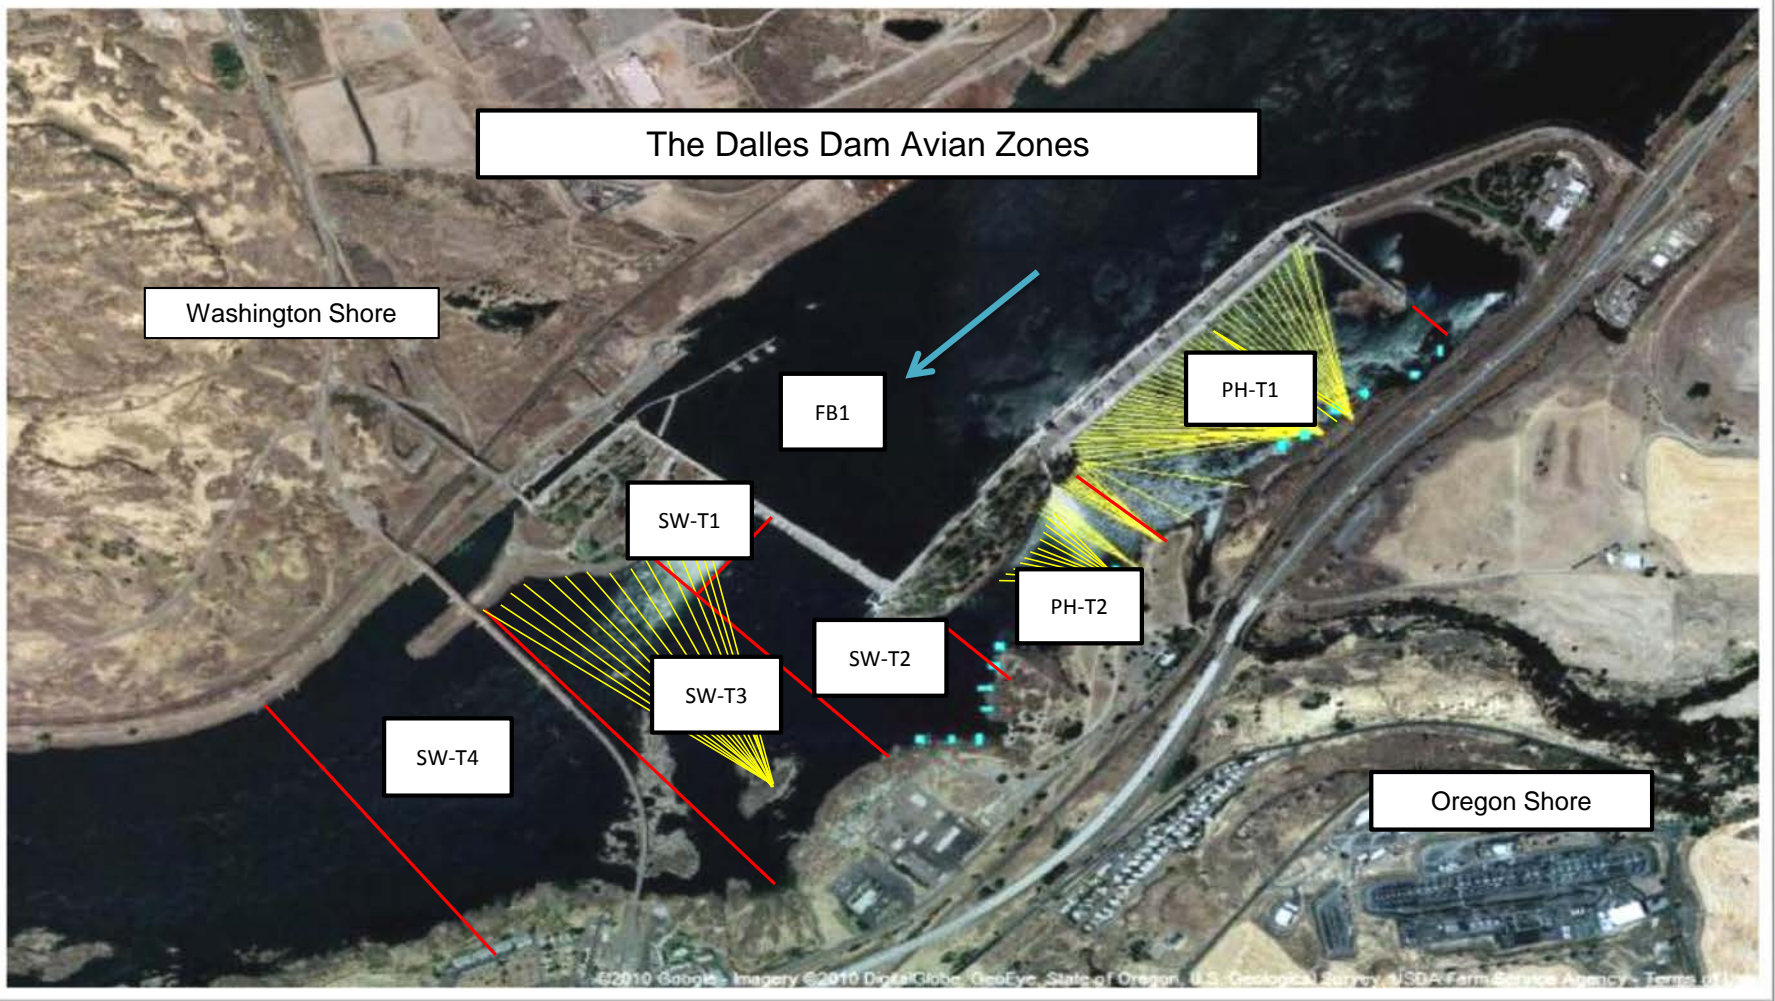
Avian lines in yellow, zones in red, river flow in blue.
