The Dalles Dam Fishway Status Report

06/7/2020

Inspection Period: 5/31-6/6

US Army Corps
of Engineers
Portland District

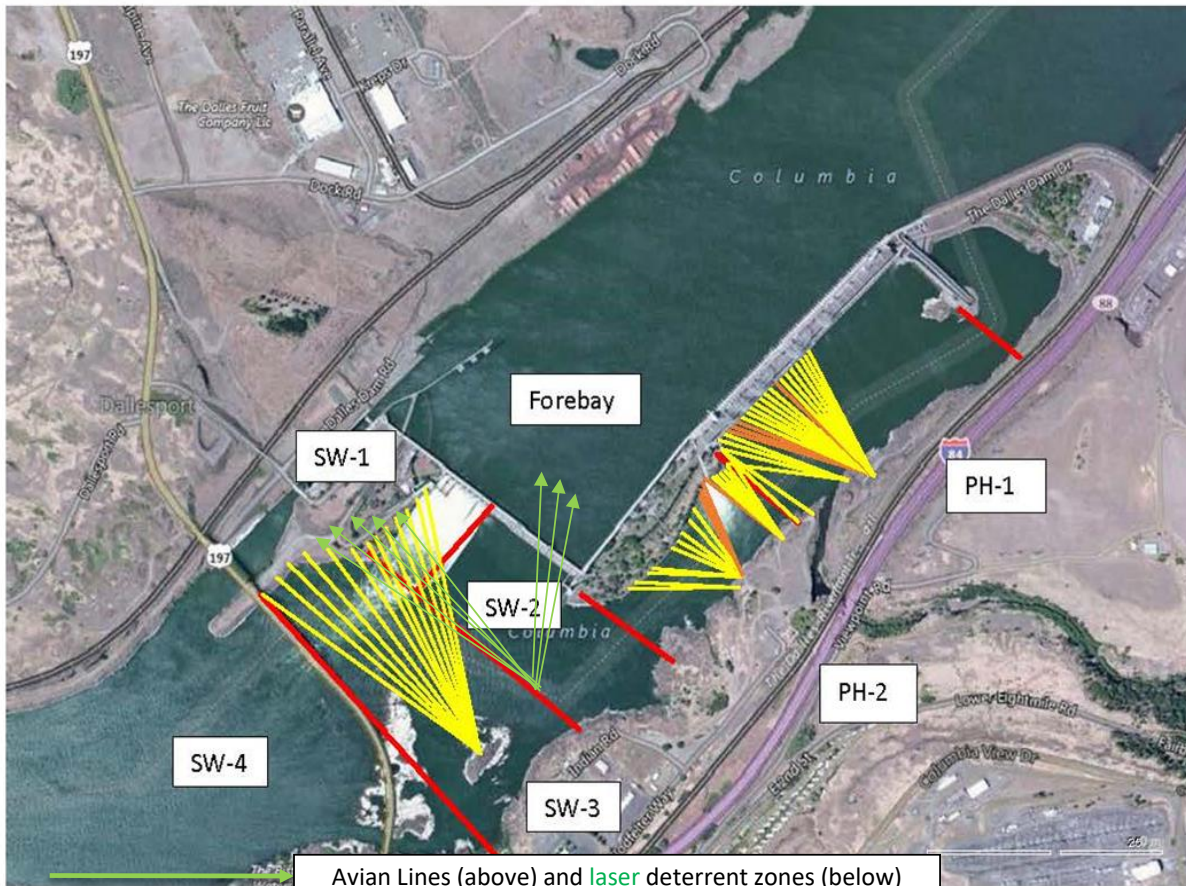
Avian Lines (above) and laser deterrent zones (below)

Orange lines = down or missing wires

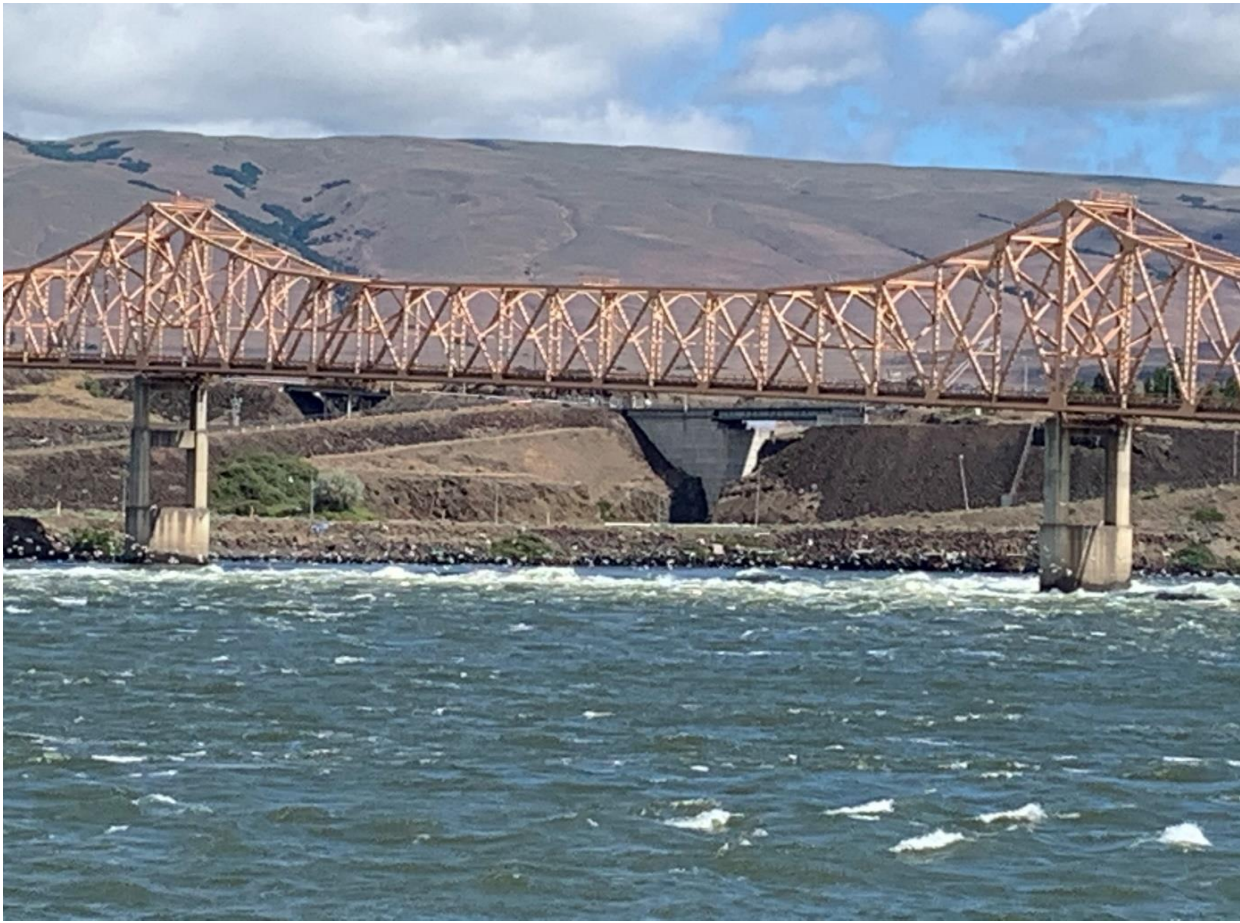
Hungry gulls are doing their thing despite continued hazing efforts.
