The Dalles Dam Fishway Status Report

9/13/2020

Inspection Period: 9/6-9/12

THE DALLES DAM

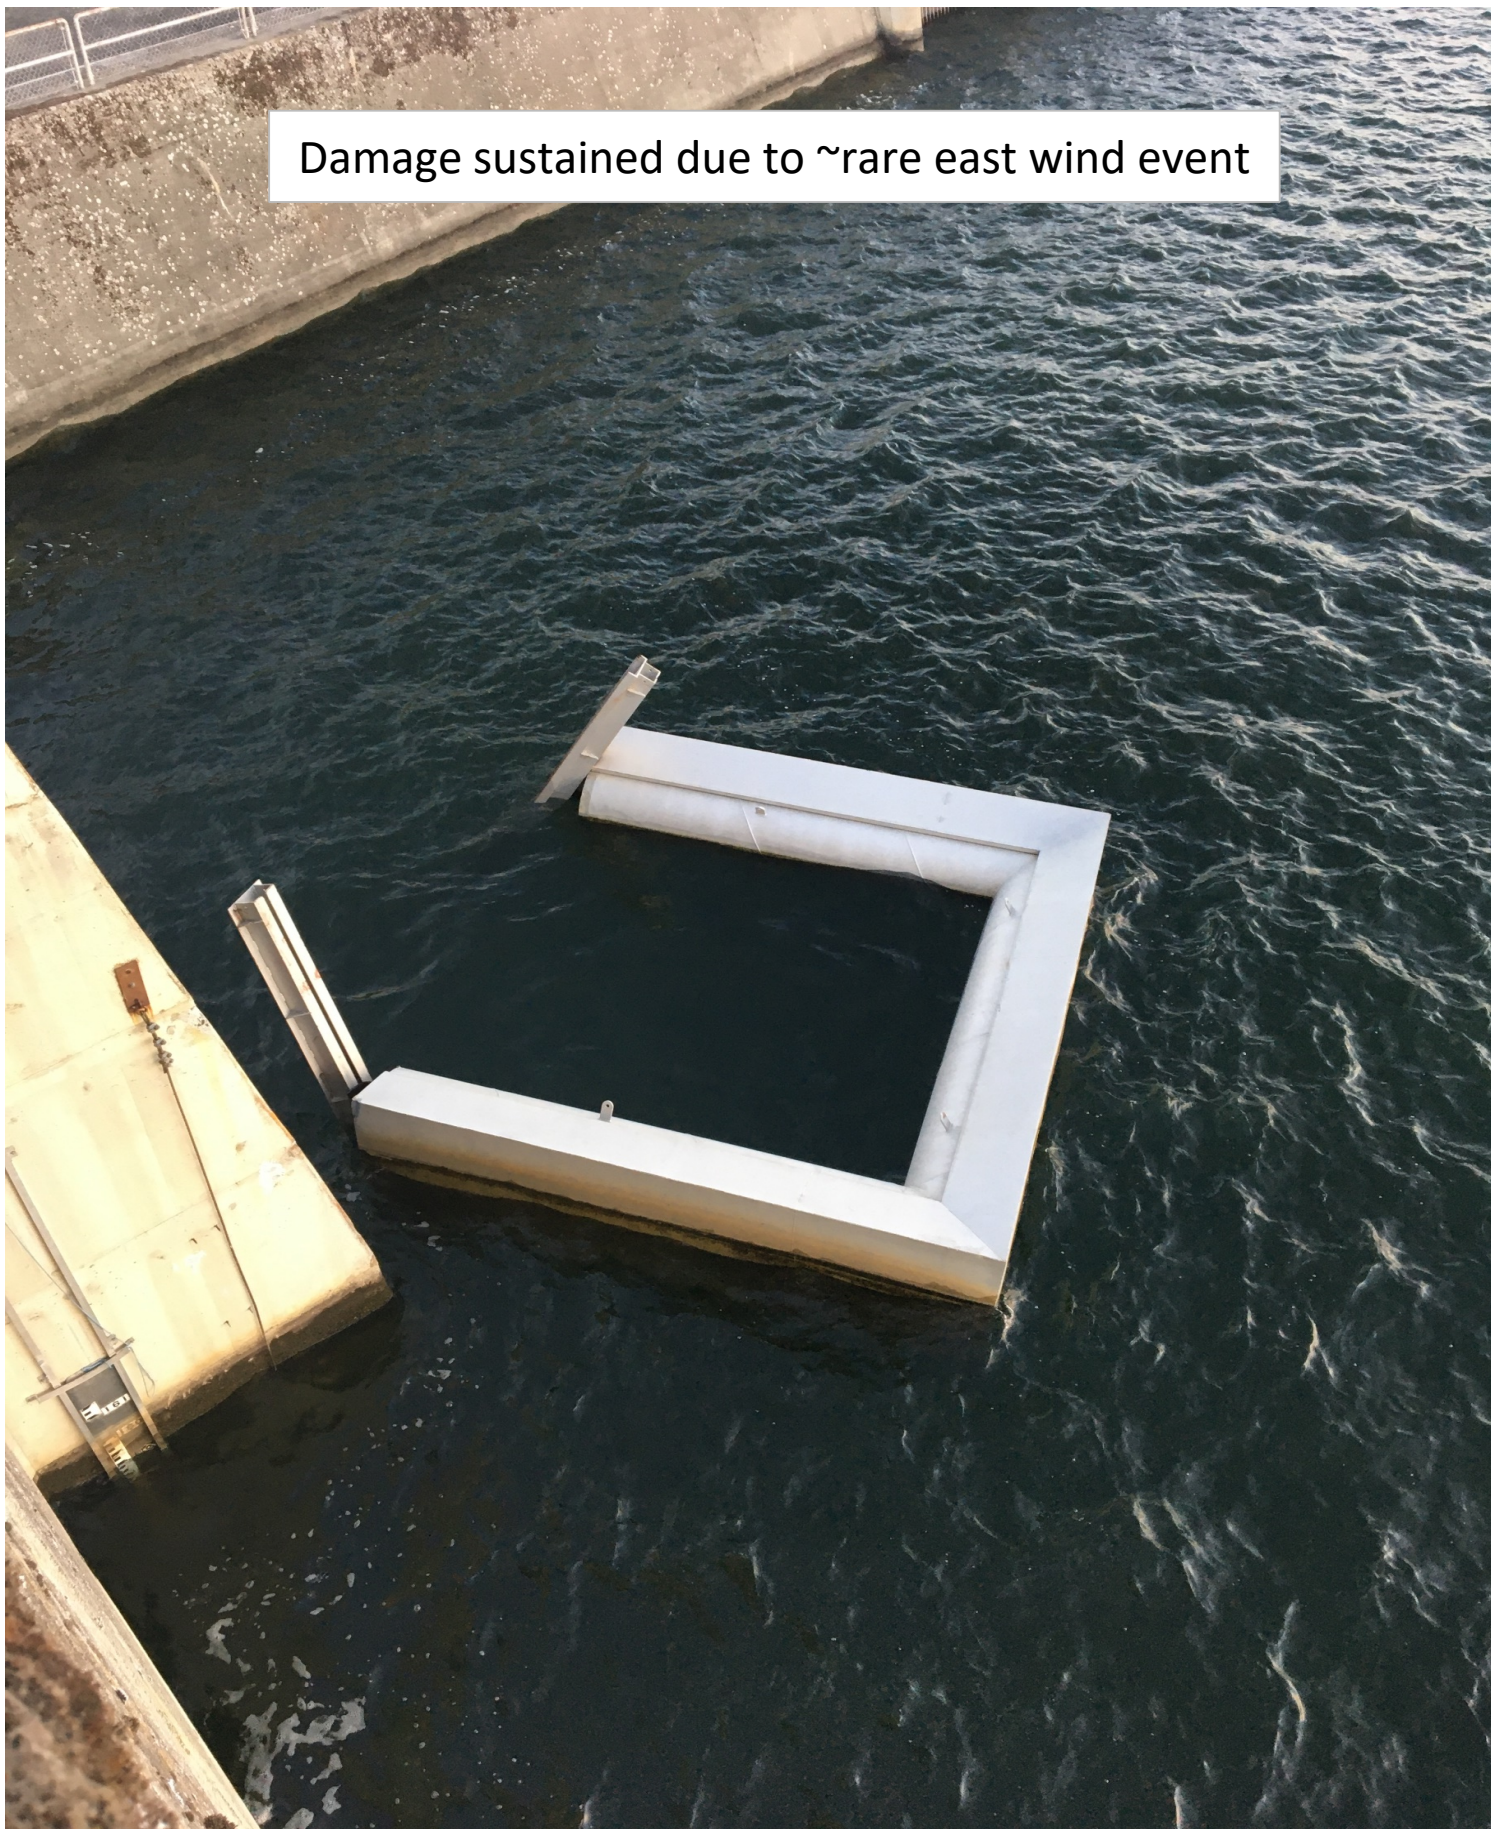
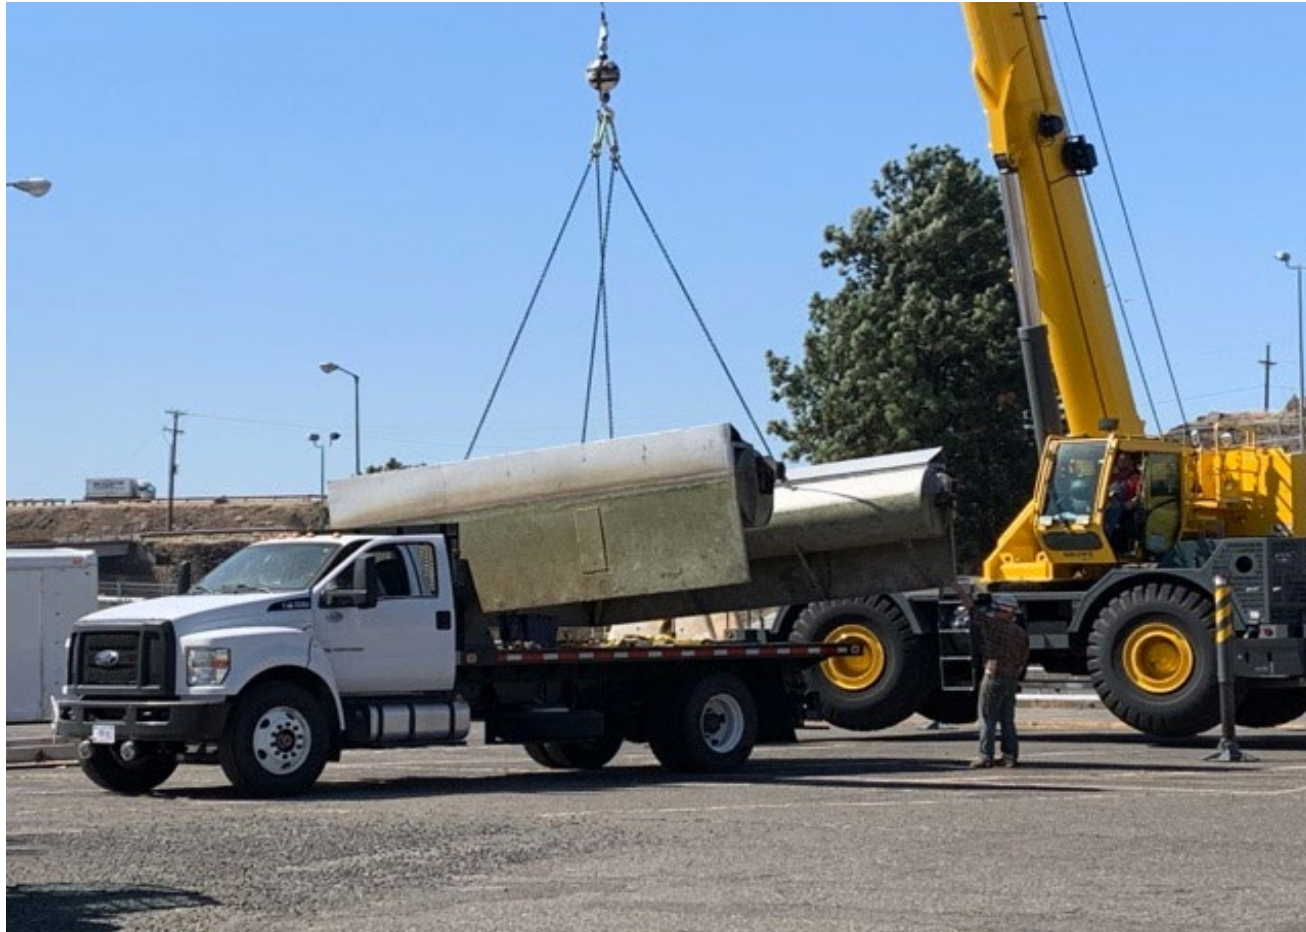
Damage sustained due to ~rare east wind event

repairs underway

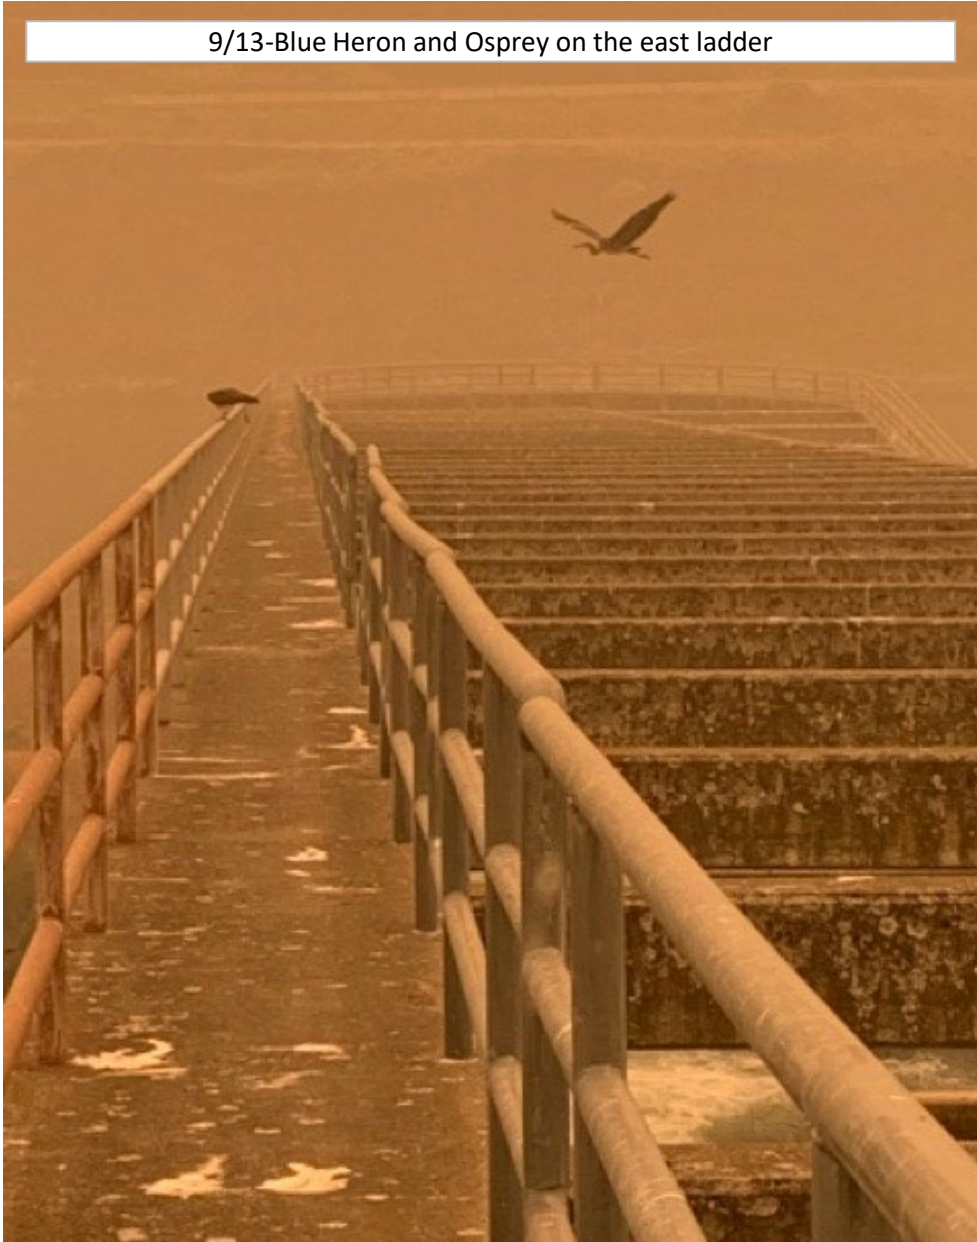
9/13-Blue Heron and Osprey on the east ladder
