The Dalles Dam Fishway Status Report

10/5/2020

Inspection Period: 9/27-10/03

THE DALLES DAM

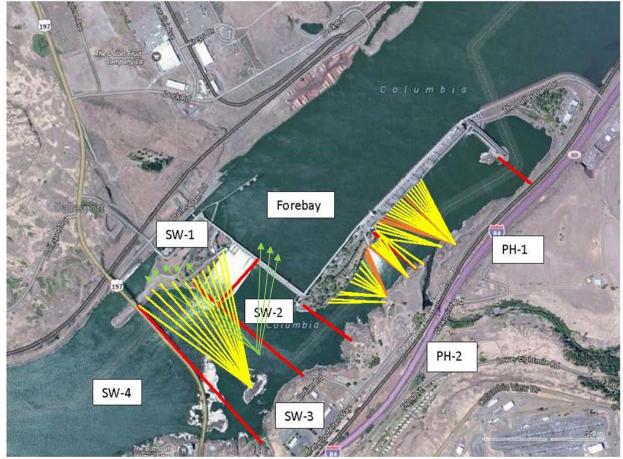
Avian Lines and laser deterrent zones

Red lines = avian zones

Yellow lines = current wires

Orange lines = down or missing wires

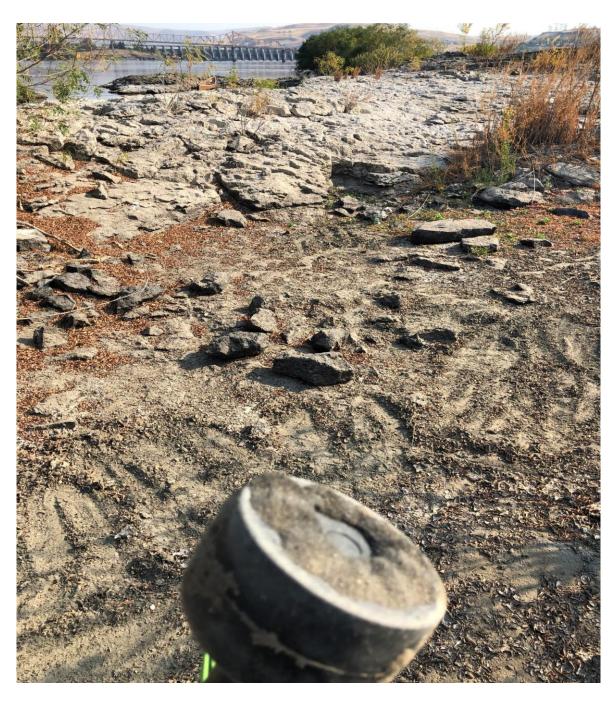
PIT recovery efforts below dam 10/2/2020. No tags were found. Plenty of magnetic grit.
