# The Dalles Dam Fishway Status Report

11/29/2020

Inspection Period: 11/22 - 11/28

US Army Corps  
of Engineers  
Portland District

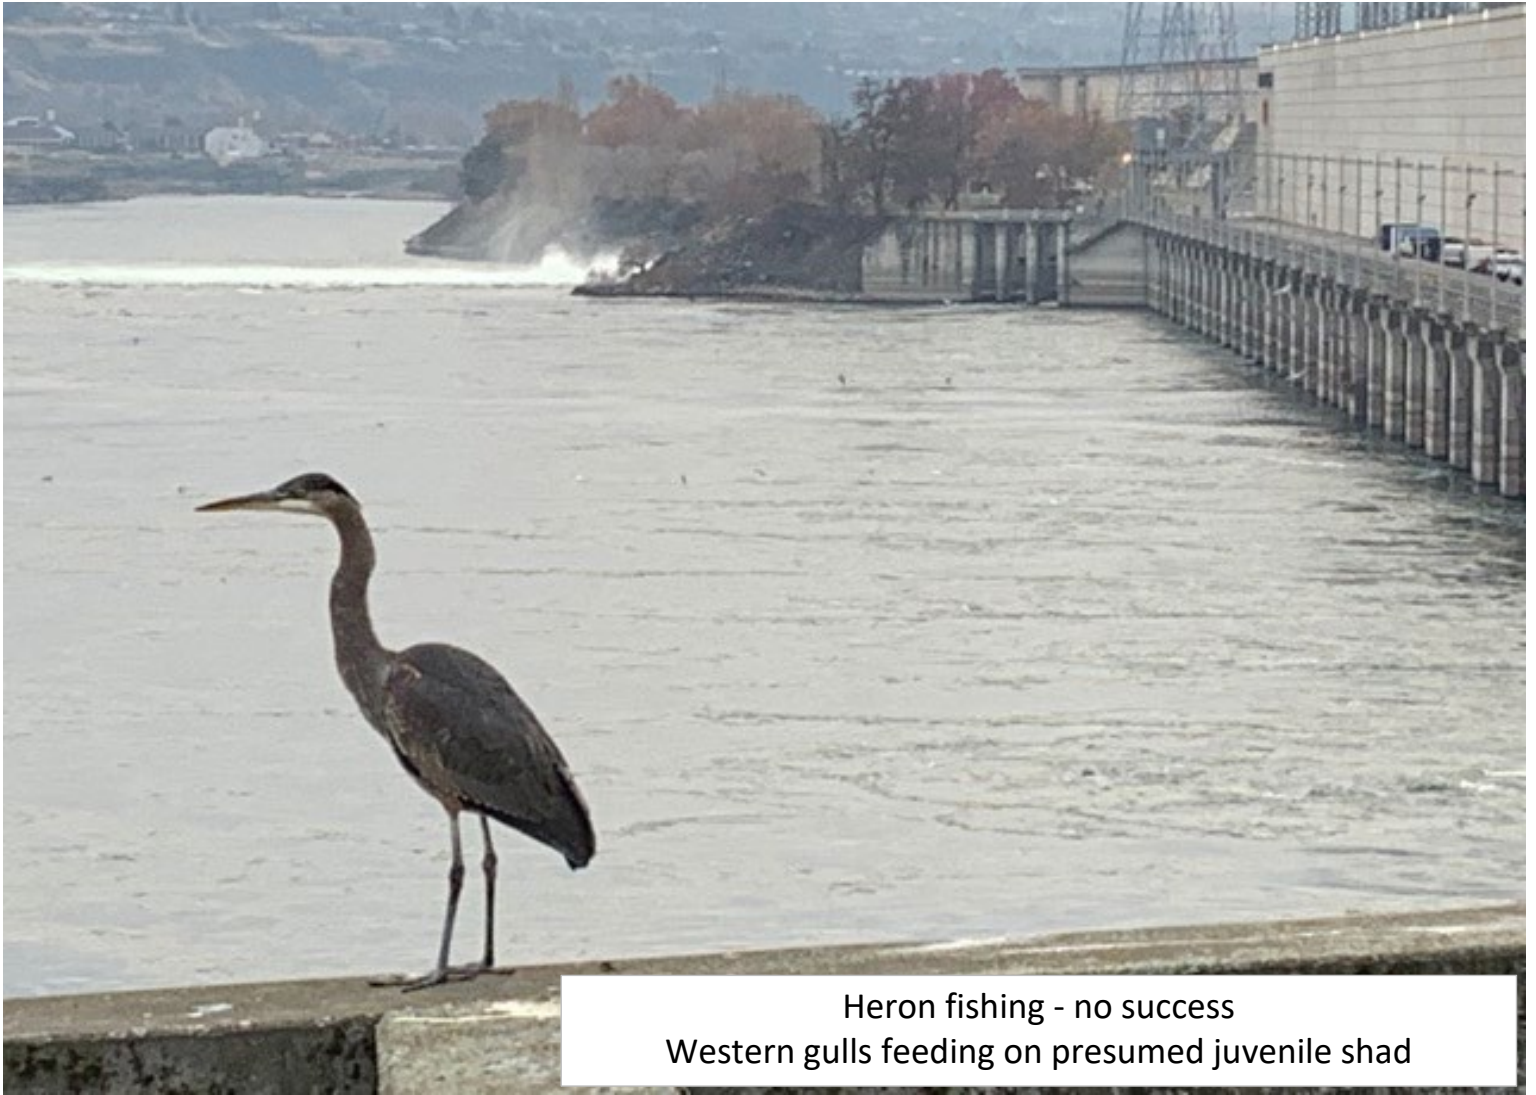
Heron fishing - no success  
Western gulls feeding on presumed juvenile shad
